IN REPLY REFER TO:
5830
CMFR
6 Sep 18

From: Commander, Marine Forces Reserve
To: File

Subj: COMMAND INVESTIGATION INTO THE CLASS A AVIATION MISHAP WITHIN
MARINE AERIAL REFUELER TRANSPORT SQUADRON 452 ON 10 JULY 2017

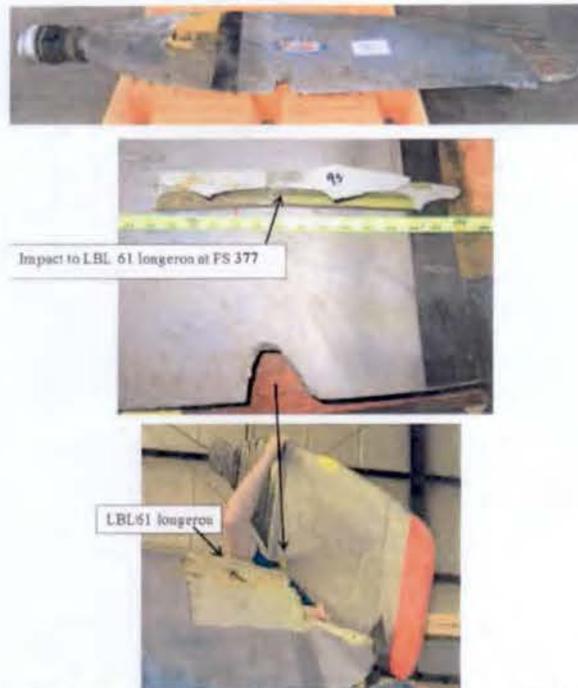
Figure 6: Reconstruction of P2B4 Impacting Port Side Panel

121. After departure, P2B4 sliced through the port side of the fuselage at FS 377 slightly aft of the propeller arc plane upon entry in a near vertical orientation. This deteriorated the left side longeron support structures as the tip cut 36 inches below left butt line (LBL) 61 and the root end of the blade impacted 19 inches above LBL 61. P2B4 then passed unobstructed through the MAC interior, and did not exit the airframe but rather impacted the interior starboard side of the cargo compartment where it remained until cargo compartment separation. [Encls (13), (21), (22)]

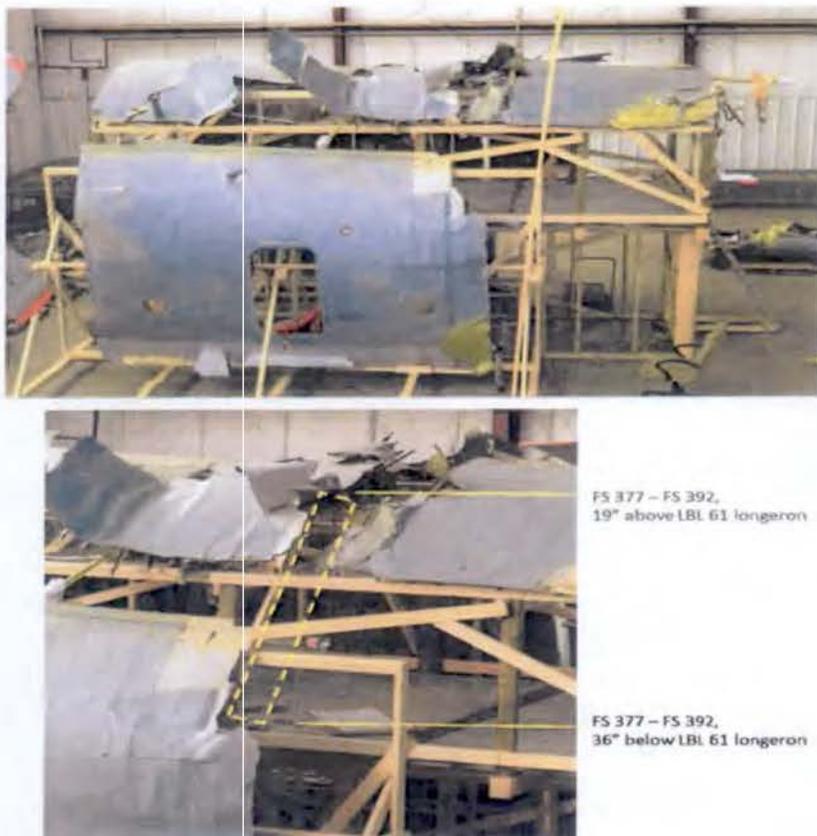
Figure 7: P2B4 Fuselage Damage

122. P2B4's intrusion resulted in an overload failure of the LBL 61 longeron on both sides of the impact point at FS 377. [Encl (21)]

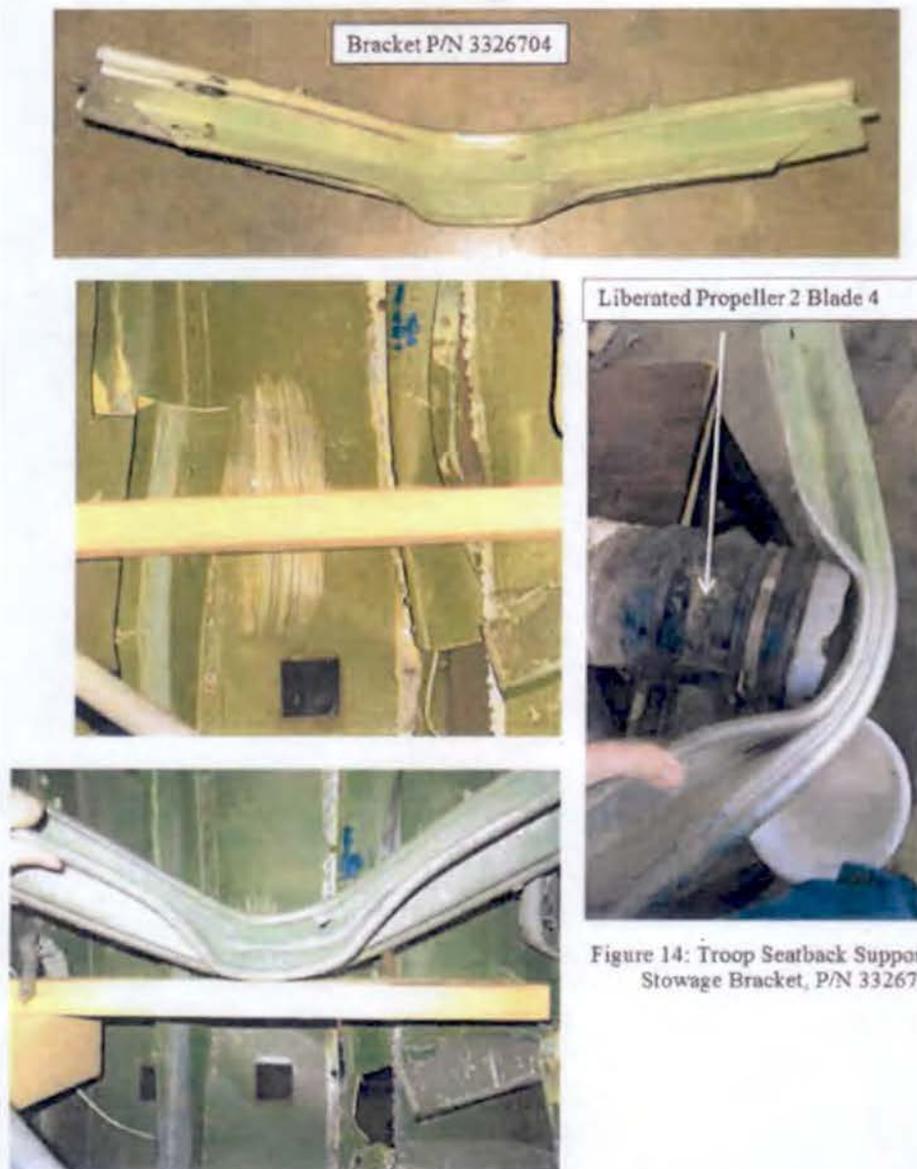
Figure 8: Reconstruction of P2B4 Impact to Stanchion Bracket

123. When P2B4 passed unobstructed through the occupied space of the fuselage and impacted the starboard interior, the butt end of the blade then embedded into the robust stanchion bracket from a troop seatback support beam stowage assembly on the starboard side of the fuselage near waterline (WL) 200 between the ring segments at FS 383.67 and FS 397. [Encl (21)]

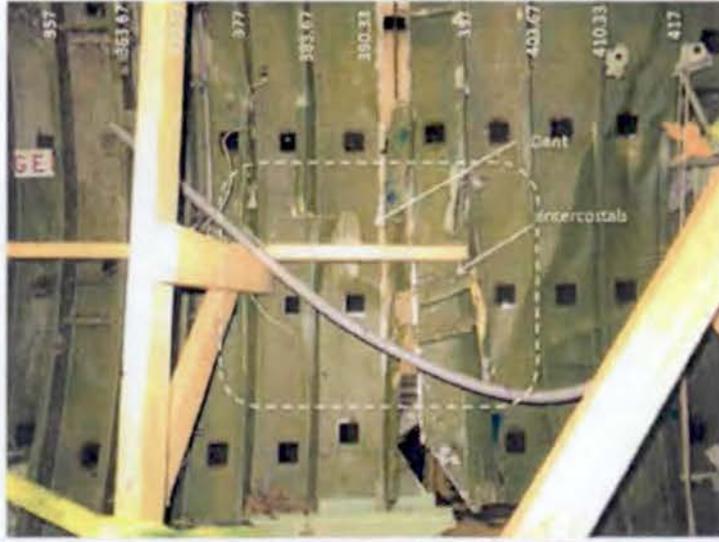
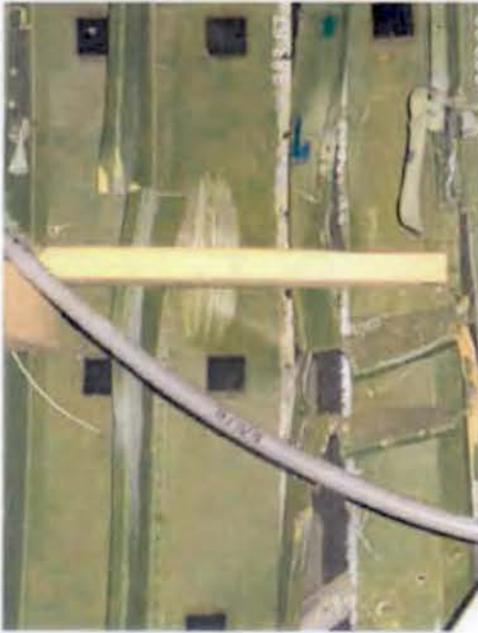
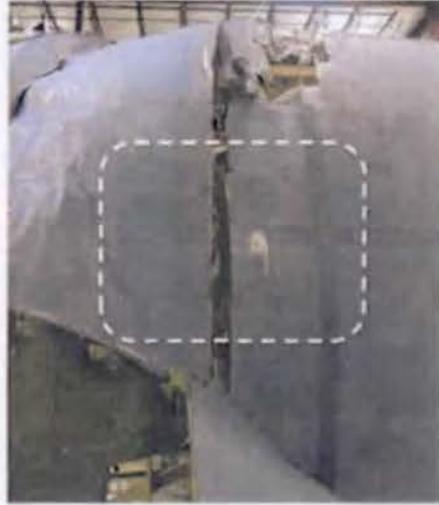
Figure 13: Center Fuselage Section Right Side

125. Just aft of the point where P2B4 impacted the starboard interior support beam, the center fuselage starboard side skin separated along FS 390.33 up toward the starboard side longeron support structures. [Encls (13), (21), (22)]

Impact damage from blade impacting right sidewall near WL200 between STA 377-397

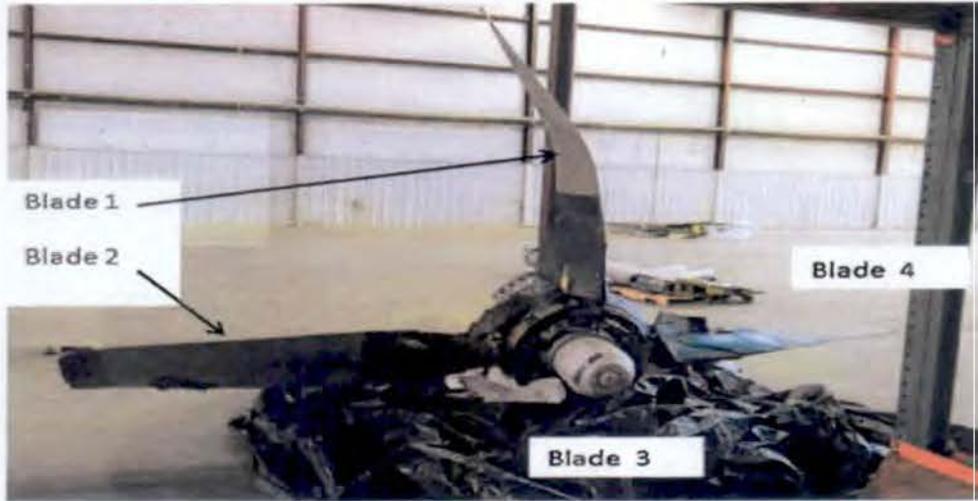
Figure 10: Propeller Assembly Three

128. When propeller three embedded in the upper section of the fuselage, it pushed the upper structure backward, resulting in an accordion-like buckling failure of RBL 20 longeron. [Encl (21)]

129. This intrusion of propeller three caused overload failure of the RBL 61 longeron to each side of the point of impact, and the propeller continued upward to exit approximately 10 inches below RBL 20 longeron. [Encl (21)]

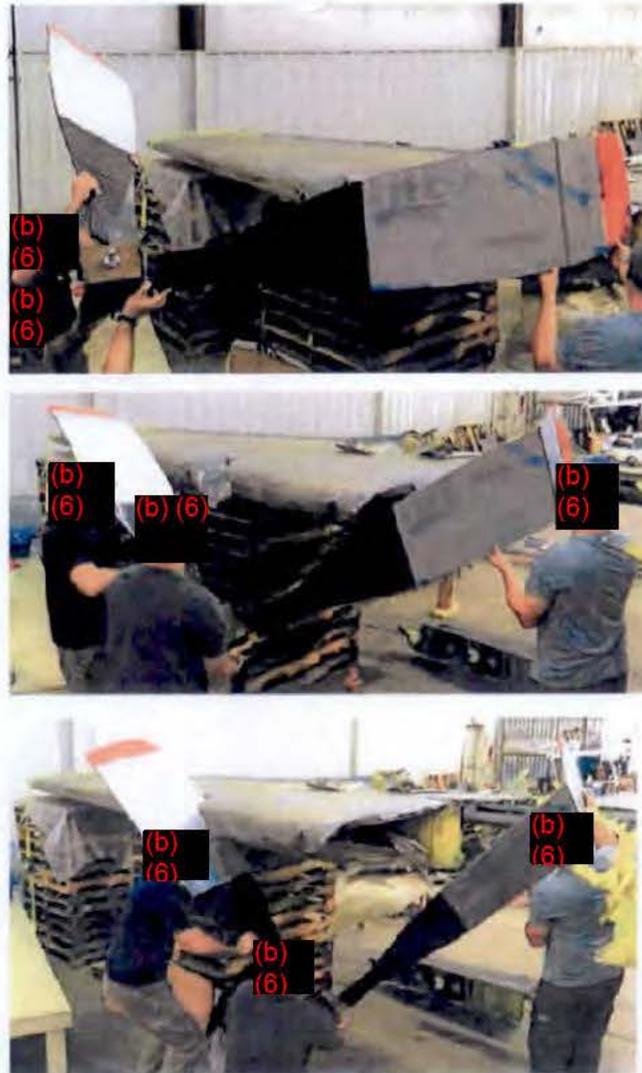
Figure 11: Reconstruction of Propeller Three Impact to Horizontal Stabilizer

135. Blade one of propeller three impacted the starboard side horizontal stabilizer at horizontal stabilizer station (HSS) 130 oriented such that the end of the airfoil tip inserted into to the leading edge, pushing rear through the stabilizer and rotating downward upon contact with the front beam assembly, slicing through the lower surface. [Encl (21)]

edge of the right side horizontal stabilizer near HSS 180 and halting before coming into contact with the front beam. [Encl (21)]

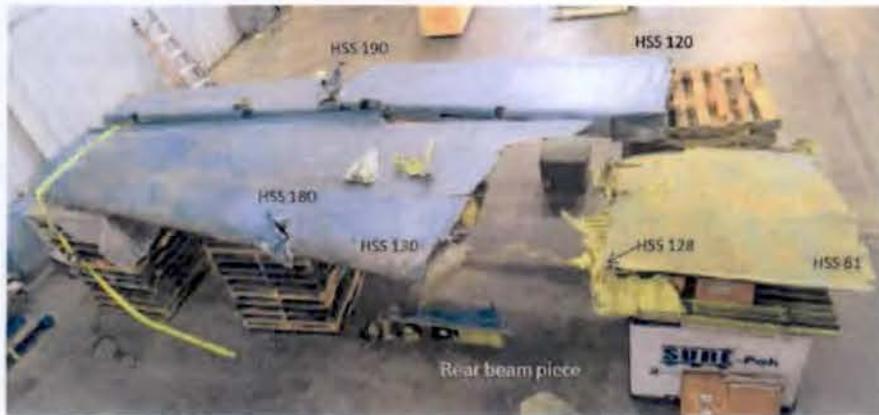
Figure 12: Horizontal Stabilizer

137. The right hand outer section of the starboard horizontal stabilizer, as well as the right hand elevator, both liberated as a direct consequence of impact from propeller three. [Encl (21)]

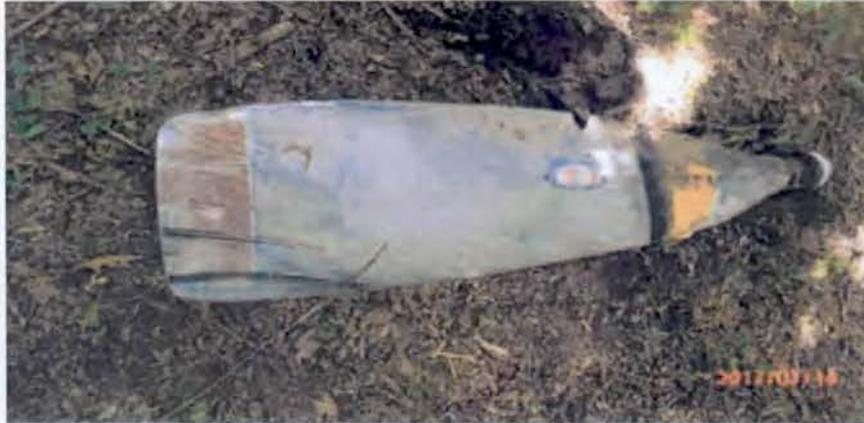
Figure 13: P2B4

145. A post-mishap inspection showed that P2B4 had an intergranular crack (IGC) and radial crack in the vicinity of the bushing bore of the propeller. This developed from corrosion pitting and intergranular cracking that was present and not removed during the last overhaul performed by WR-ALC in September 2011. [Encls (22), (30), (31)]

146. Bushing and taper bore inspections of P2B4 revealed the following discrepancies: bushing epoxy primer was not present; permatreat was not present; and substantial clustered active corrosion was found with fluorescent penetrant inspection (FPI), and confirmed with an eddy current inspection in the bushing bore area of the blade taper bore. [Encls (22), (27)]

147. Active corrosion and the resulting IGC were found in the bushing bore area of the taper bore. [Encls (22), (27)]

148. Anodize coating was found extending into corrosion pitting and IGC. [Encls (22), (27)]

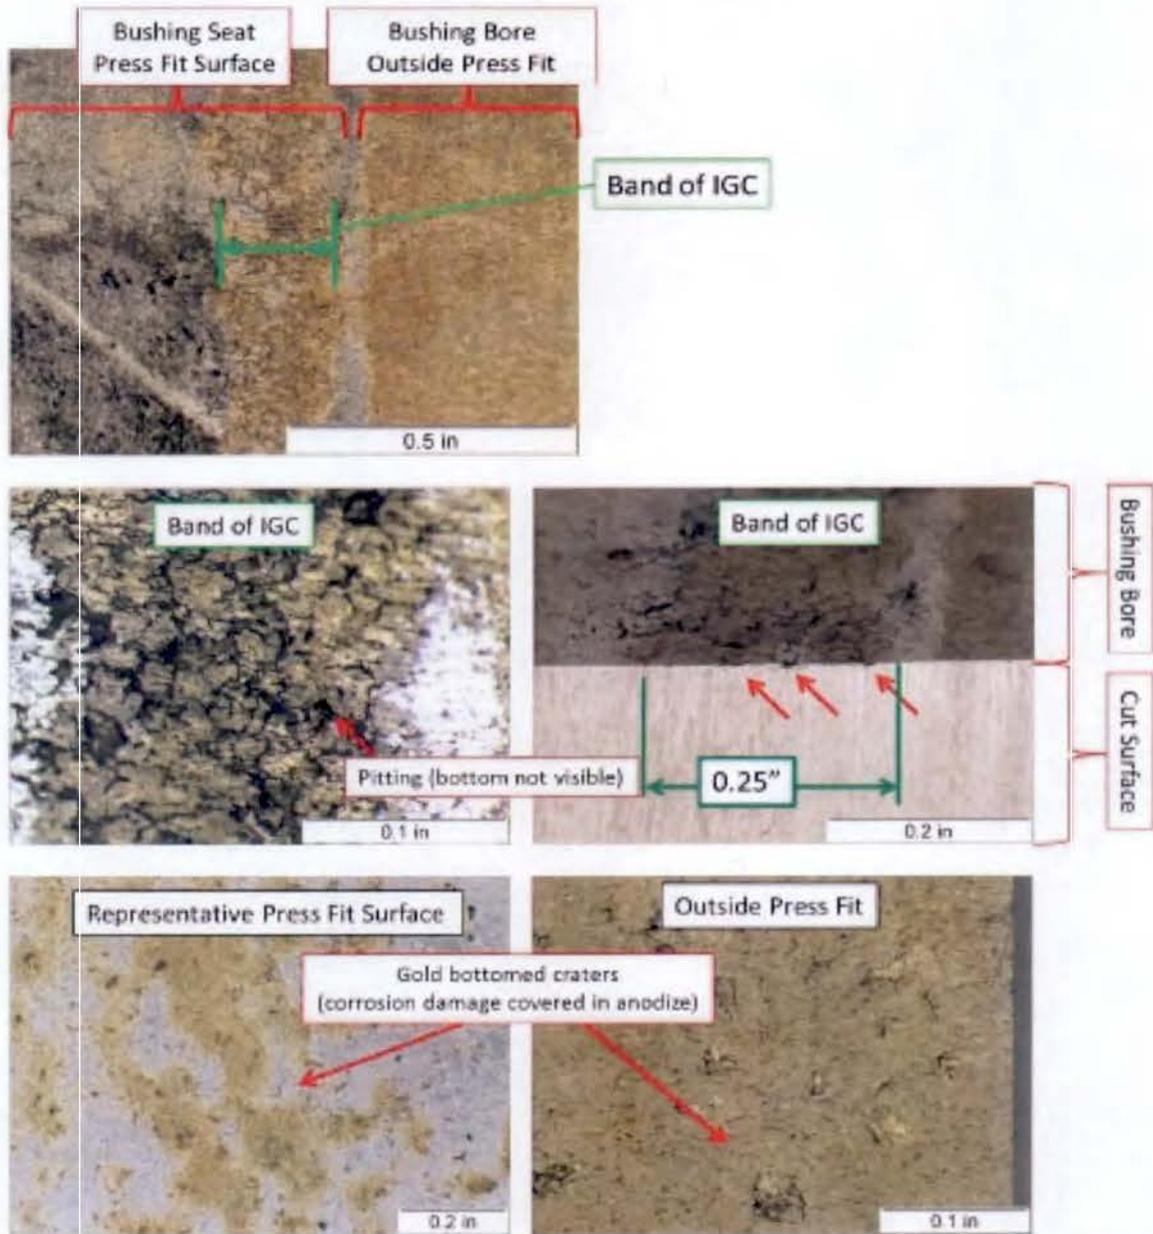
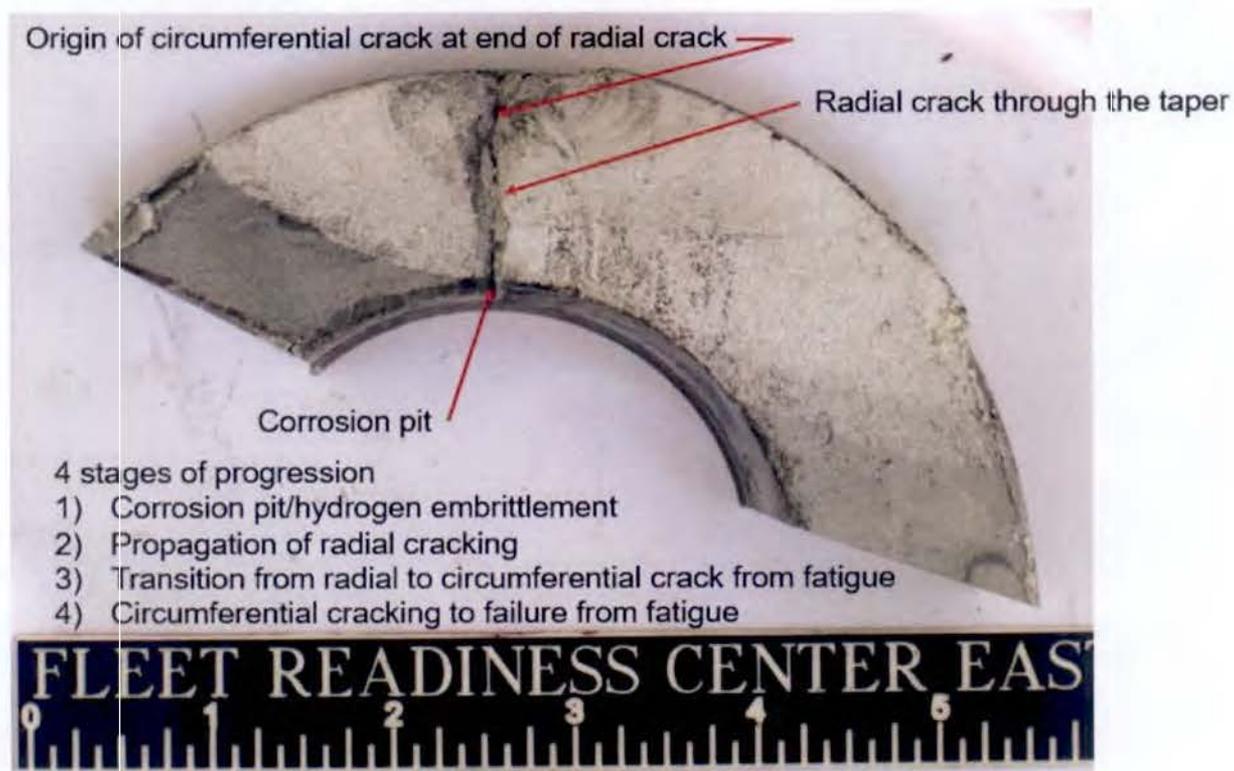
Figure 15: Radial Crack Root Cause

152. The presence of the clustered active corrosion and IGC initiated the formation of the intergranular radial crack in blade four. [Encls (22), (27)]

153. This intergranular radial crack in P2B4 had grown to a total of 2.7 inches in length along the interior taper bore of the blade, extending 1.25 inches beyond the bushing. [Encls (22), (27), (30)]

155. The radial crack had grown outward through 64 percent of the shank wall section until it was 0.45 inches from the outer diameter at the time P2B4 liberated on 10 July 2017. [Encls (22), (27), (30)]

156. This radial crack propagated towards the blade tip and led to the formation of the circumferential fatigue crack which propagated around the blade shank due to normal operating loads. This circumferential fatigue crack was undetectable by an off wing eddy current inner taper bore inspection due to the fact it was entirely behind the bushing. [Encls (22), (27), (30)]

159. The intergranular radial crack in blade four, which ultimately was the root cause of this catastrophic mishap, developed and matured from corrosion pitting and IGC that was not removed during the last blade overhaul in the fall of 2011. [Encls (22), (27), (30)]

163. The corrosion damage on P2B4 should have been detected and removed, but was not removed, at WR-ALC during the last overhaul in 2011. The lack of detection and removal of this corrosion is attributed to noncompliance with established publications and procedures within them. [Encls (22), (24), (27), (28), (30)]

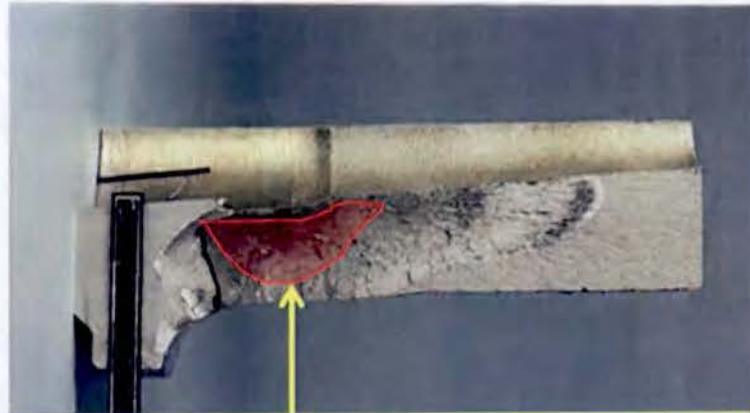
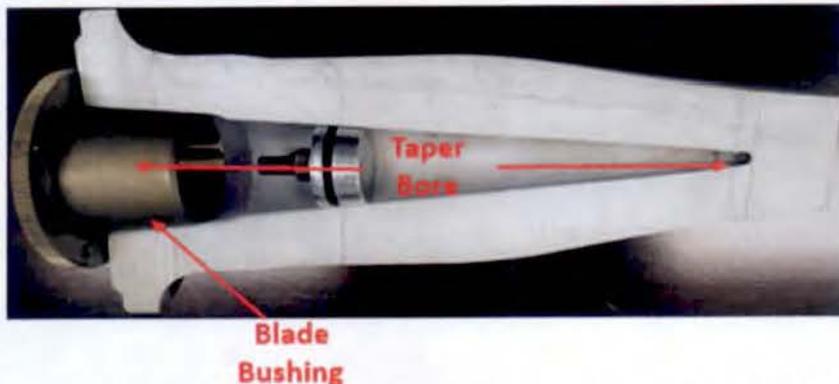
Figure 18: Taper Bore Side View with Blade Bushing

Approximate location of intergranular band
Coincident with outboard tip of bushing

289. An eddy current inspection can only detect cracks which are within 0.017 inches of the surface of this particular propeller blade material. [Encls (33), (34)]
