Subj: COMMAND INVESTIGATION INTO THE CIRCUMSTANCES SURROUNDING THE  
F-35 MISHAP OF MAG-31, VMFAT-501 ON 17 SEPTEMBER 2023

**LOCKHEED MARTIN (LM) AERONAUTICS COMPANY**  
**ENGINEERING INVESTIGATION REPORT OF F-35B BUNO 169591 (BF-66)**  
**CLASS A FLIGHT MISHAP, 17 September 2023, AFSAS (b)(4)**

**Date: 13 October 2023**  
**Document Type: Engineering Investigation Report**

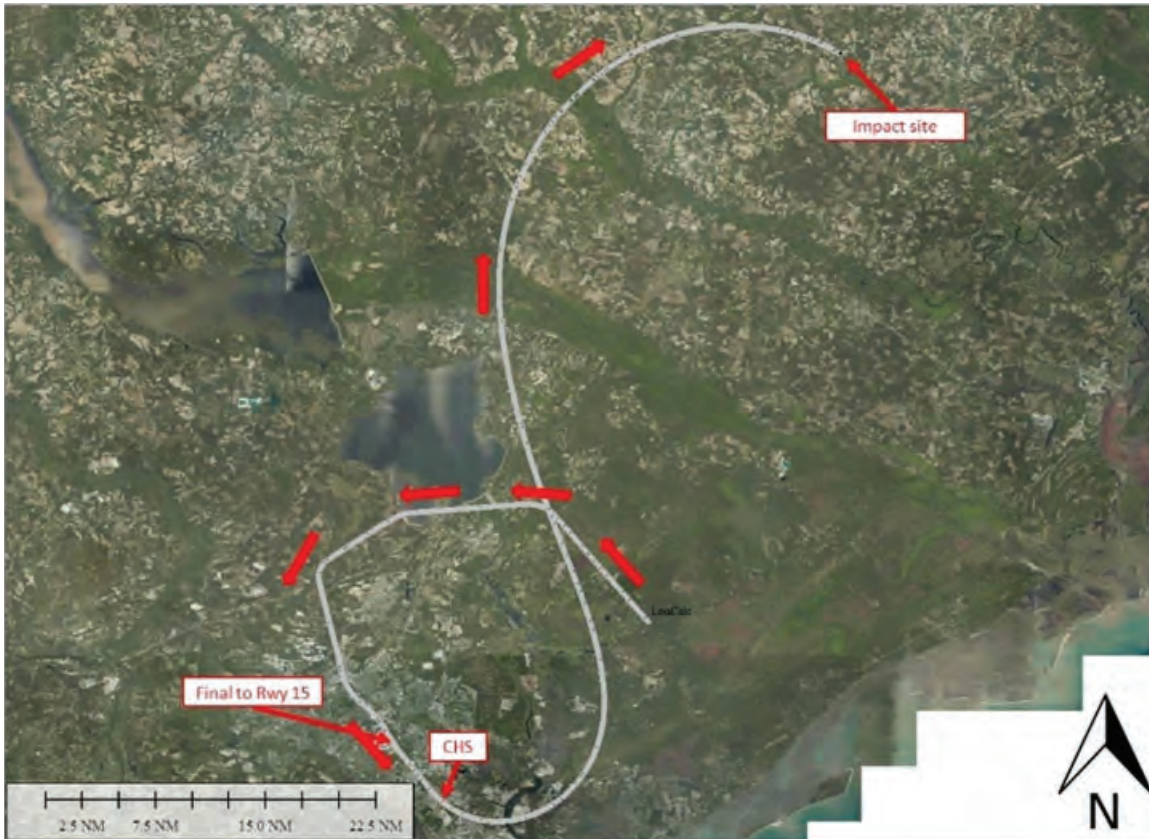
Figure 3. MA Ground Track

reversed its bank to a shallow right descending turn and began clipping the top of a densely forested area. The MA plowed through dense forest approximately 64 miles northeast of Joint Base Charleston in a rural area creating the second crash site (see Figure 3 below).

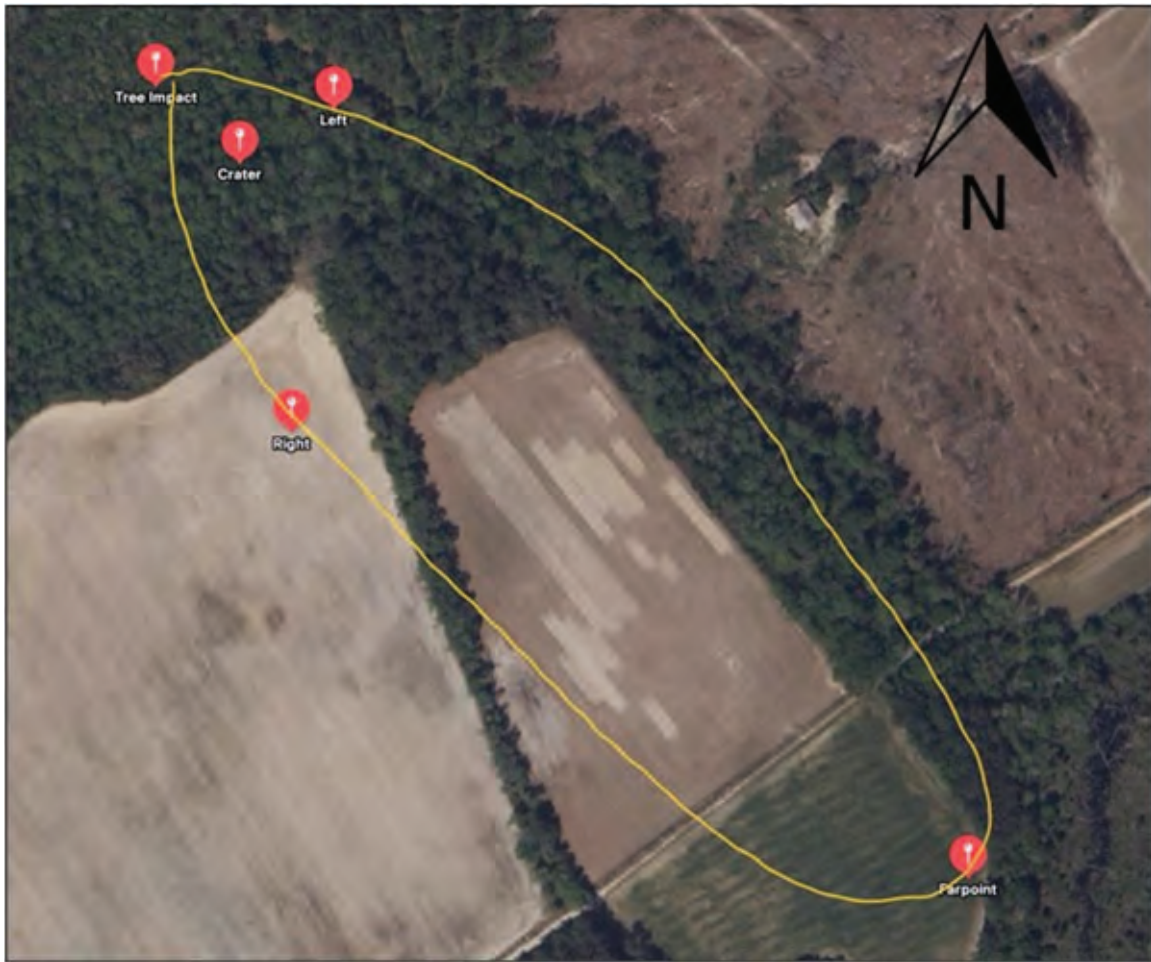
Figure 4. Crash Site Overview

231. The debris field was found amid dense forest, cotton, and soybean fields, and it was oblong in shape, stretching approximately 1,800 feet long by approximately 300 feet at its widest point. [Encl (25)]

The center of the wreckage created an impact crater approximately 15 feet wide by 30 feet long at 33.74918N, 079.58021W that had filled with water by the time the investigation team arrived at the site. The debris field was found amid dense forest, cotton, and soybean fields and was oblong in shape, stretching approximately 1,800 feet long by approximately 300 feet at its widest point. The MA crash site (see Figure 4 below) indicated a low angle/high speed trajectory leaving the MA wreckage shredded into mostly small pieces, with the largest pieces ranging from three to five feet. There was no evidence of a post-impact fire at the site, but fuel vapors were present in the crash site foliage.

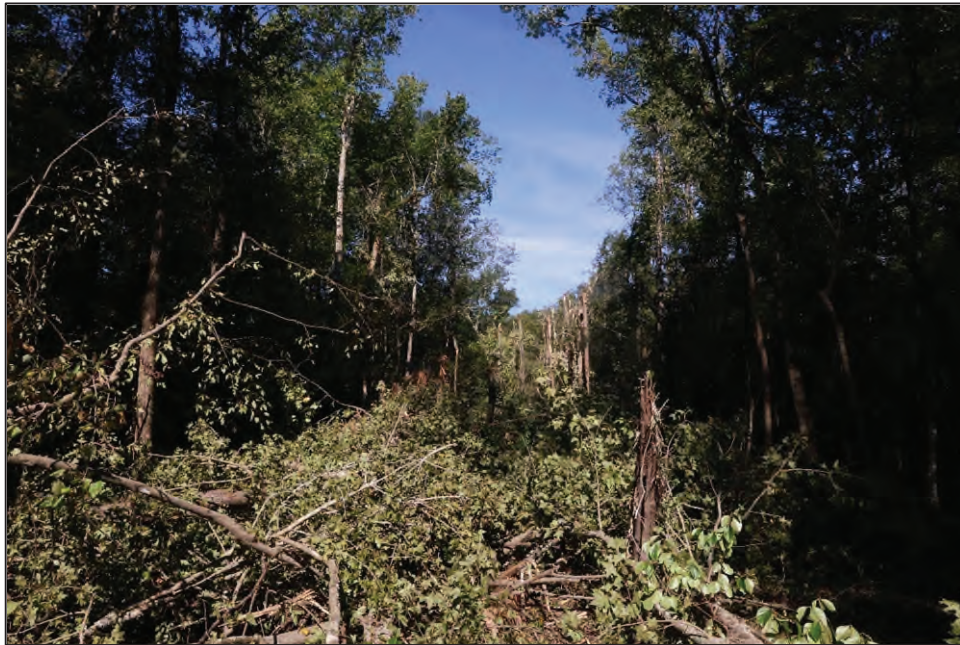
**Photograph 1. Entry into forest (looking Northwest)**

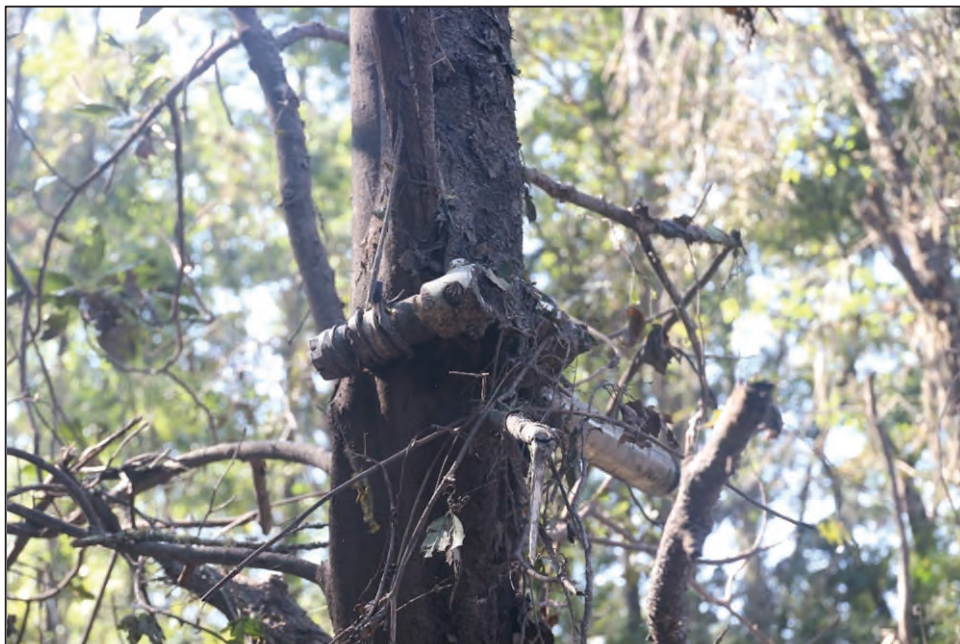
**Photograph 2. Nose Landing Gear (NLG) Strut embedded approximately eight feet up tree trunk**

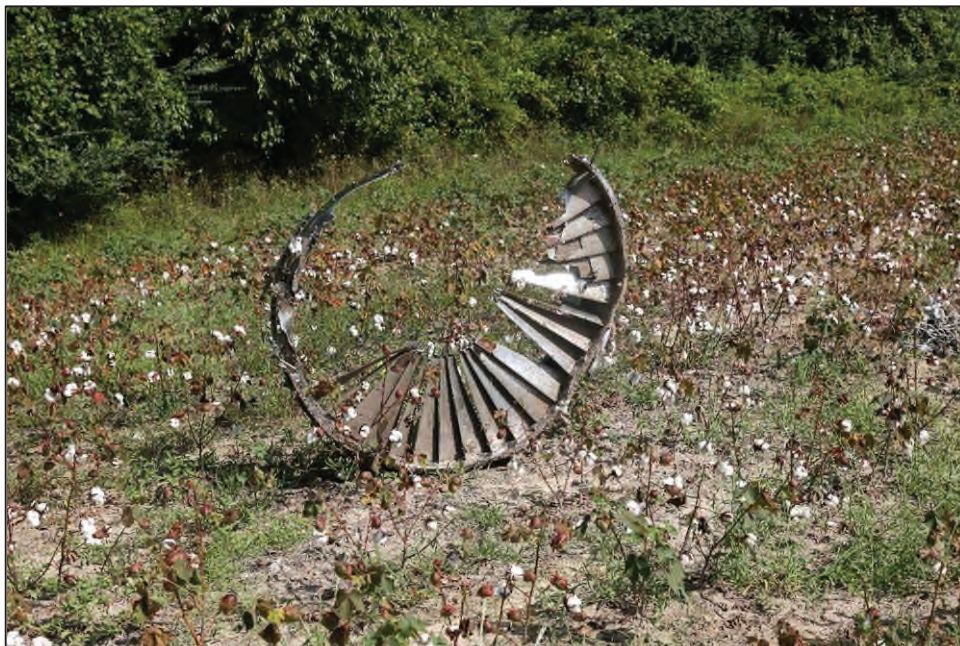
Photograph 4. Lift fan remnants

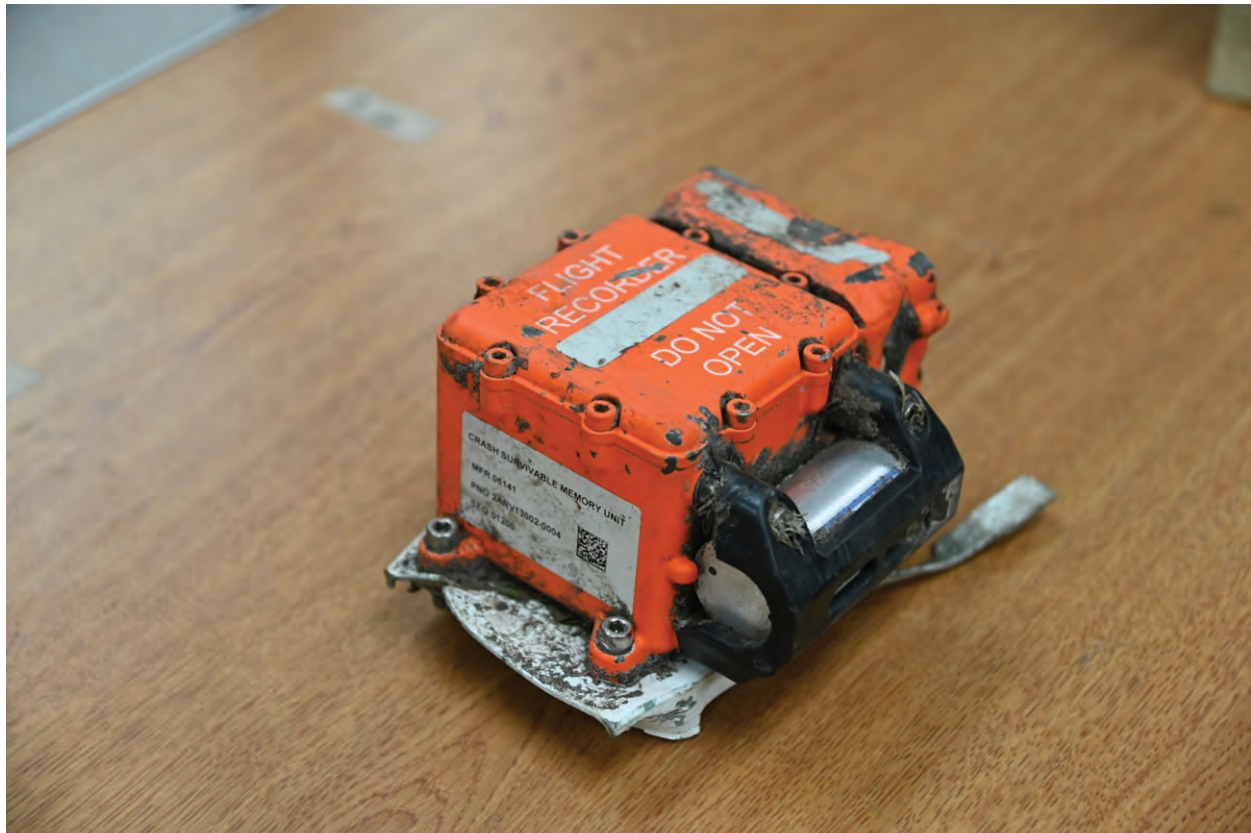
**Photograph 5. CSMU - Received Condition**

Incoming inspection showed the CSMU was very badly damaged (see Photograph 5 below). The electronic control module housing was broken, and all circuit cards were missing likely due to excessive impact during the crash. The crash protected memory (CPM) module was disassembled at the LM Aeronautics Design Development Lab (DDL) the next day to extract mishap data (b)(3), (b)(4)
