From: Investigating Officer

To: Commanding General, III Marine Expeditionary Force

Subj: COMMAND INVESTIGATION INTO THE FACTS AND CIRCUMSTANCES SURROUNDING THE
AVIATION MISHAP INVOLVING TWO CH-53E SUPER STALLION HELICOPTERS FROM
HMH-463 ON 14 JANUARY 2016 OFF THE NORTHERN COAST OF OAHU

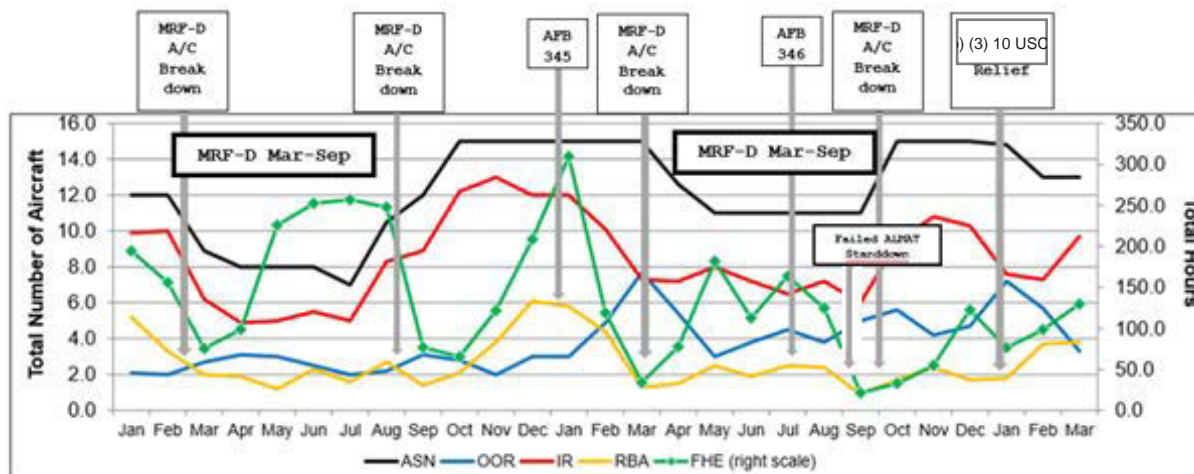
210.

The above chart plots HMH-463's RBA (in yellow) and total flight hours (right side) together with key events in 2014 through March 2016 (top in black boxes). ASN (black line) denotes assigned aircraft, OR (blue line) denotes aircraft Out-of-Reporting, IR (red line) denotes aircraft In-Reporting, and FHE (green line) denotes Flight Hours Executed. [Encl (231)]

211. From 2013 to January 2016, the number of RBA in HMH-463 spiked during the first quarter of each fiscal year to six RBA and dropped during the summer and fall months, to two or less RBA. [Encl (151), (201)]

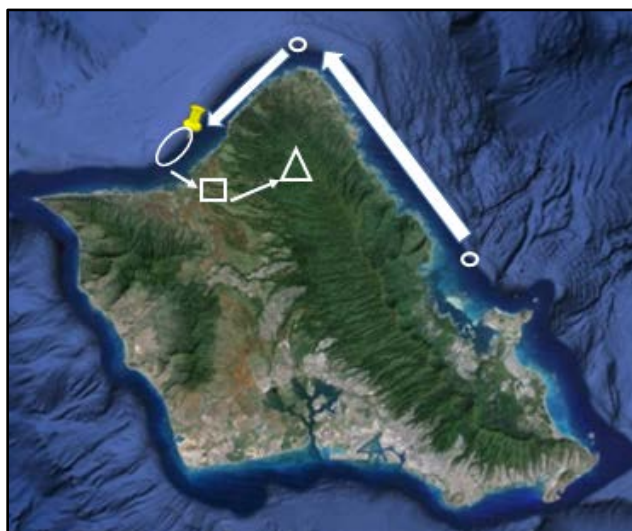
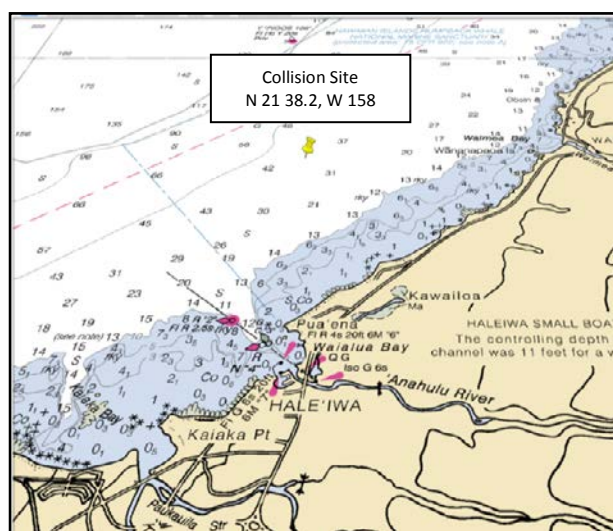
382. The images below depict the flight's planned scheme of maneuver and location of the collision. The first small white circle (right) is Checkpoint⁴³ Buoy. The second circle (top) is Checkpoint Barstow. The oblong circle is Holding Area⁴⁴ (HA) Wendy. The yellow thumbtack is the collision location. The square is the Initial Point⁴⁵ (IP) for the landing training, and the triangle is the landing zone.⁴⁶ The image on the right depicts the collision site. [Encl (10), (110), (111), (144)]

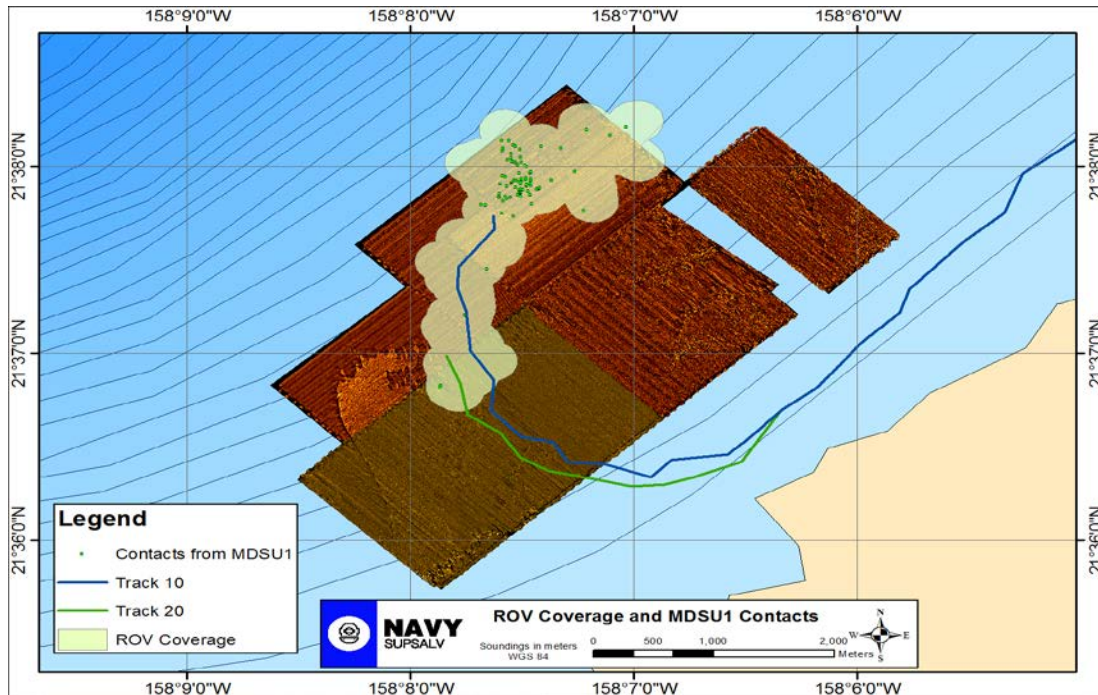
584. The image below depicts the total search area and debris fields associated with the 14 January mishap. The center of the three debris fields was located approximately 1.9 nautical miles from Haleiwa Harbor. The blue and green lines identify the remotely operated vehicle paths. [Encl (168)]

585. By 5 April 2016, 90% of the wreckage items were recovered. A sonar scan of the remaining items yielded only items measuring six inches or smaller. On that day, salvage operations ceased. [Encl (210), (215), (216), (232), (233)]

586. No aircraft anomalies were identified from collected debris that would suggest that the mechanics of or something on the aircraft caused or contributed to the mishap. [Encl (4), (6), (7), (11), (109), (110), (110), (212)]
