Figure 4: Center Fuselage Side Section Panels

Figure 8: Center Fuselage Side and Upper Section, FS 245 – FS 477

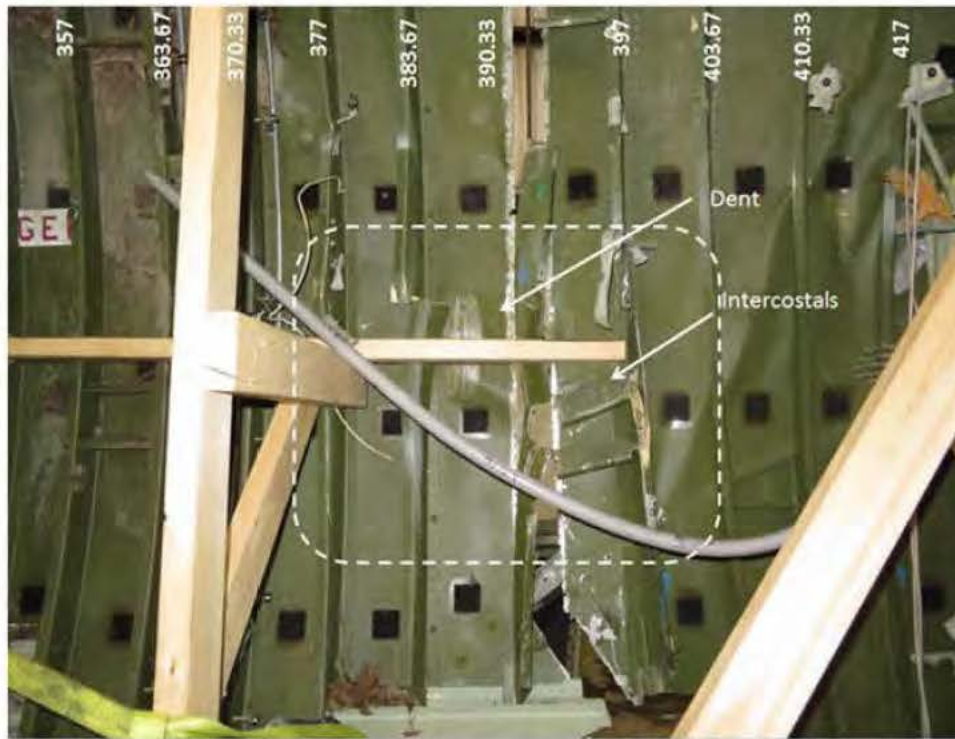
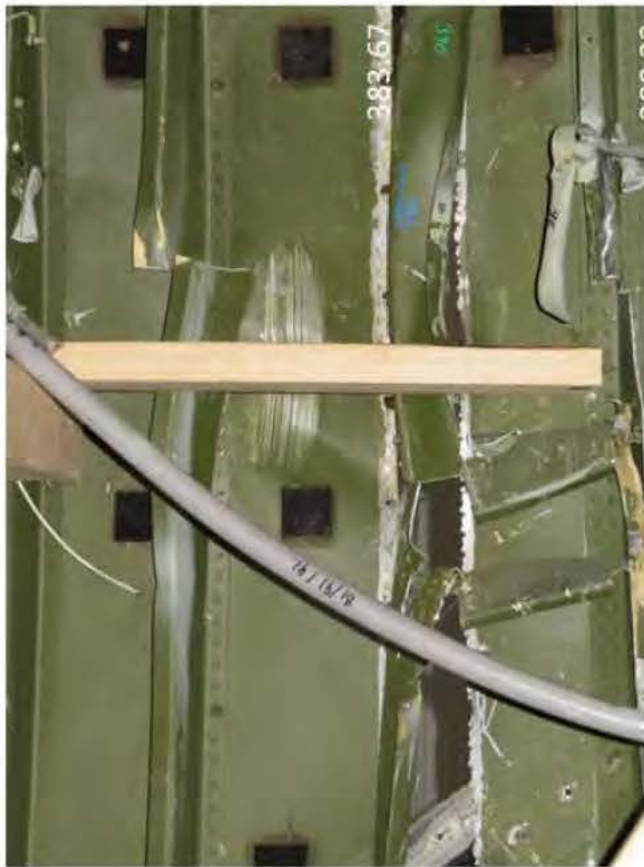
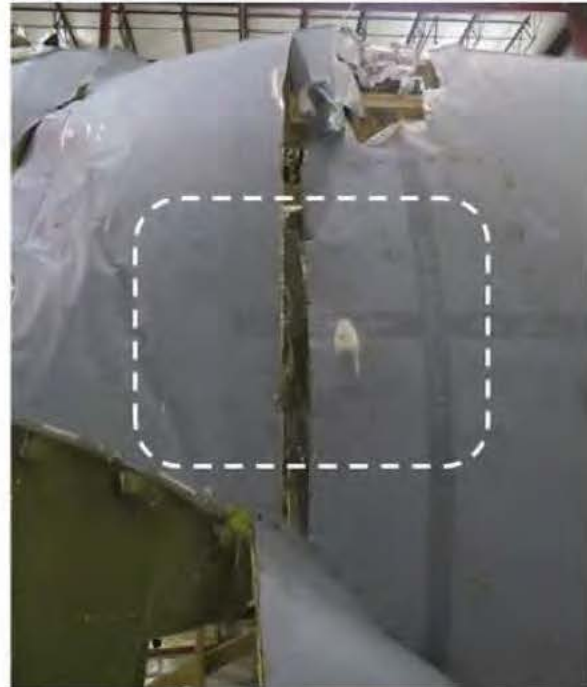
Figure 13: Center Fuselage Section Right Side

Impact damage from Blade 4 of Propeller #2
impacting RH side panel near WL 200 between
FS 377 – FS 397

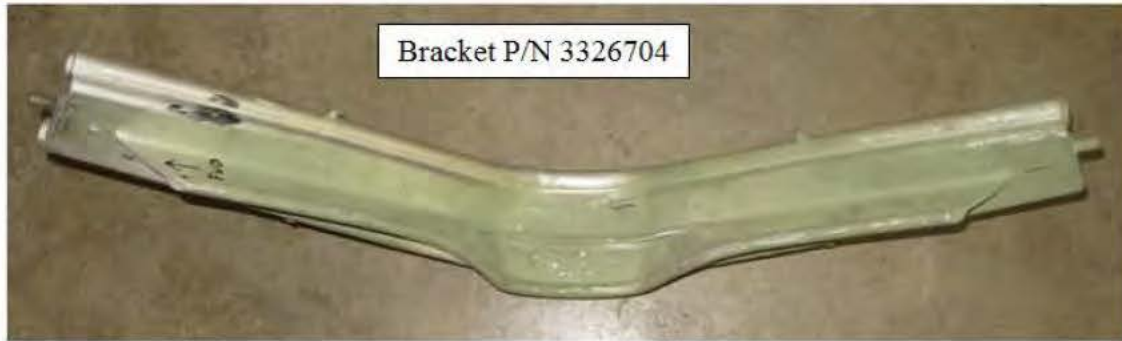
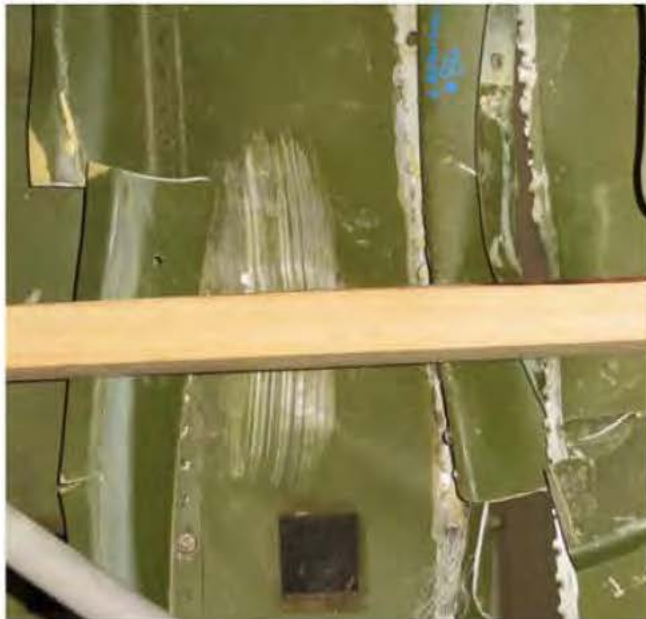
Figure 14: Troop Seatback Support Beam
Stowage Bracket, P/N 3326704

Liberated Blade 4, Propeller #2

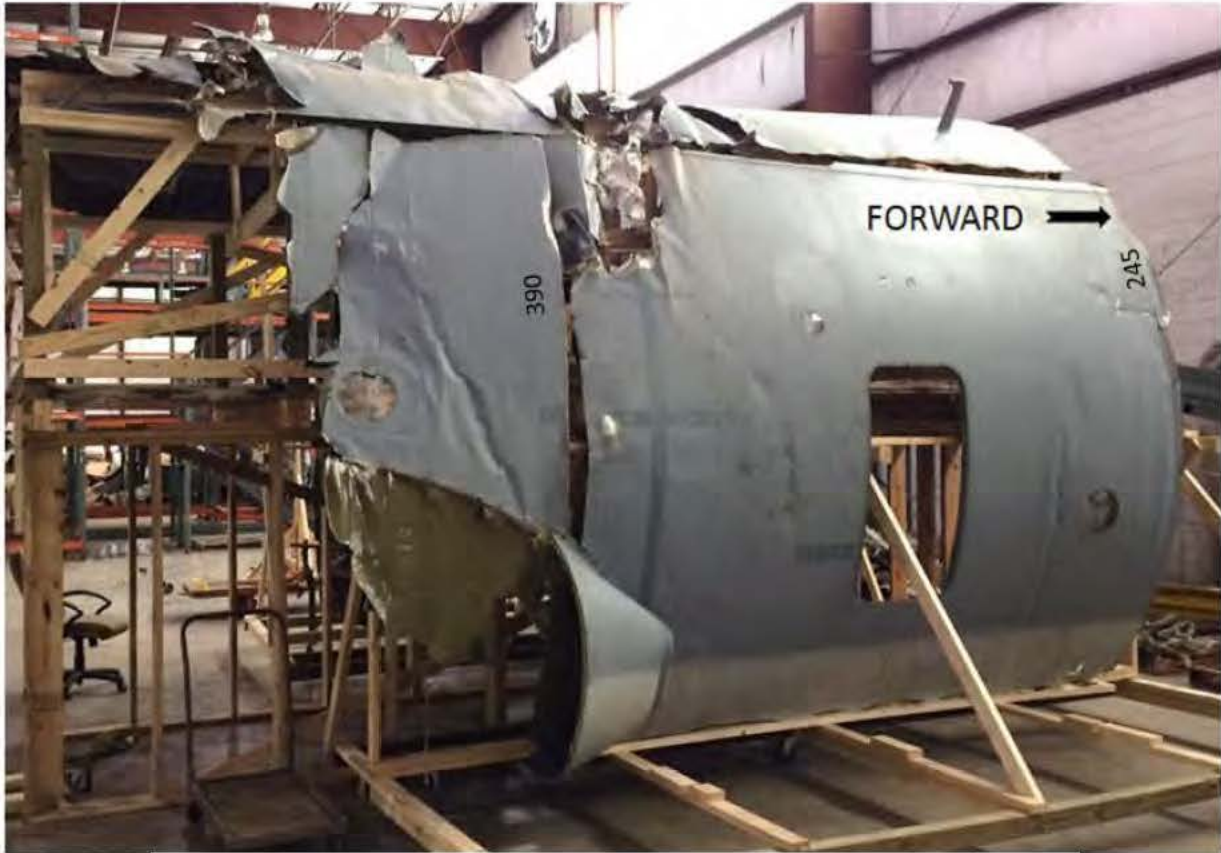
Figure 16: Right Center Fuselage Section, FS 245 – FS 477

The fuselage side section panel aft of the strike bulged outward from FS 390 to FS 430 and the side skin split along FS 390 in tension from RBL 61 longeron downward to the wheel well fairing. This section of side panel tore away from the fuselage in the aft and right direction as evidenced by the diagonal buckling crease angled upward and aft from the wheel well fairing to RBL 61 longeron near FS 447. It was not determined when this panel departed other than it separated after or in concert with liberation of the adjacent upper panel between FS 363.67 and FS 477.

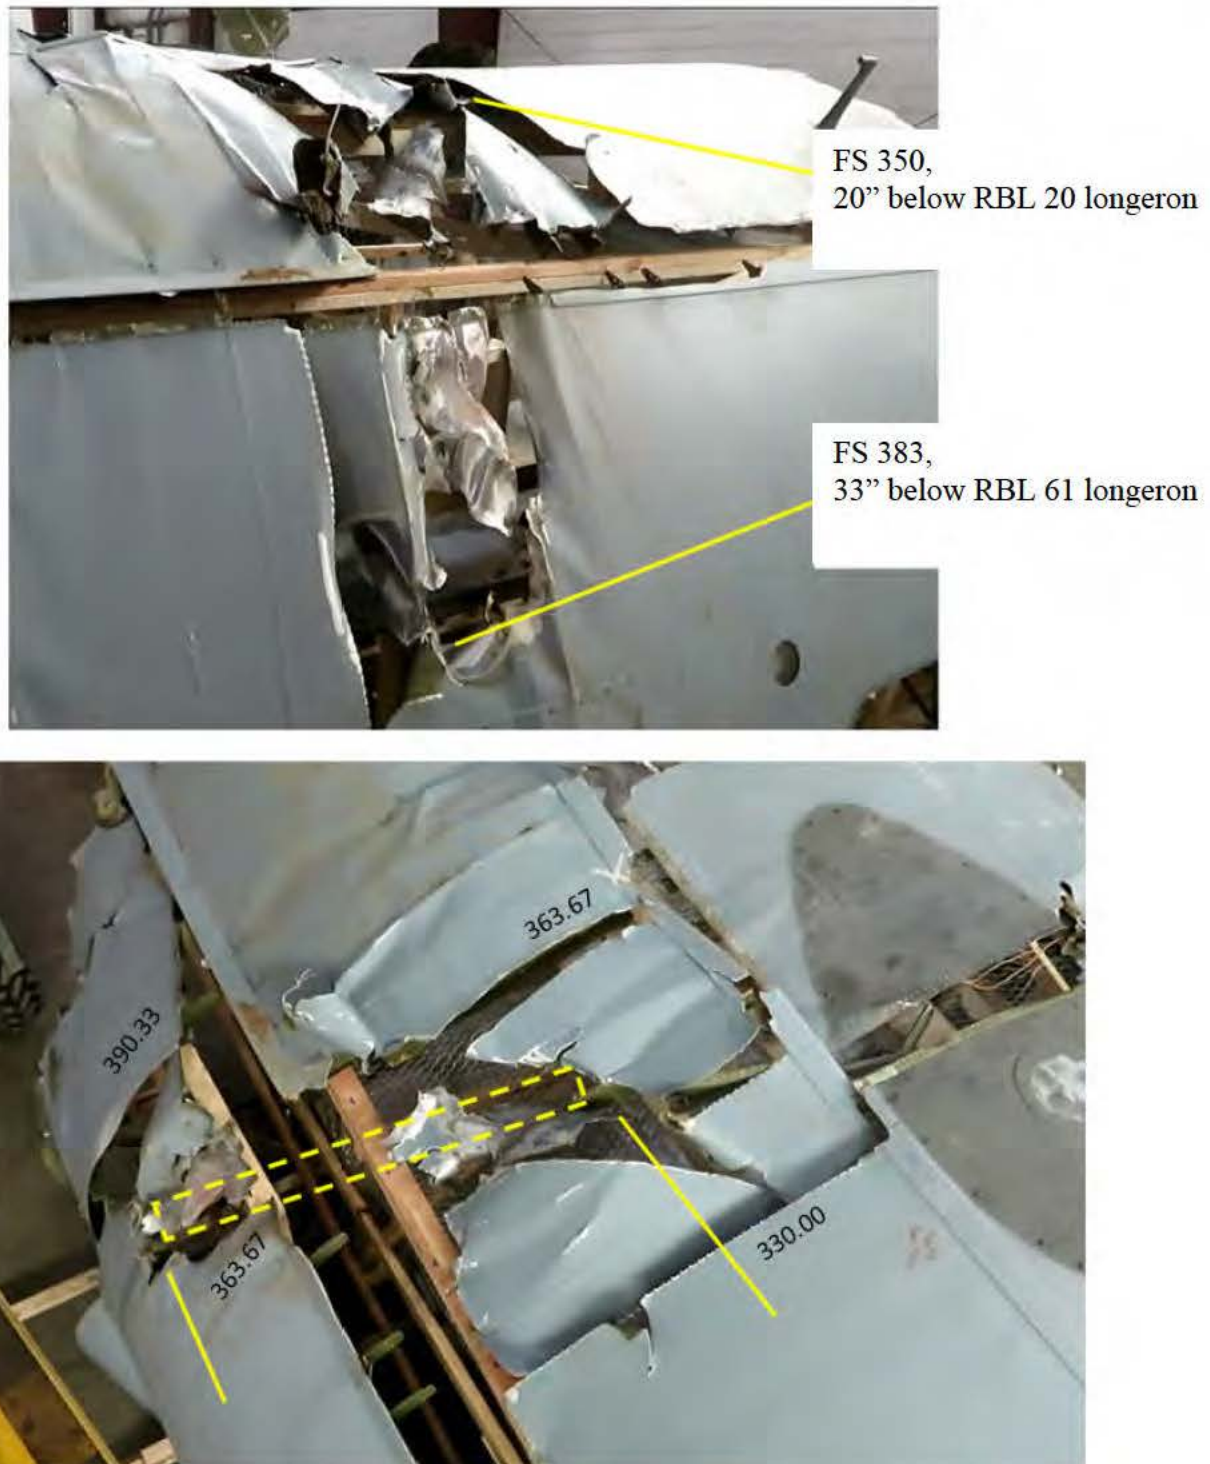
Figure 17: Overhead view of Right Side Center Fuselage Section
Damage attributed to Intrusion of the liberated #3 Propeller

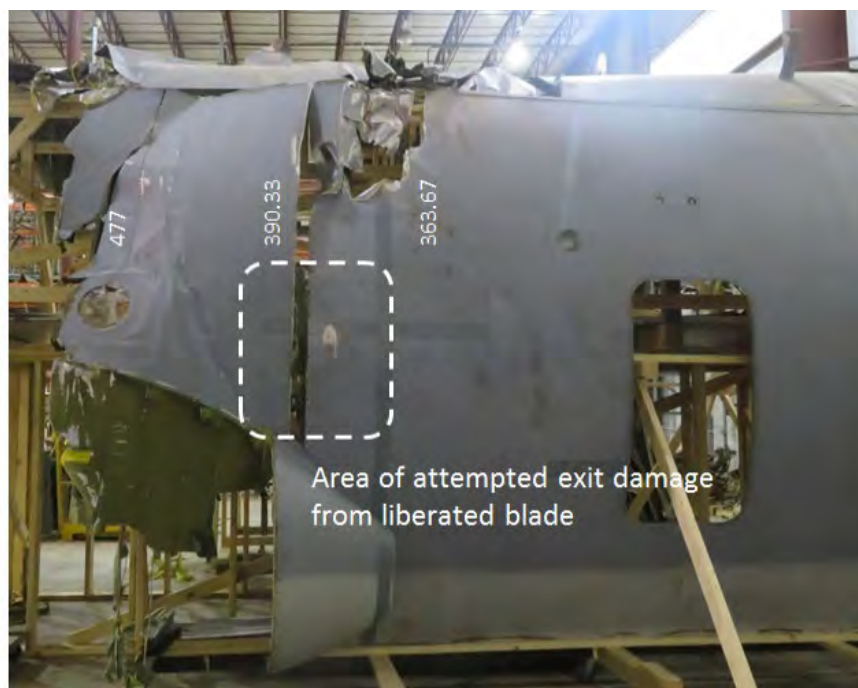
Figure 21: Right Center Fuselage Section

Findings/Observations: As described previously, it appeared that a large panel of upper section between FS 363.67 and FS 437 departed up and to the right as an immediate consequence of the intrusion from Propeller #3. Aft of the propeller intrusion on the right side of the fuselage, the side skin split from RBL 61 upper longeron to the floor panel. The skin separated through the rivet pattern of FS 390.33 ring segment in nearly pure tension, as demonstrated by dome nut/screw tear out in the aft direction at every fifth fastener. The split in the side panel occurred immediately aft of both sites of major structural damage caused by attempted exit of the liberated blade from Propeller #2 and the intrusion damage caused by Propeller #3. The side structure aft of the split was deflected outward above the main landing gear wheel well causing a diagonal crease angled upward and aft to the RBL 61 longeron (Figure 21). It was not definitive if this skin split was a consequence of the Propeller #2 blade impact, intrusion of the Propeller #3 or final disassociation of the center fuselage section.

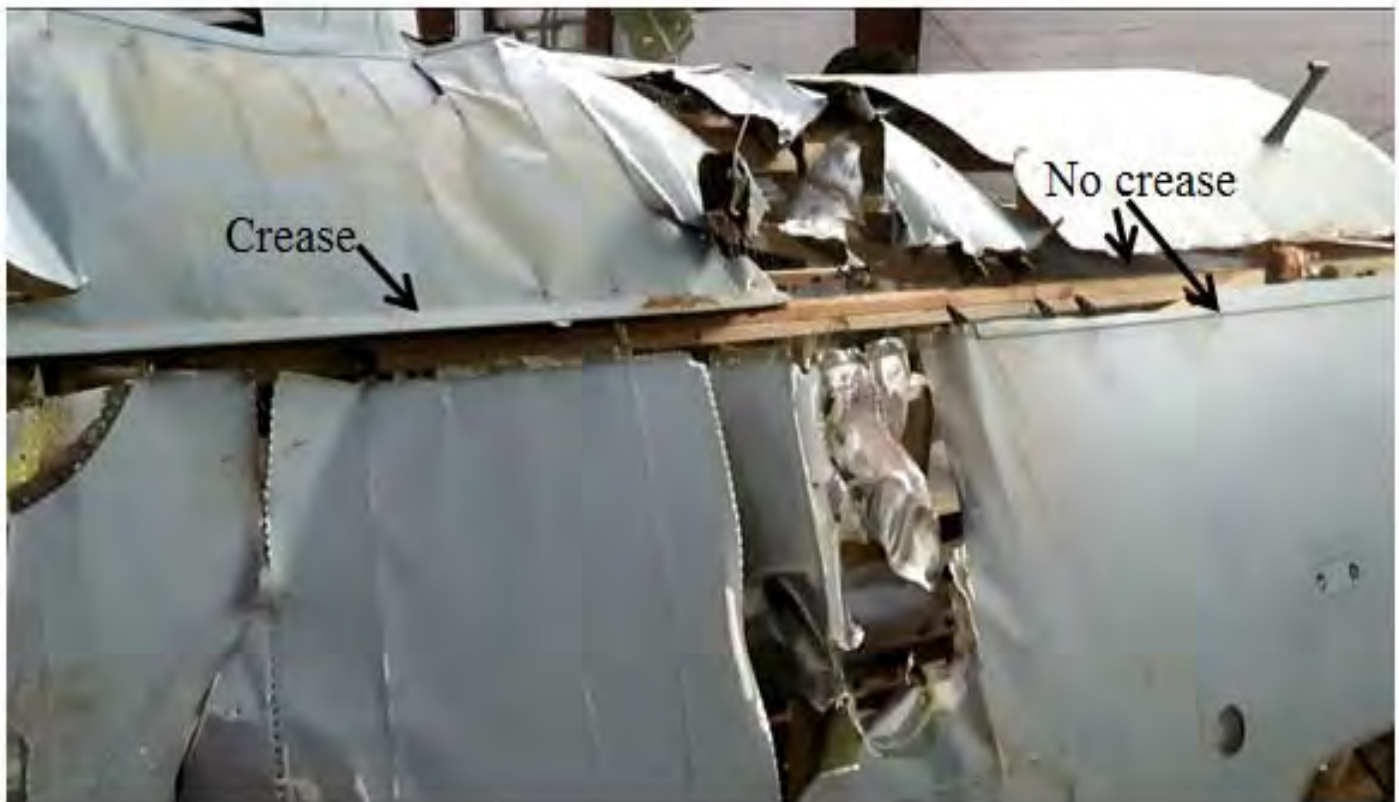
Figure 22: Right Center Fuselage Section

The RBL 61 upper longeron bent in the upward direction and failed in overload through the entire cross section at the propeller impact site near FS 367. The body of the longeron was torn away from the side panel from FS 367 forward to FS 317 where it fractured again through the cross section via torsional overload. The lower leg of the longeron along this section remained with the side panel. The right side panel forward of the propeller strike was relatively intact to FS 245. The crease formed along the upper edge of RBL 61 longeron aft of FS 363.67 (Figure 22), attributed to the aft panel departing up and toward the right, was not present on the section forward of the strike indicating that the forward upper section remained attached immediately after the propeller strike. Separation of the upper panel from the side panel between FS 245 and FS 317 occurred by shear along the dual rivet pattern in the RBL 61 longeron upper leg. Separation of the ring segment tying across the longeron between upper and side panels forward of FS 317 failed in tension.

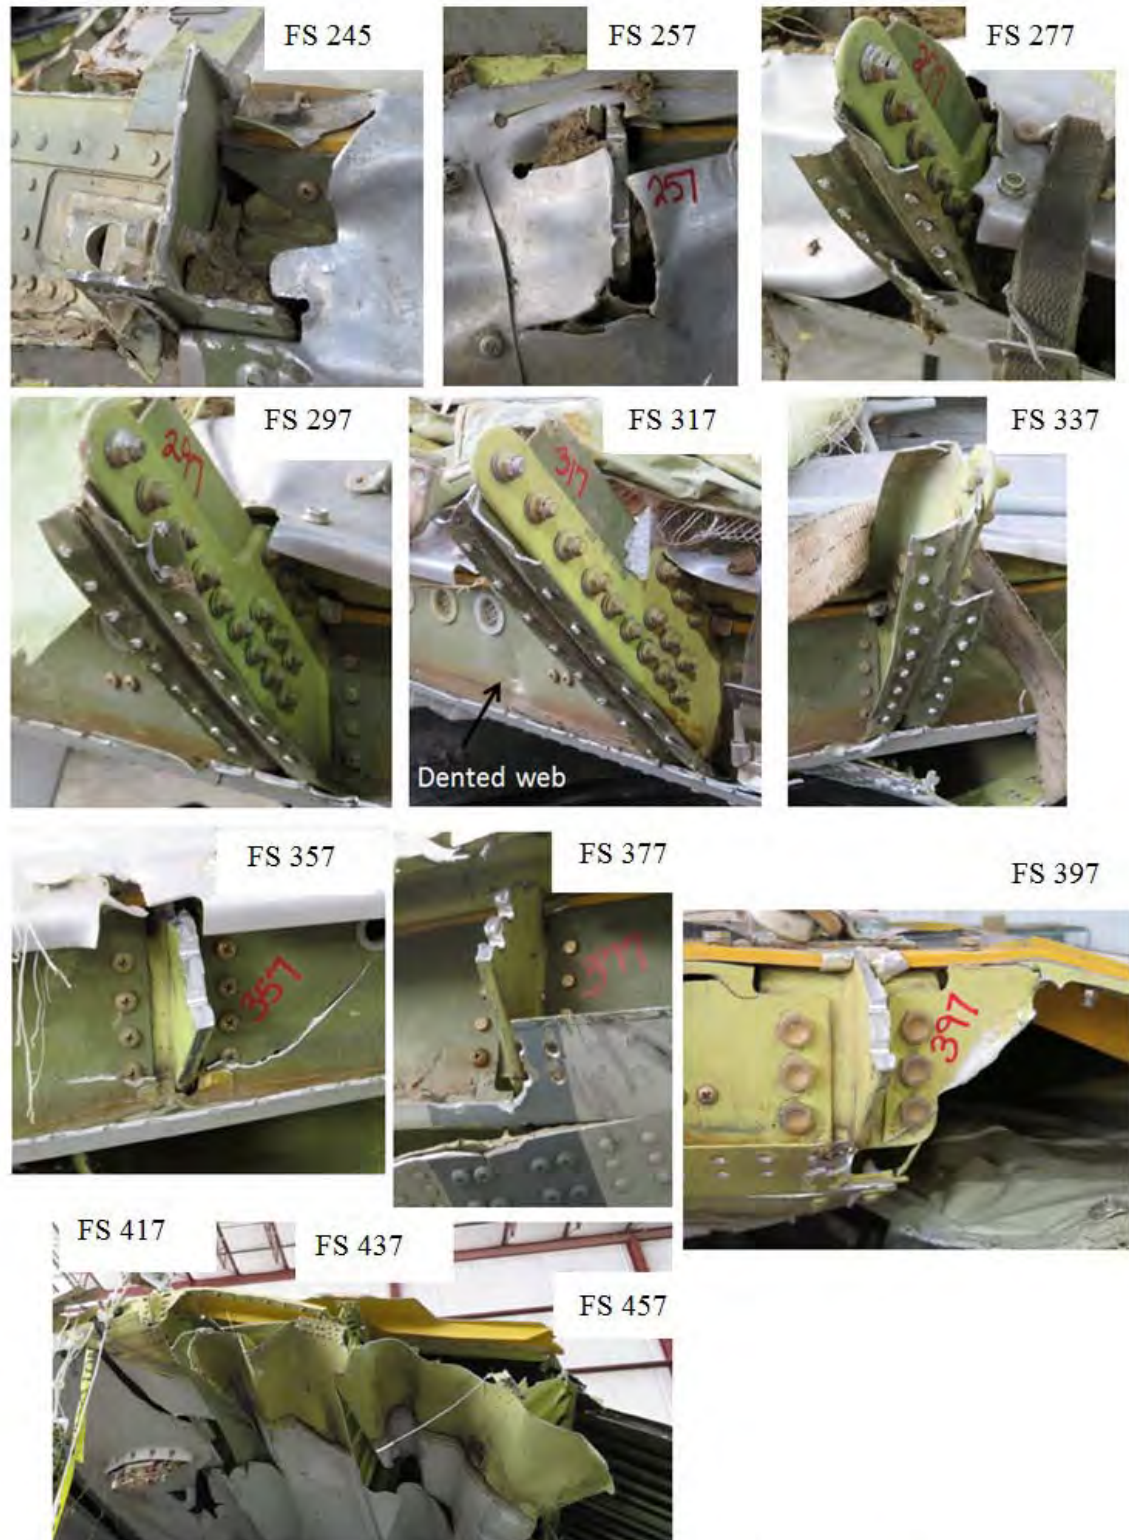
Figure 28: Left Side Floor Fitting to Ring Segment Joint along Chine Assembly

The left side panel of the center fuselage tore away from the floor panel leaning to the left. Views of each fitting are shown in Figure 28. Fractures of all floor fittings and ring segments were visually verified as overload. At the front of the panel, the FS 245 bulkhead fitting failed in tension just above the lowest bolt in the chine attachment. Minimal to no distortion was associated with fracture of this fitting. FS 257 ring segment separated by tensile failure of the chine floor fitting across the lowest bolt holes. Failure of ring segments at FS 277, FS 297, FS 317 and FS 337 occurred by tearing across the upper bolt hole in the floor fitting. Failure of the FS 357, FS 377, and FS 397 primary ring segments occurred through the lowest bolt hole of the floor fitting. The chine assembly was torn completely out of the floor panel aft of FS 397 failing the floor fittings inboard of the chine. The chine assembly collapsed and tore around the lower edge of the FS 357 and FS 377 fittings and ruptured completely through the cross section just aft of FS 397. As the panel rolled outward, the ring segments were forced inward to crush against the chine assembly aft of FS 317. The intermediate ring segments and floor fittings crushed against the chine assembly denting the chine web near FS 310, puncturing it aft of FS 317 and forcing the fitting completely through the web aft of FS 357. Between each primary ring segment where the two intermediate frames are not joined to the floor, panel separation occurred by overload failure of the chine assembly outboard leg. Most of the fuselage skin between FS 285 to FS 337, with exception of a panel to each side of FS 283.67 ring segment, rolled outward approximately 11" above the lower edge (Figure 29). The damage collectively suggests that the fuselage left side panel departed the floor rolling outward toward the left.

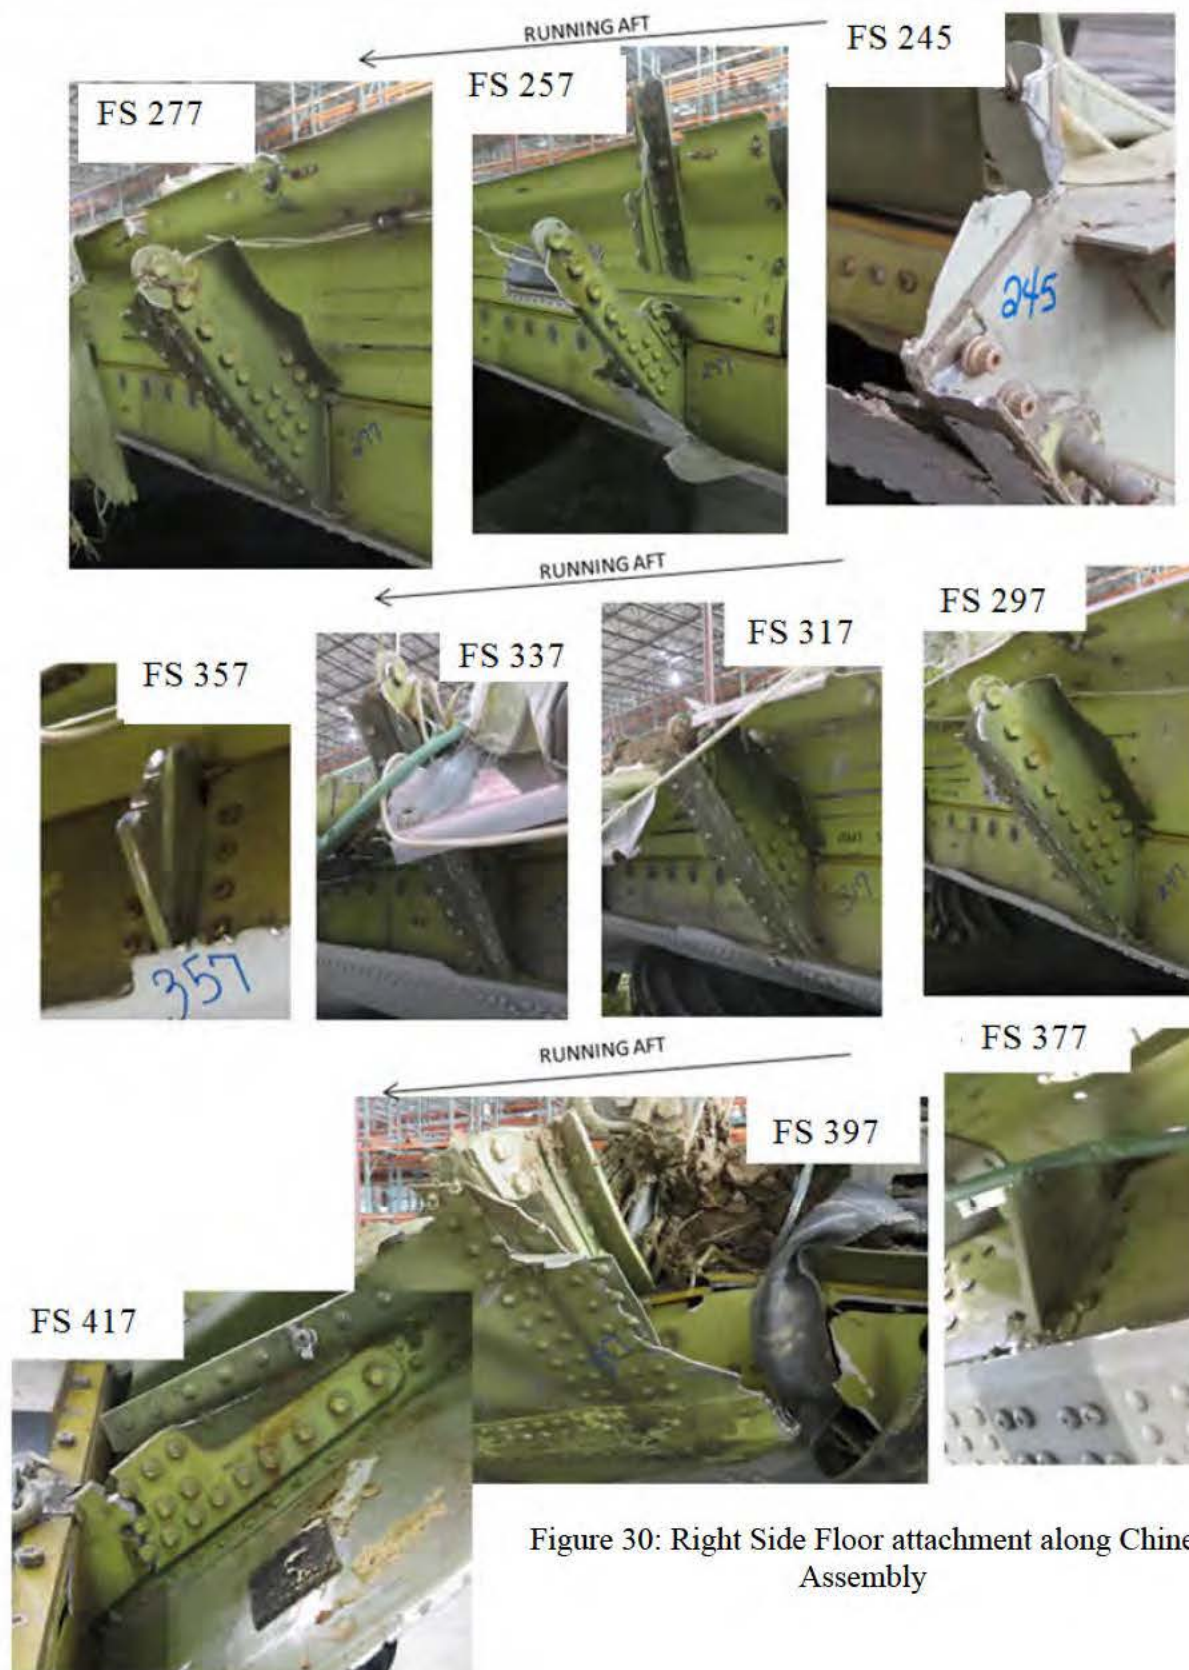
Figure 30: Right Side Floor attachment along Chine Assembly

The right side panel of the center fuselage separated from the floor panel by collapsing toward the left. Views of each fitting are shown in Figure 30. Fractures of all floor fittings and ring segments were visually verified as overload. The FS 245 bulkhead fitting and side panel ring segment failed in tension near the plane of the bulkhead upper cap. At the lower end of the FS 257, FS 277, FS 297, and FS 337 primary ring segments, the skin panel tore away from the floor fitting by tensile tear-out along the vertical rivet pattern on each side of the fitting. The ring segments failed via tensile bending overload through the upper bolt hole in the floor fitting. FS 357 and FS 377 ring segments failed across the floor fitting at the lowest set of bolt holes near the chine assembly (indicative of higher loading and/or higher strain rate than failure at the forward ring segments to drive failure into the stronger structure). Near FS 390, the chine assembly collapsed as a consequence of the floor panel buckling downward at the aft end. The fuselage side skin tore upward from FS 390 across to the third set of rivets attaching FS 397 ring segment to the floor fitting, upward through three rivets in the forward leg of the fitting, then diagonally across to the top of the floor fitting and continued aft past FS 417 under the wheel well fairing (Figure 31). FS 397 ring segments failed in tension immediately above the floor fitting. The floor fitting and FS 417 ring segment failed in tension immediately above the chine assembly through the lowest set of bolt holes. The chine assembly and floor fittings from FS 457 to FS 471 were torn out of the floor panel.

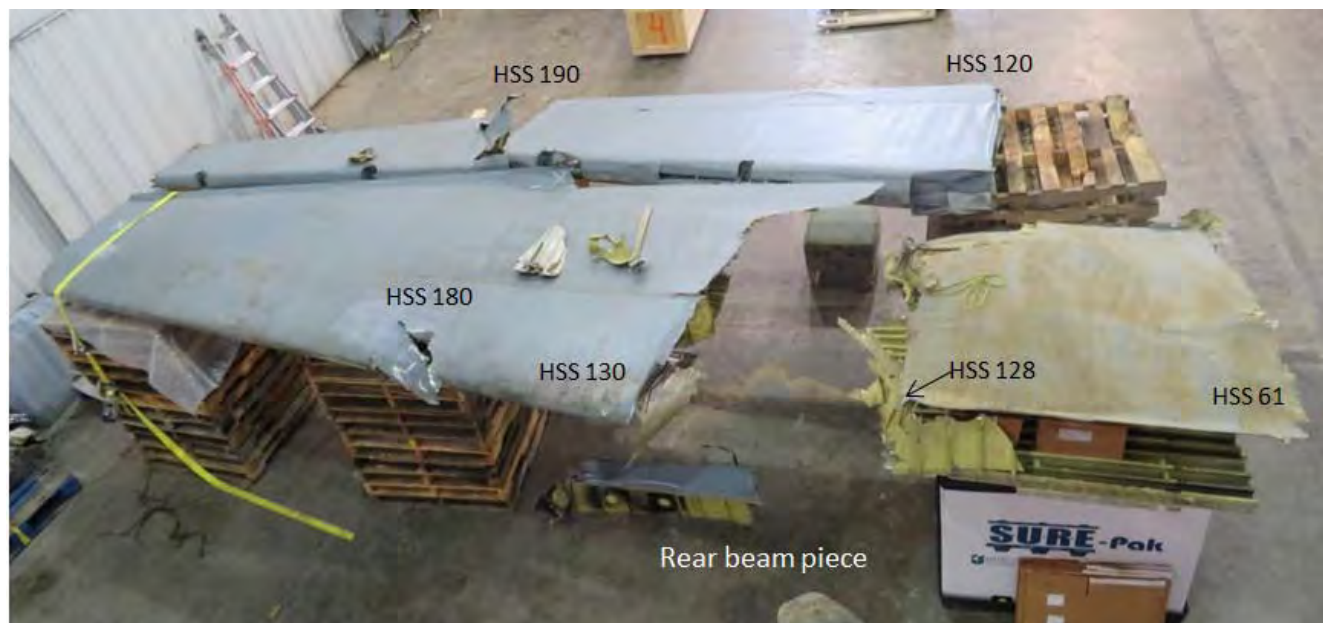
Figure 33: Right Outboard Section of Horizontal Stabilizer and Elevator

Figure 33 documents reconstruction of the RH outer section of the horizontal stabilizer and RH elevator (the inboard piece of lower skin was cut from the center structure to facilitate evaluation in proximity to the liberated pieces). One large section of horizontal stabilizer structure, a section of stabilizer rear beam assembly, two pieces of right elevator and two detached hinge fittings were recovered from the North site. The large stabilizer section extended from HSS 130 to the tip; the rear beam section extended between HSS 122 and HSS 180 with approximately 5" of lower skin attached. The outboard elevator sections extended from HSS 190 to the tip and the inner section extended from HSS 120 to HSS 190. Structure inboard of the break remained attached to the stabilizer center section and fuselage until ground impact. The upper skin of section HSS 61 - HSS 130 tore away but was recovered in proximity to the center section at the main wreckage site.

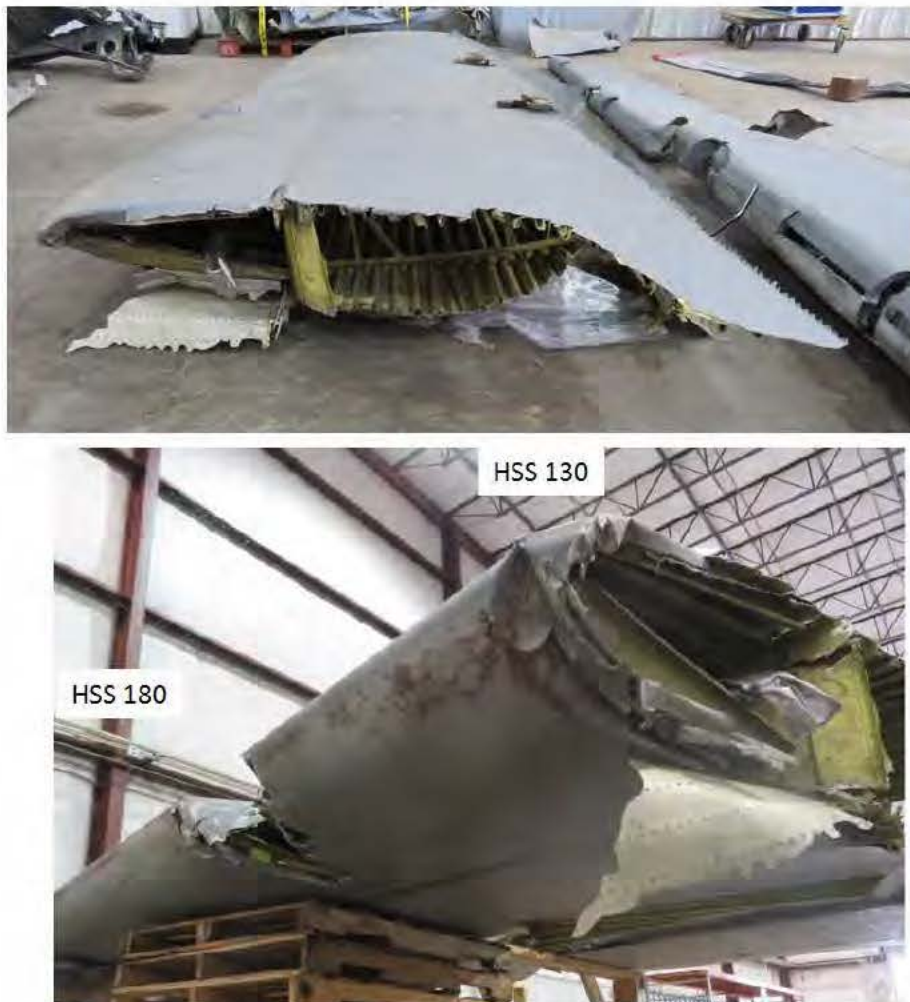
Structural failure of the RH outer section of the horizontal stabilizer occurred at HSS 130 as a consequence of impact with the propeller assembly, which separated from the wing in flight due to failure of the RGB case. Blade 1 from Propeller #3 appeared to have impacted the leading edge of the stabilizer presenting the trailing edge first. The blade sliced through the upper skin, front beam assembly and internal stringer constituting approximately 75% of the chordal cross-section of the stabilizer. The leading edge skin was crushed downward and outward against the rib at HSS 130. The upper skin showed saw-tooth curls running aft to the front beam characteristic features of structure being sliced by an object passing through it. The lower skin inboard of HSS 130 was torn in the downward direction and the anti-icing heater ejector tube was severed and pushed aft against the front beam. The dissimilarity in damage between upper skin and lower skin separation suggests that the intruding blade transited spanwise through the upper skin structure and upon contact with the front beam rolled downward to force the lower structure outward. The blade continued through the stabilizer structure to completely slice through the front beam assembly and internal stringer. Red paint transferred along the upper skin structure and front beam further support blade tip entry attitude of the propeller assembly. The upper skin aft of the stringer tore diagonally inboard to the trailing edge near HSS 122 and the lower skin tore outboard to HSS 180 resulting in liberation of a section of the rear beam assembly.

Figure 34: HSS 130 Impact Damage
Leading Edge of Horizontal Stabilizer RH outer section

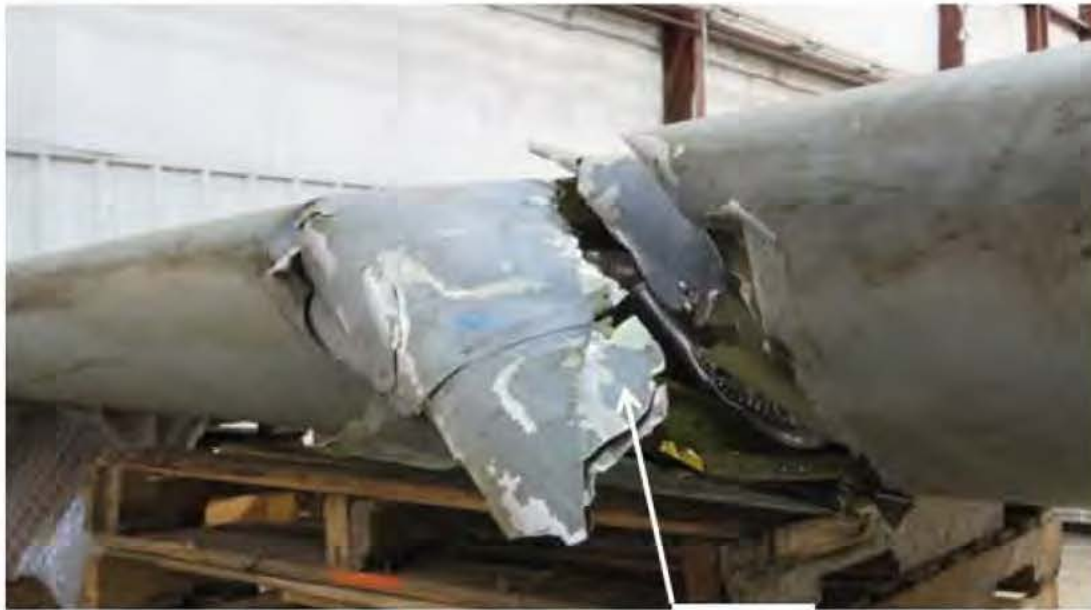
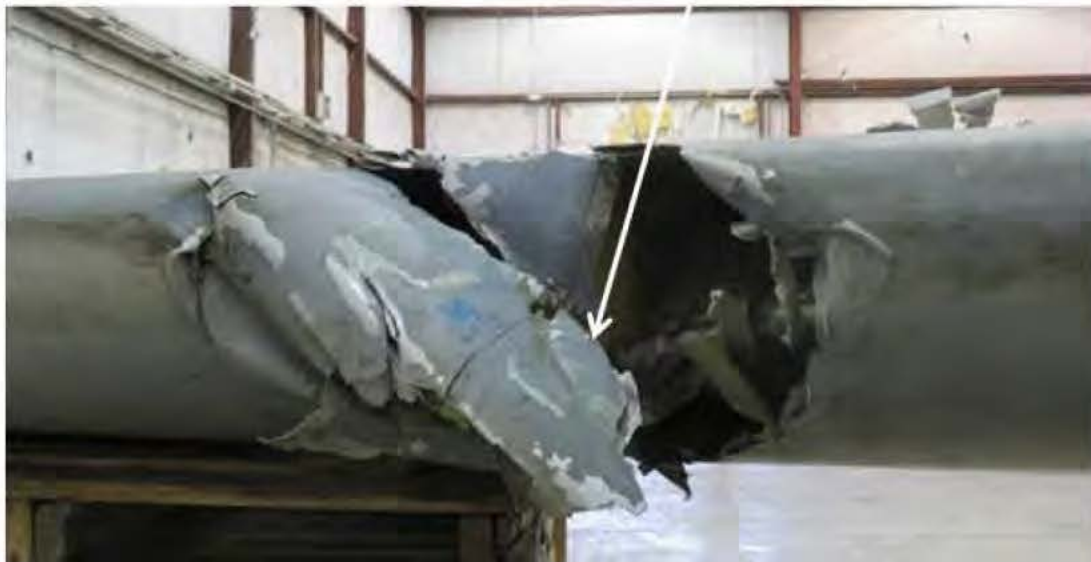
The horizontal stabilizer also had leading edge damage between HSS 174 and HSS 180, shown in Figure 36. As at HSS 130, the narrow slice was consistent with the geometry of the airfoil edge of a propeller blade. The intrusion sliced through the leading edge at a diagonal angled outboard from bottom to top. Intrusion forced the leading edge to buckle downward between HSS 174 and HSS 180 and then sliced through the anti-icing ejector tube, stopping short of cutting the front beam assembly. A linear imprint crushed into the upper skin surface of the buckled leading edge structure was of similar geometry as the trailing edge of a propeller blade.

Figure 36: HSS 180 Impact Damage
Leading Edge of Horizontal Stabilizer RH Outer Section

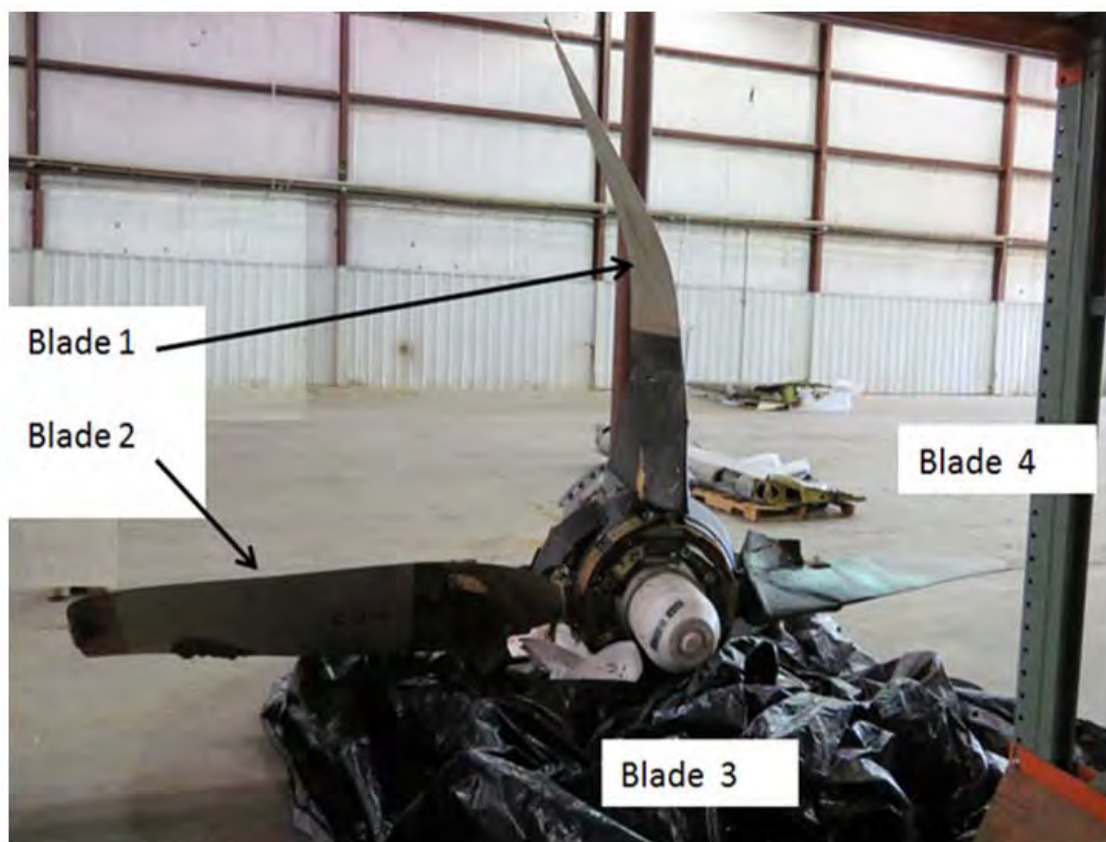
Figure 37: Propeller Assembly #3

Figure 37 documents the #3 Propeller that was recovered from the North site. All four blades remained attached to the propeller assembly until ground impact. Blade 1 (Figure 38) was in the feathered position on recovery and the foil was bent along the span in the direction advancing rotation. Blade 2 (Figure 39) was in a low to negative pitch position on recovery. Blade 3 fractured by overload on ground impact and multiple pieces constituting 19" of the tip end were recovered from the North site but distant from the Propeller impact site. Blade 4, was in a near feathered pitch position on recovery and the tip end fragmented on ground impact.

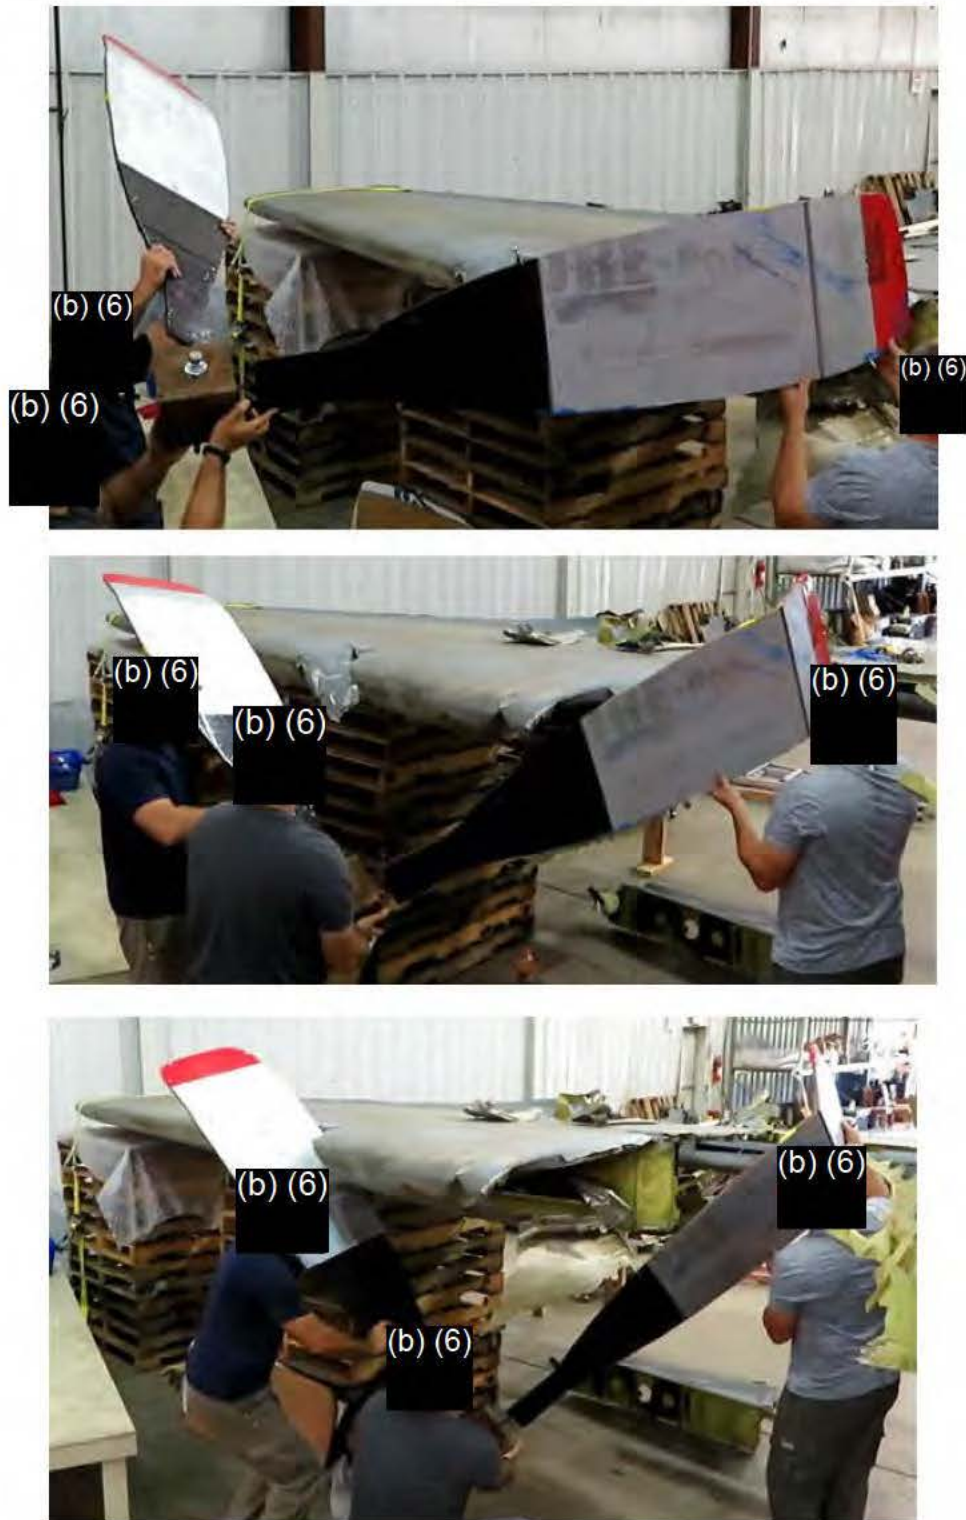
Figure 40: Reconstructed sequence of Propeller #3 impact to Horizontal Stabilizer

Using a crude mock-up of a propeller assembly, and recognizing that a flat blade does not fully replicate the true contours of an airfoil, the scar damage and tip crushing witnessed on Blade 1 was replicated by pushing a blade through the stabilizer with the airfoil oriented spanwise then rotating downward after passing through the front beam assembly. A sequence of the reconstructed evolution of propeller impact based on blade scar damage and stabilizer damage is shown in Figure 40. As the mock-up propeller rotates downward, the trailing edge of Blade 2 contacts the stabilizer leading edge at HSS 180 in the approximate location to account for the trailing edge damage witnessed on Blade 2. Reconstruction of the mock-up blades against the leading edge damage to conform to the stabilizer signatures revealed that both blades likely impacted with approximately 40-45 degree pitch attitude.

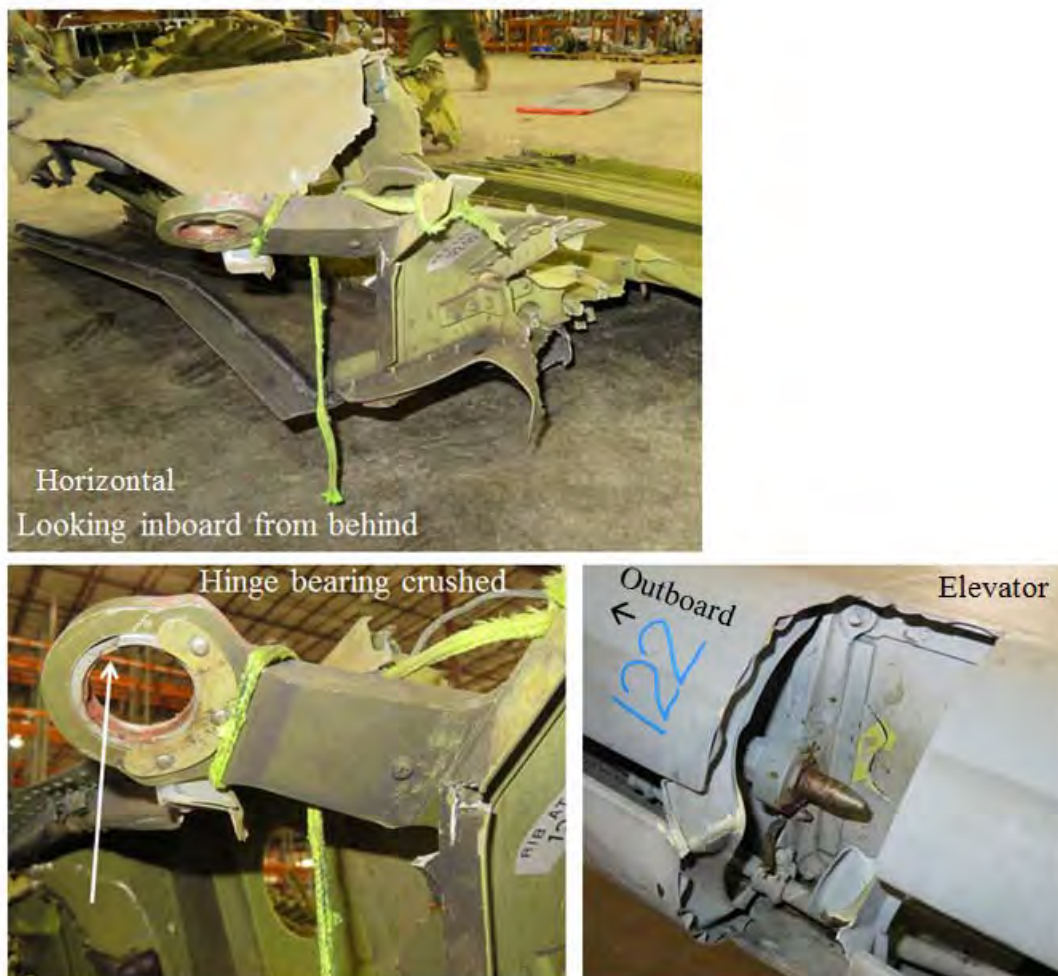
Figure 41: Elevator Hinge Fitting HSS122

- HSS 122 (Figure 41): The stabilizer rear beam web inboard of HSS 122 buckled downward and the hinge fitting and supporting rib assembly collapsed outboard. The hinge fitting bearing was destroyed and the bearing outer race was crushed around the upper quadrant on the outboard side due to binding against the elevator pin. This damage serves to indicate that the hinge deflection occurred as the elevator separated from the stabilizer during flight and not as a consequence of ground impact. The leading edge of the elevator showed two impact marks from the hinge being forced against the elevator after separation from the pin. One impact was oriented relatively parallel to normal alignment and the second was angled inboard at the lower edge indicating that the fitting rotated outboard with respect to the elevator. The upper and lower skins of the leading edge showed no interference with the trailing edge of the stabilizer. The pin showed multiple signatures of interference against the hinge bearing inner race, both located inboard of normal hinge position and evidence of elevator separation. The first impact occurred with slight hinge separation along the pin but squarely seated and the second occurred with more hinge separation and angled similar to the recovered orientation of the HSS 122 hinge as collapsed on the stabilizer rear beam

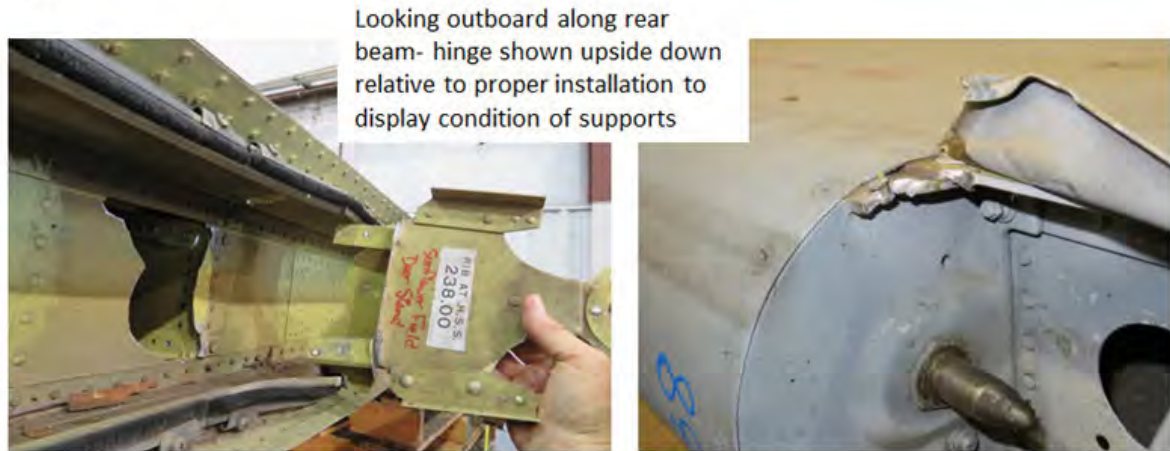
Figure 43: HSS 238 Elevator Hinge Attachment

- HSS 238 (Figure 43): The hinge fitting separated by shearing the rivets to the upper and lower supports due to the hinge being pulled aft. The hinge rolled inboard to locally tear the rear beam web and fold the web flat against the fitting. The hinge bearing was intact and free to rotate. The elevator pin was intact and the upper skin surrounding the pin housing was deflected upward due to interference with the hinge.

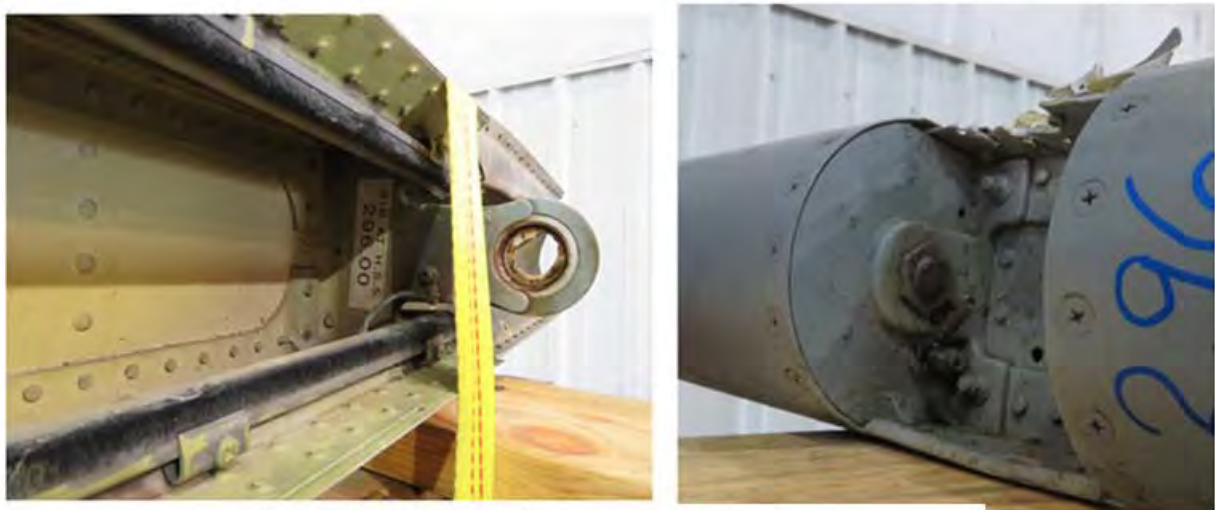
Figure 44: HSS 296 Elevator Hinge Attachment

- HSS 296 (Figure 44): The outboard hinge fitting remained attached to the rear beam. The pin failed via overload bending in the upward direction. The hinge bearing was destroyed and the outer ring captured within the hinge fitting was crushed at the upper quadrant on the outboard face, consistent with the elevator/pin deflecting upward with respect to the stabilizer. The upper skin surrounding the pin housing was bent upward in the same location as HSS 180 and HSS 238 but more extensively, signifying increasing twist along the elevator.
