Figure 4: Center Fuselage Side Section Panels

Figure 8: Center Fuselage Side and Upper Section, FS 245 – FS 477

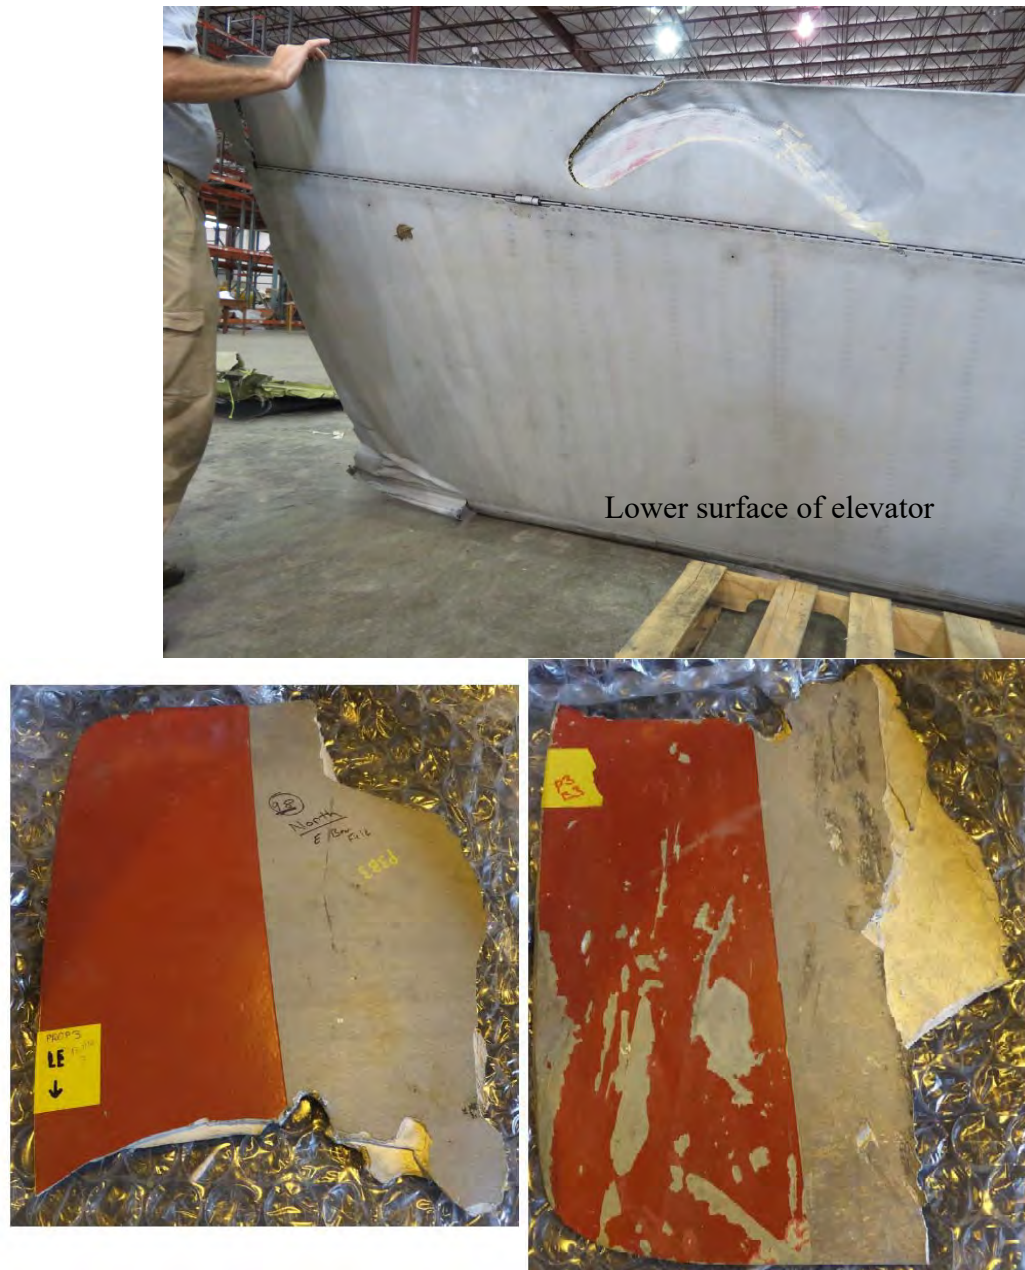
Both elevator sections from HSS 61 to the tip were recovered from the North site. The break at HSS 190 occurred by compressive buckling, likely as a consequence of separation of the right outboard section of the horizontal stabilizer. The trim tab was intact and secure to the trailing edge. A semicircular dent in trim tab swept outboard between HSS 95 HSS 130. Based on the red paint transfer and similarity in geometry to a fragment of airfoil tip from Propeller #3, Blade 3, the trailing edge damage was likely a consequence of impact with a liberated fragment of Blade 3 airfoil rather than impact with an intact blade. (Figure 45)

Figure 45: Lower Surface of Elevator near HSS 95 – HSS 130
Blade tip fragment from Propeller #3, Blade 3

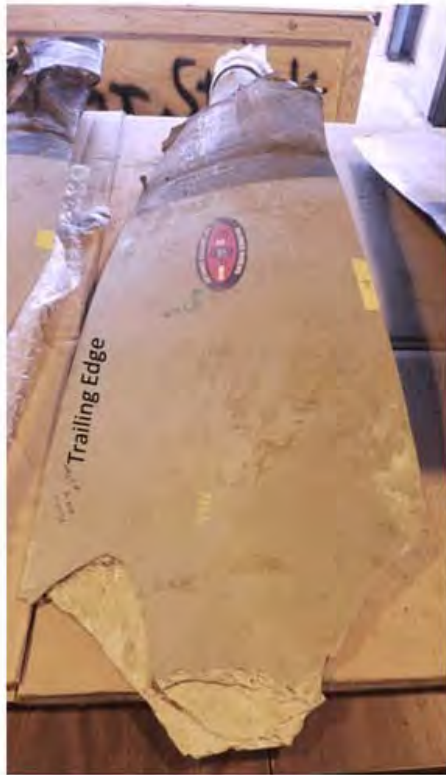
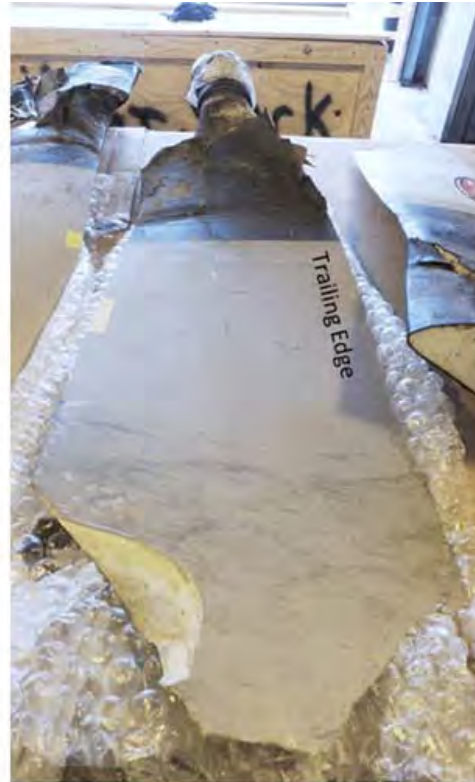
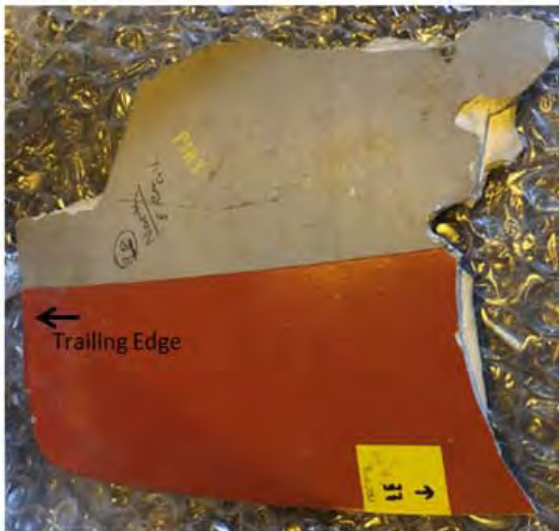
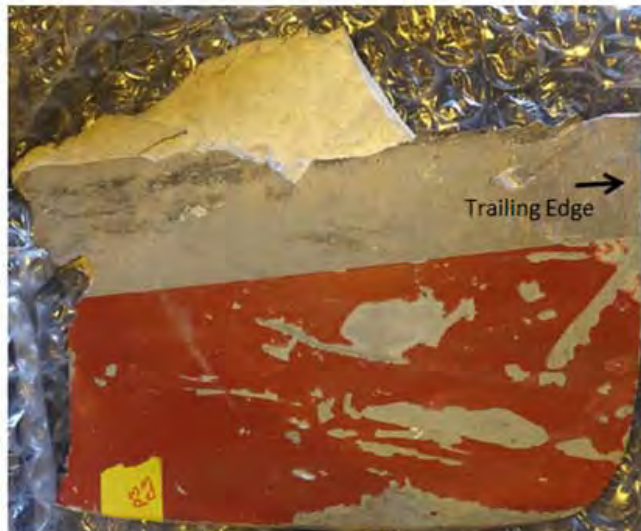
Examination of the blade damage on Propeller #3 in context to the intrusion damage witnessed by the horizontal stabilizer and the right side of the center fuselage, it is likely that Blade 3 embedded into the fuselage structure creating the intrusion damage to the side and upper sections. This conclusion was reached more as a matter of deduction rather than based on specific correlation of damage between the blade and fuselage signatures. As previously described, damage witnessed by Blades 1 and 2 of Propeller #3 correlate well with the damage witnessed by the horizontal stabilizer. Blade 4 exhibited no evidence of contact with airframe structure. Blade 3, which remained attached to Propeller #3 until ground impact, was fragmented at the outboard end and showed severe abrasive damage across the chord on the lower third of the airfoil surface. The airfoil tip fragments from Blade 3 were recovered from the North wreckage site and distant from the impact site of Propeller #3. The damage observed to the Blade 3 airfoil was considered consistent with impact against airframe structure. Figure 46 documents damage on one of the larger tip fragments showing large gouges and abrasive scoring across the chord approximately 9" from the tip end of the blade.

Figure 46: Propeller #3, Blade 3
Damage likely caused by intrusion into center fuselage airframe structure

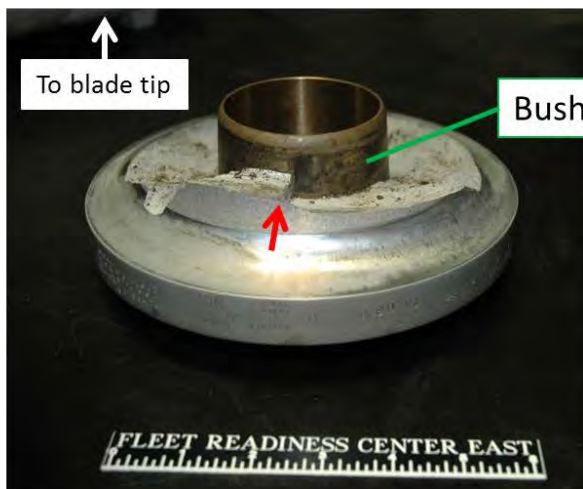
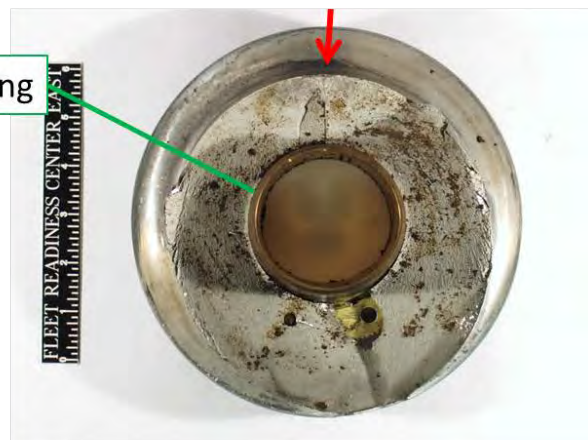
Figure 4 - Blade tip and butt ends in condition received by lab. Red arrows indicates radial crack. Yellow dotted line shows radial crack length extending into taper bore. Note separation of fatigue planes through step formed by radial crack indicated by black dotted line top right image.

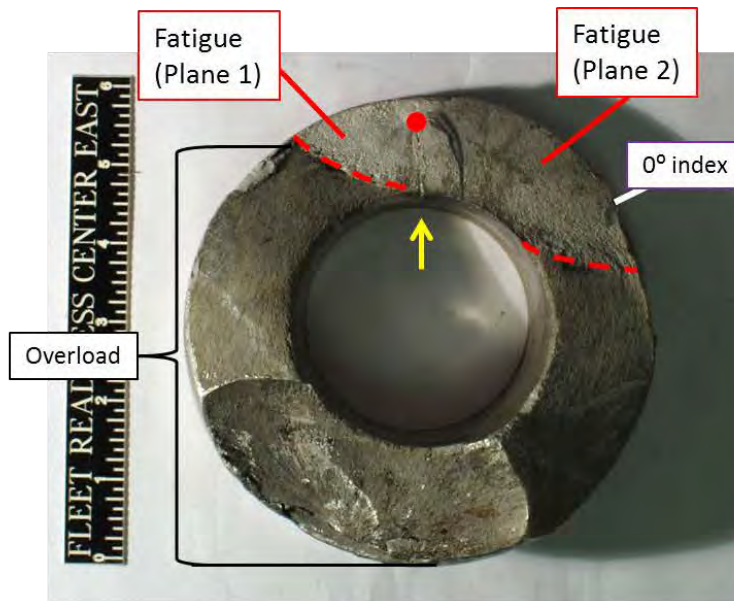
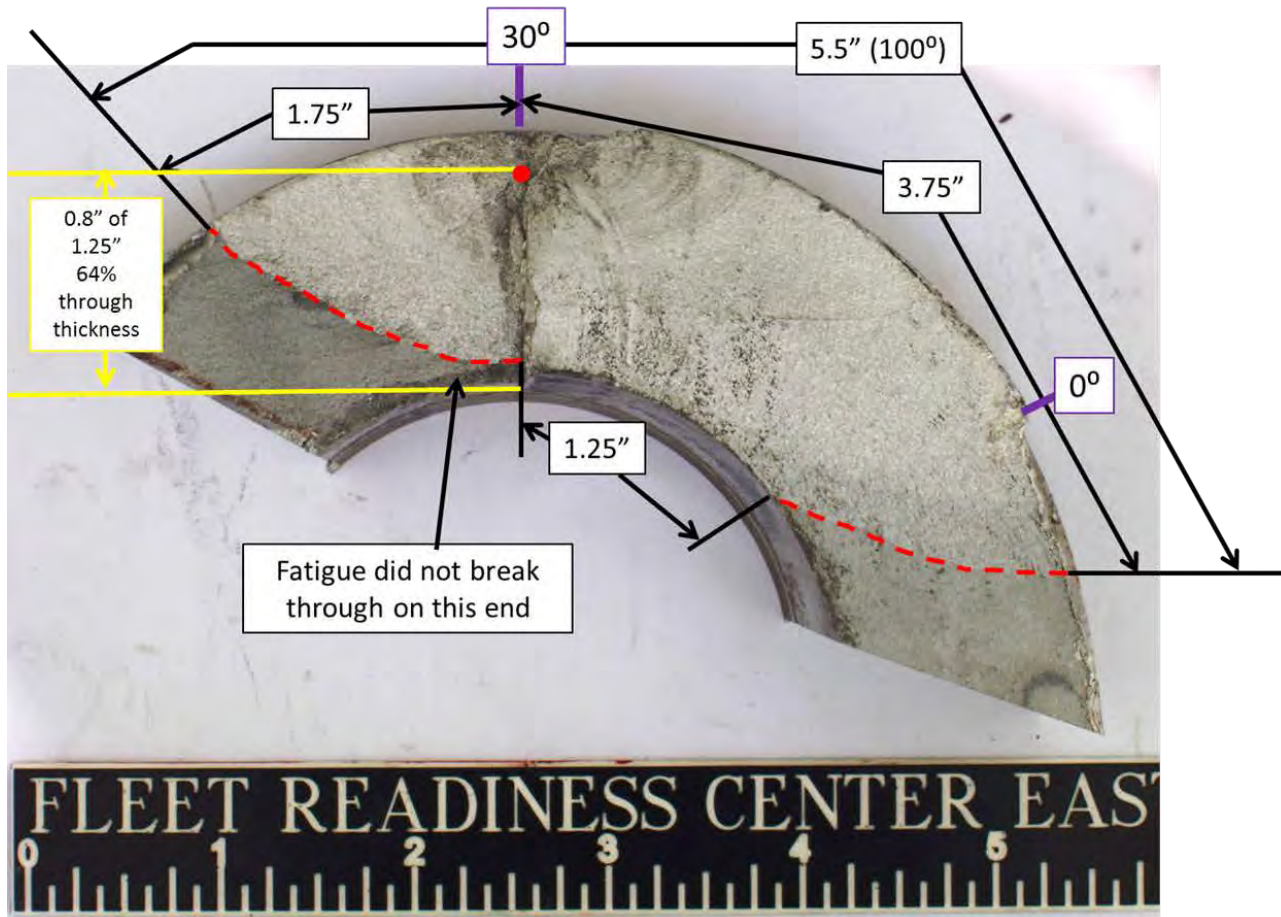
Figure 5 - Fatigue fracture surface indicated by red dotted line and associated dimensions. Blade degree indices annotated in purple boxes. Fatigue origin indicated by red dot. Yellow arrow (top image) indicates radial crack location and yellow dimensions (bottom image) are with respect to radial crack.

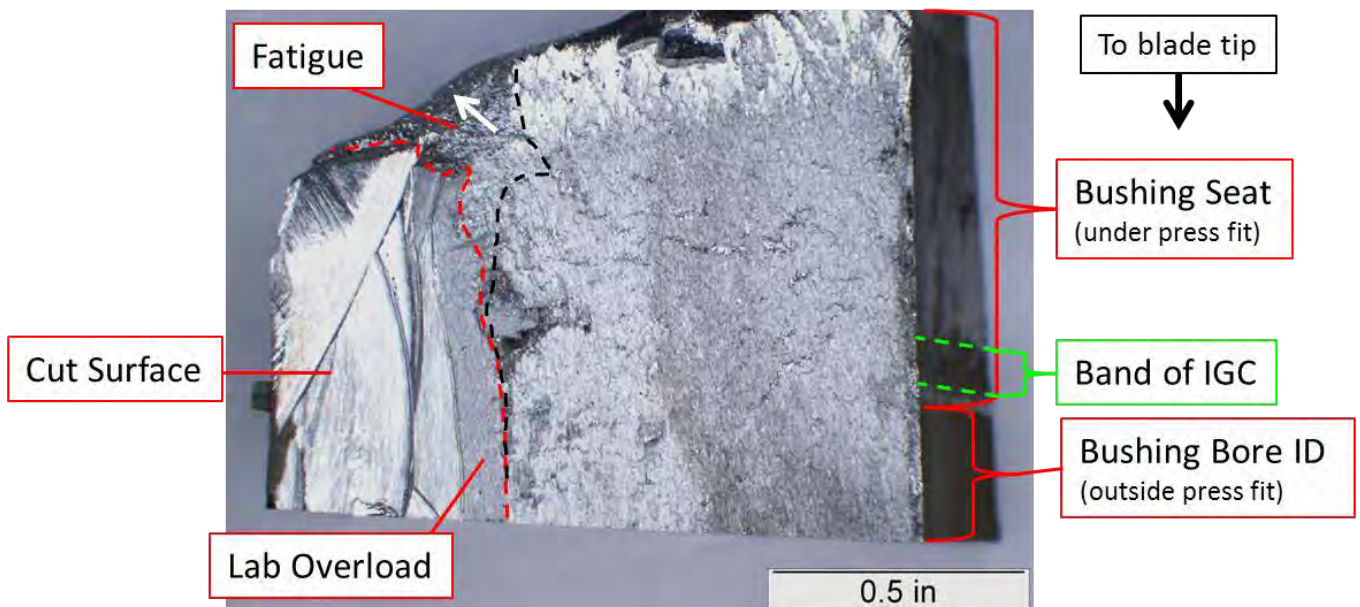
Figure 6 - Initiation and propagation of circumferential fatigue crack from intergranular radial crack.

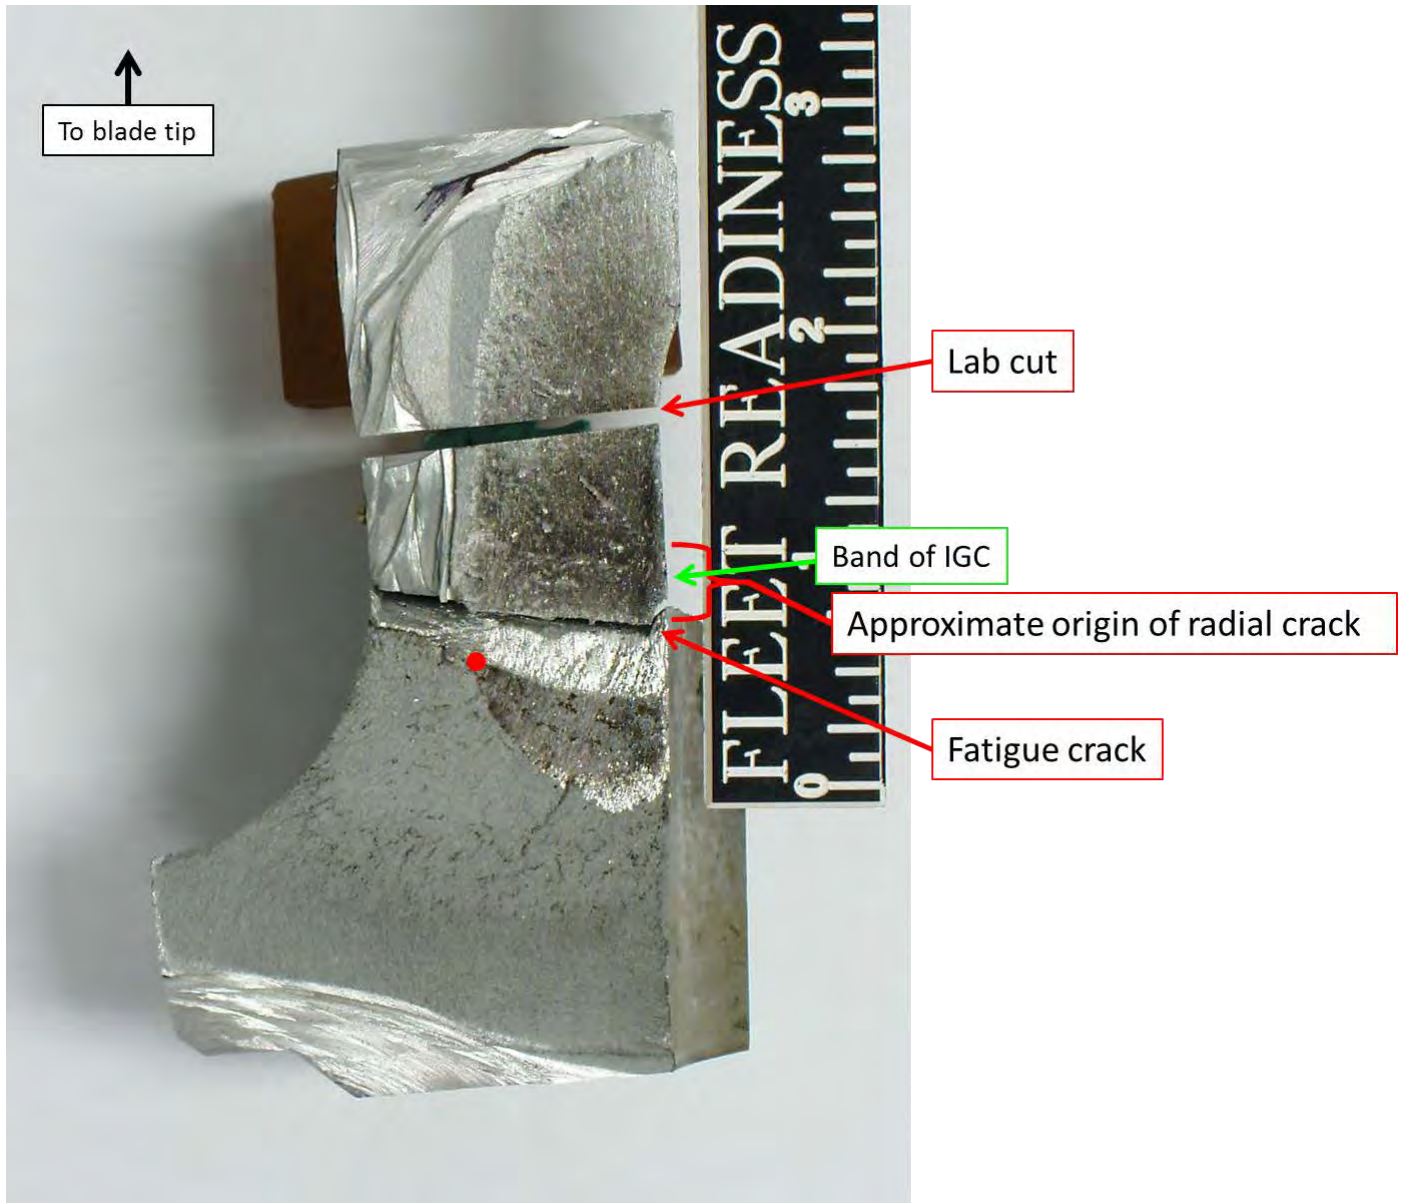
Figure 7 - Intergranular radial crack fracture surface. Red dot indicates fatigue origin. Blade shank ID (taper and bushing bore surfaces) is on right.

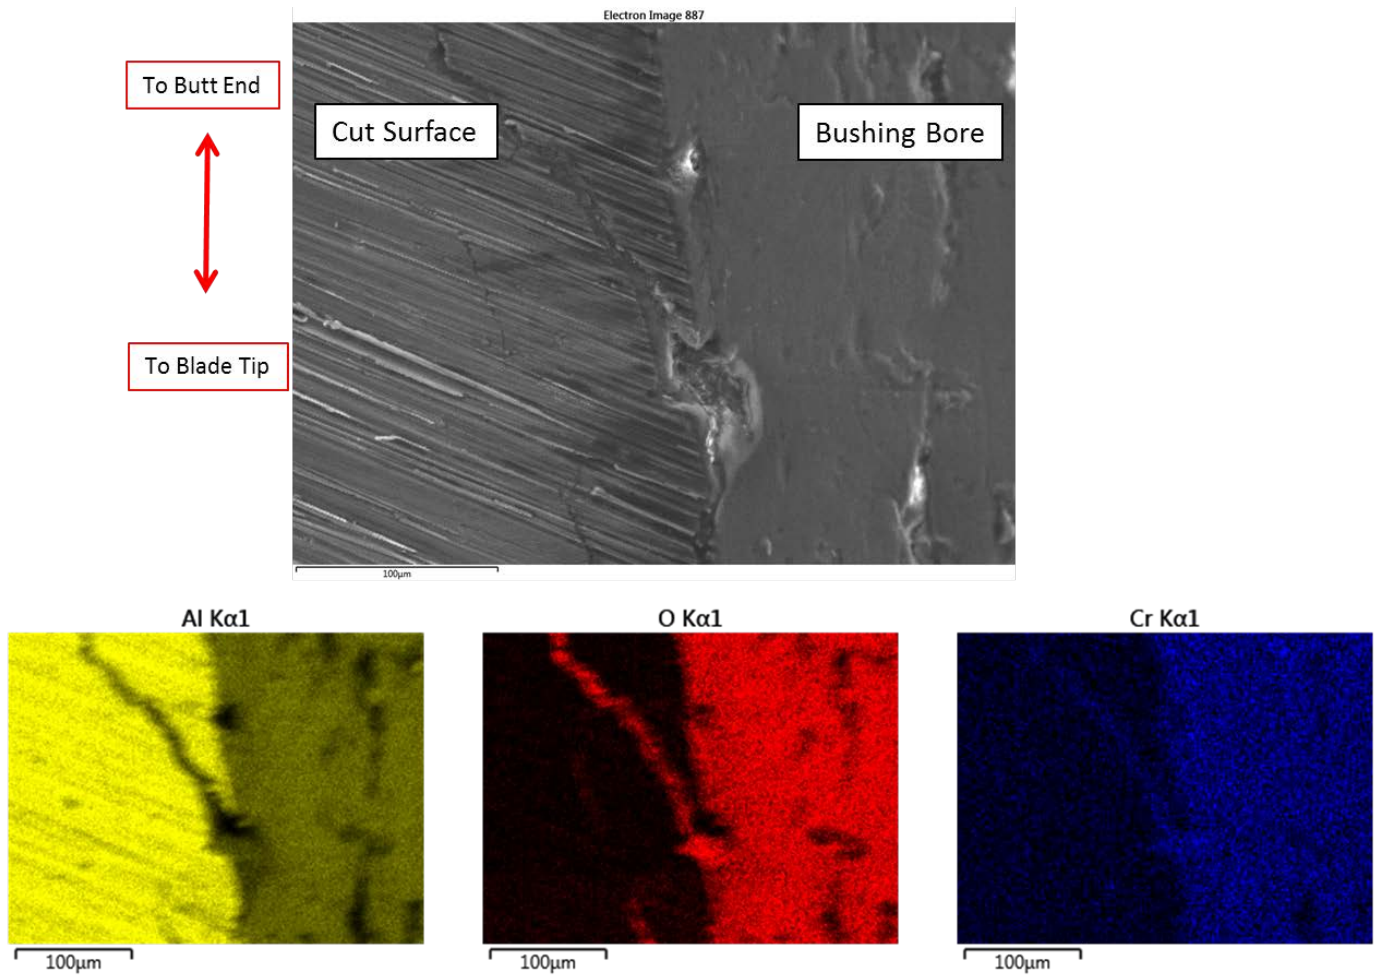
- Intergranular attack was present within the bushing bore and not removed at the last overhaul dated Sept, 2011.
 - Evidenced by anodize coating extending into intergranular cracking (IGC).
- An intergranular radial crack propagated from IGC through 64% of the shank wall cross section for a length of about 2.7"
- Fatigue initiated from the outer bound of the radial crack and propagated circumferentially for an arc length of 100° prior to catastrophic overload failure and blade departure.

Figure 10 - Chemical analysis with elemental mapping software showing anodize within pits/cracks in band of IGC. Top is SEM image with surfaces indicated.

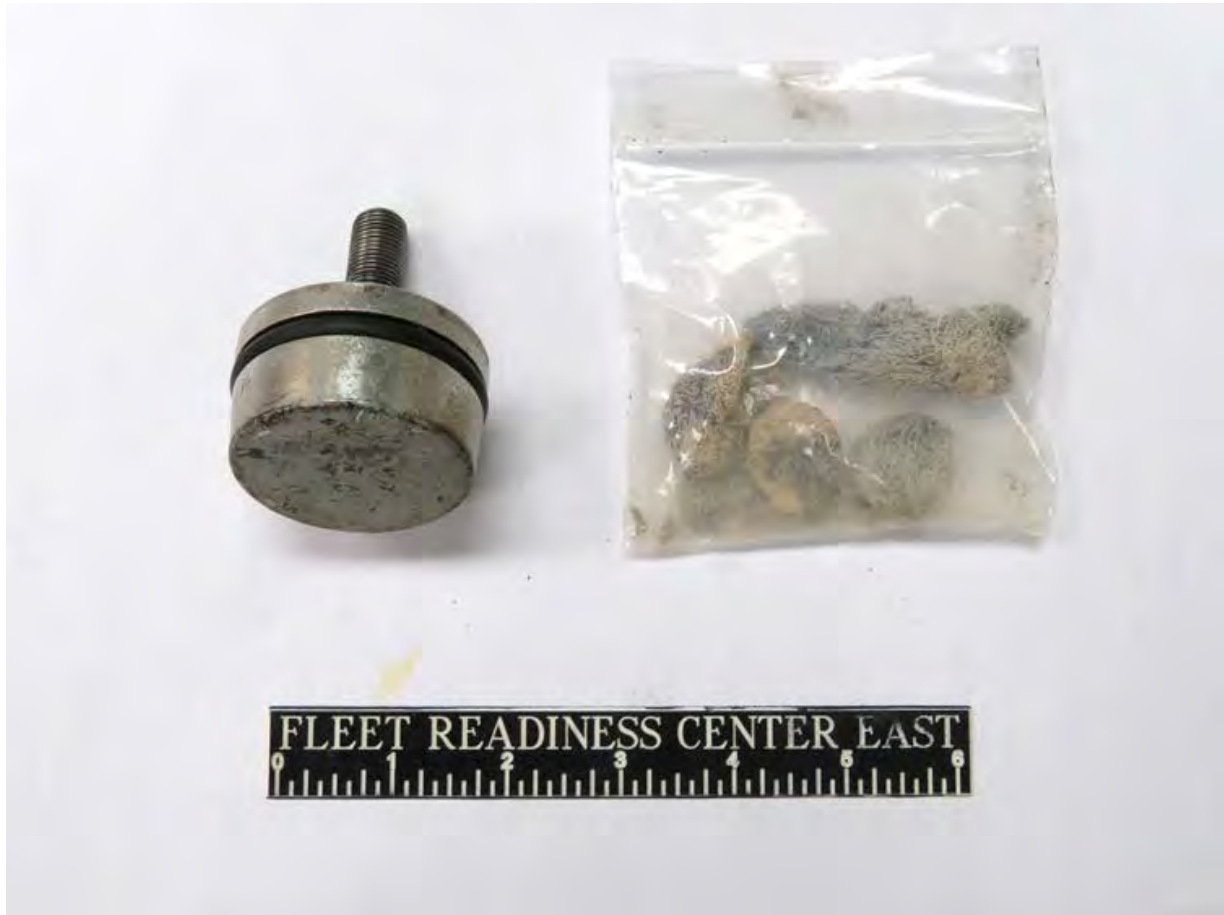
Figure 11 - Taper bore plug and lead wool showing corrosion damage

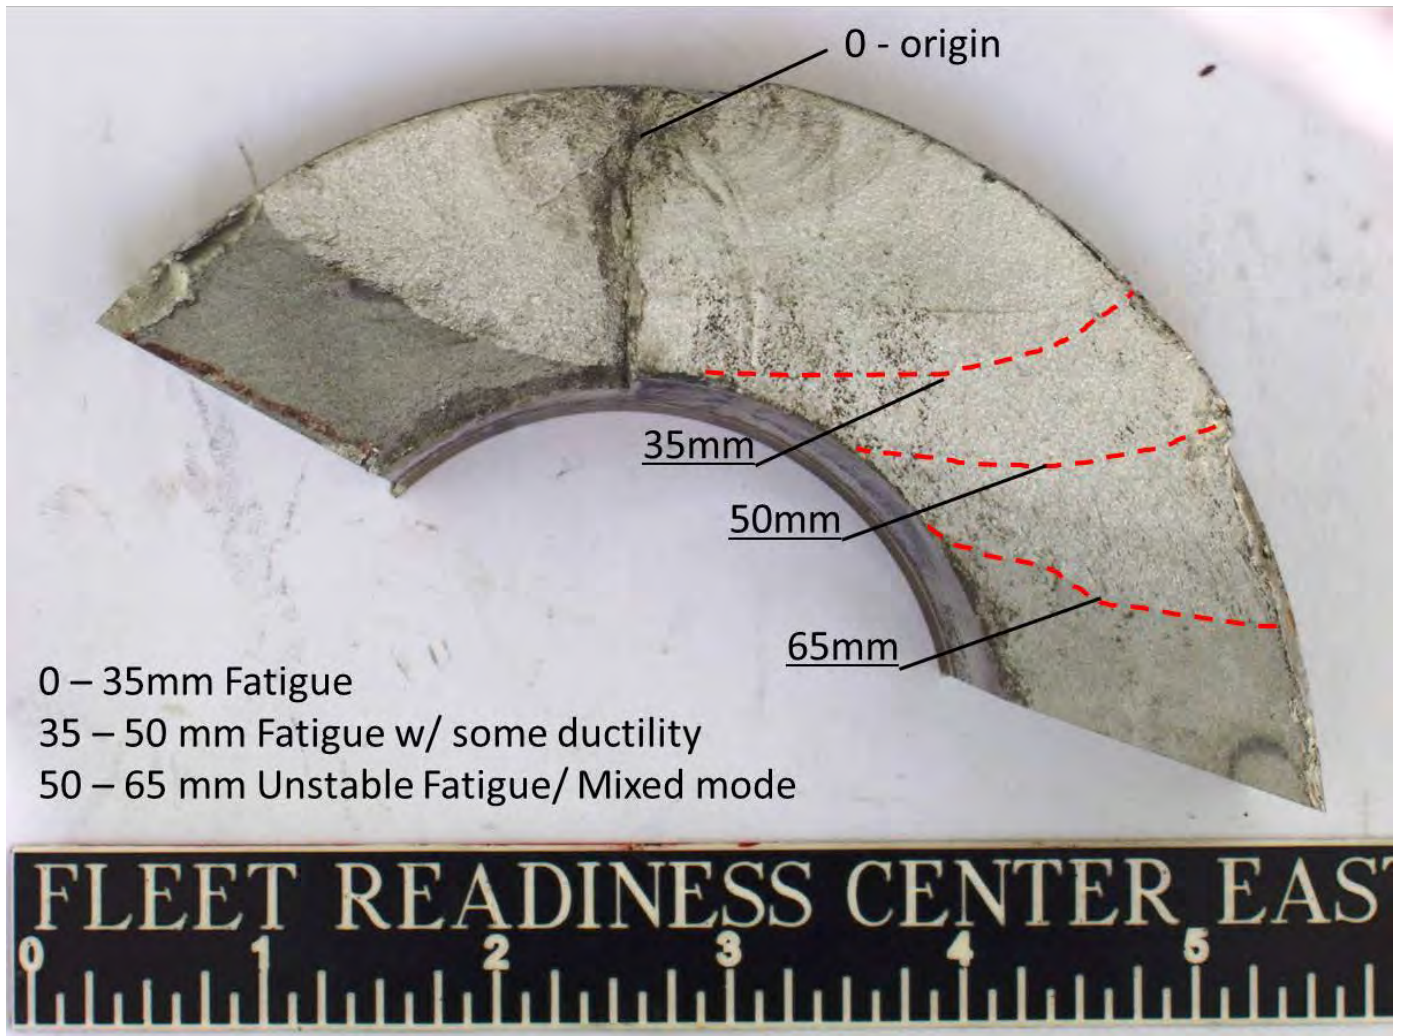
Figure 14 - Fatigue Fracture Surface. From 0-35mm only fatigue fracture observed. 35-50mm ductility (overload) began to present. 50-65mm was mixed mode fracture with some fatigue within overload fracture.

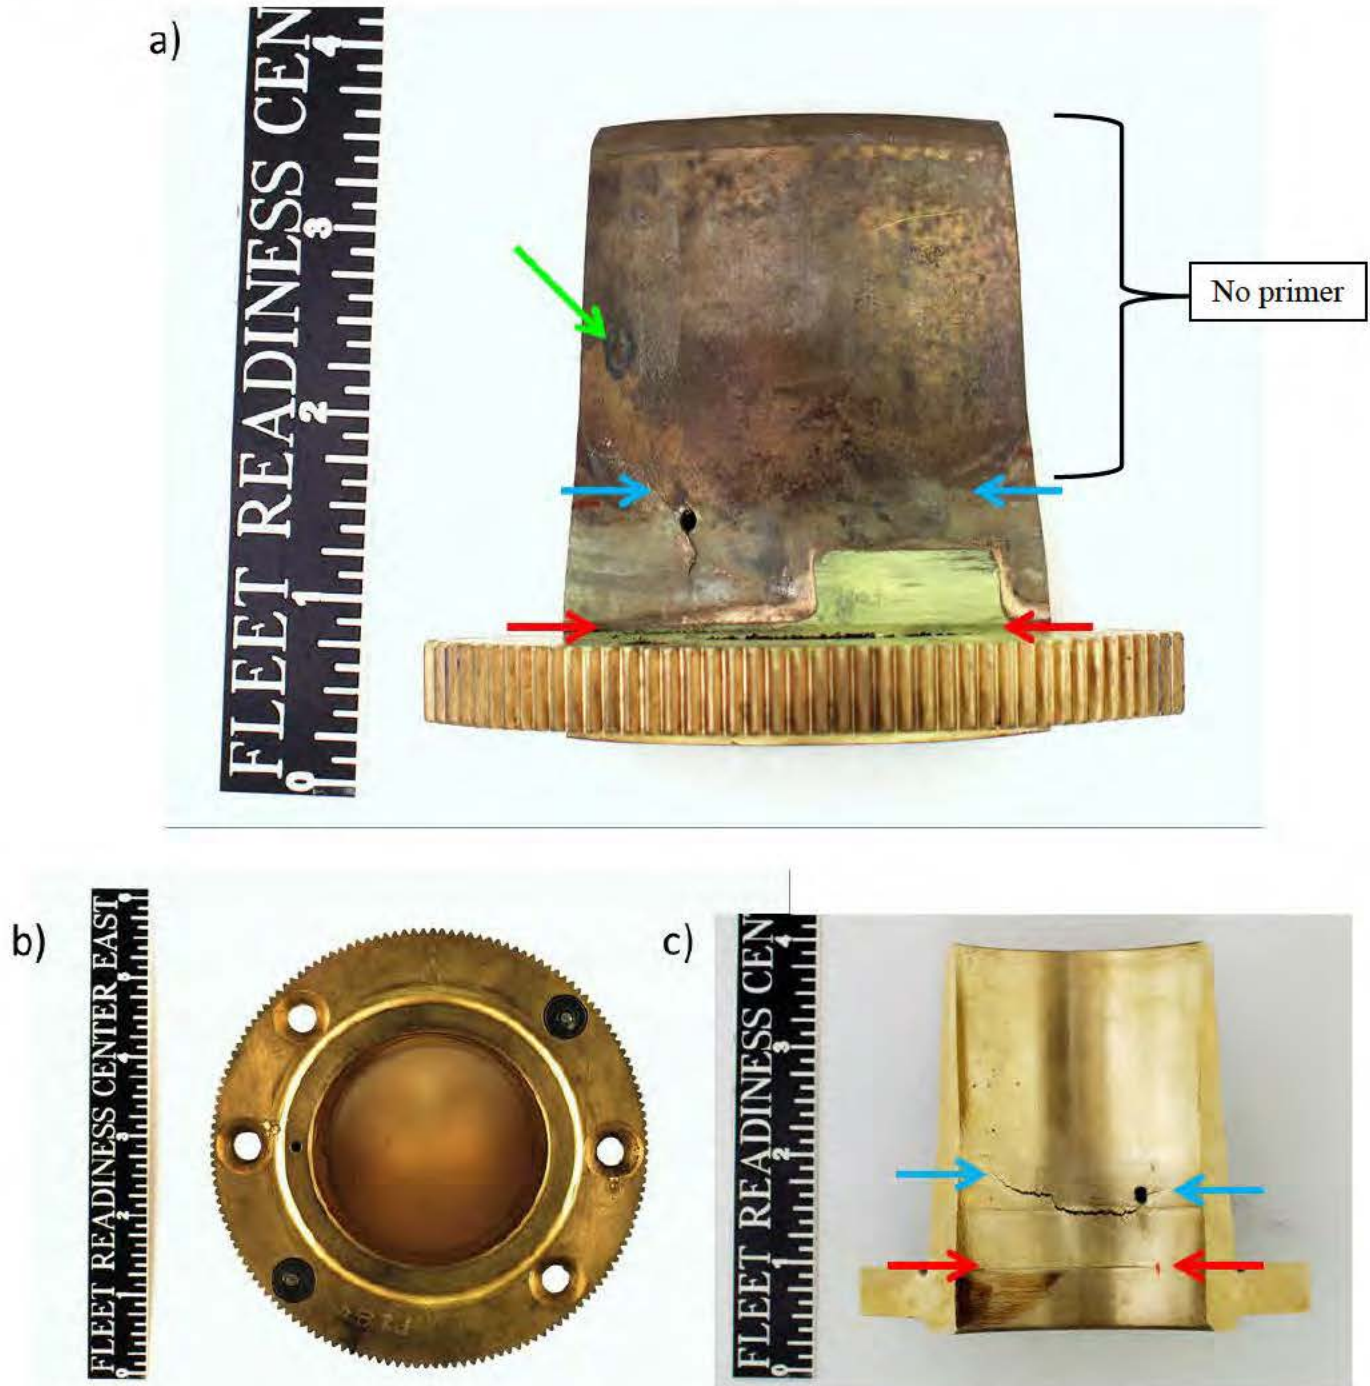
Figure 19 - P2B4 Blade Bushing; a) View from side showing crack locations; b) View looking outboard; c) Looking at ID of cracked section. Green arrow indicated lead flake. Blue arrows bracket outboard crack and red arrows bracket inboard crack.

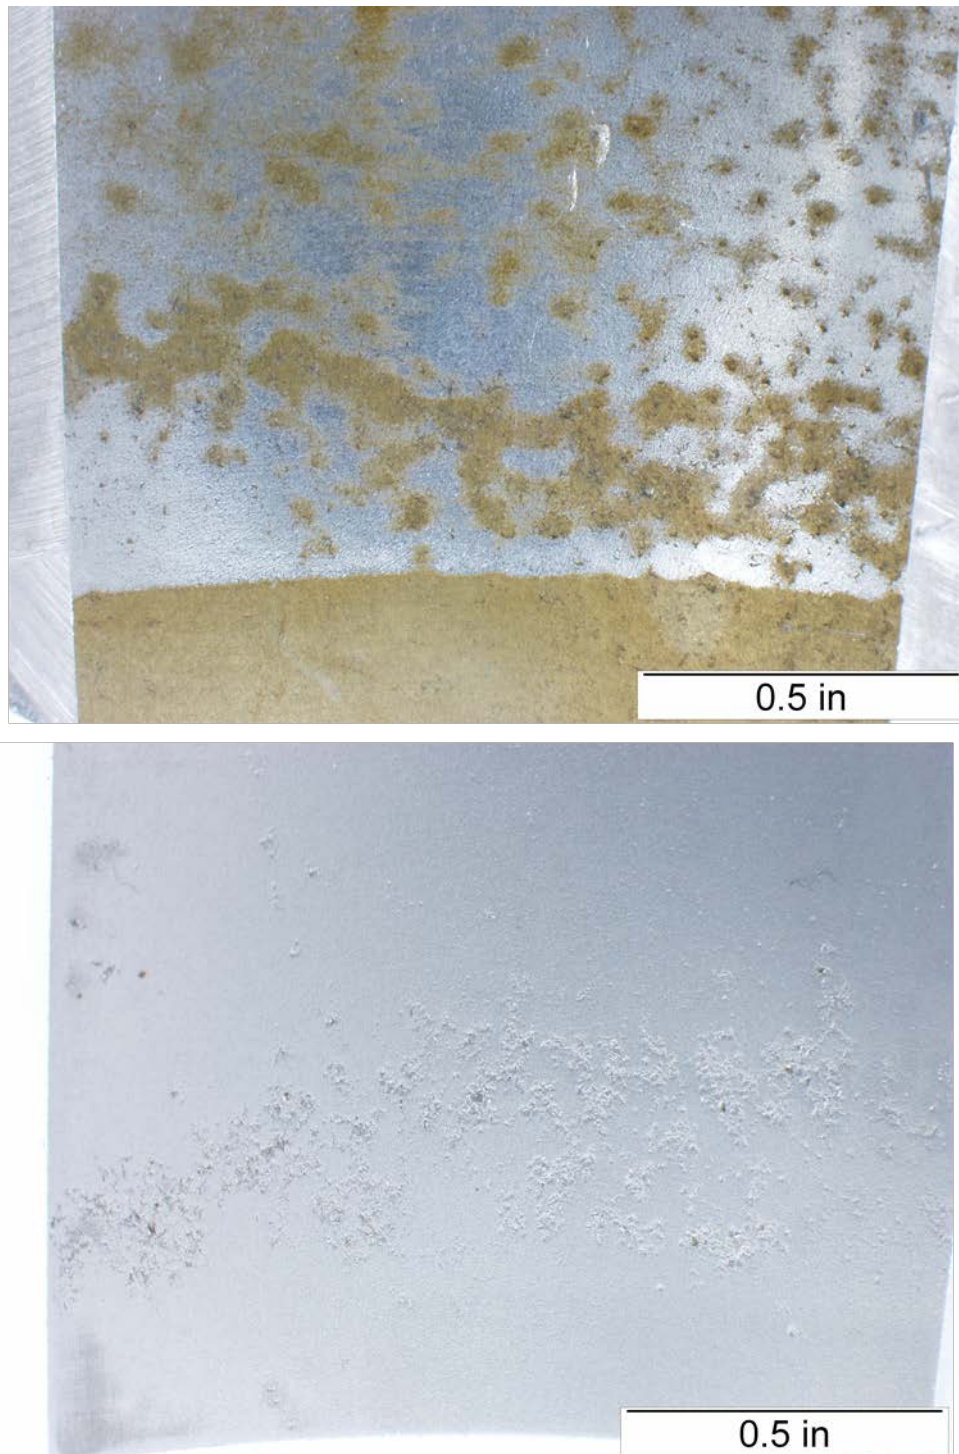
Figure 22 - Adjacent bushing bore surfaces containing band of IGC. Top) No Alteration, anodize still present; Bottom) Surface after gentle glass blasting which removed surface coatings and enhanced visible indication of corrosion damage
