IN REPLY REFER TO:
5830
CMFR
6 Sep 18

From: Commander, Marine Forces Reserve
To: File

Subj: COMMAND INVESTIGATION INTO THE CLASS A AVIATION MISHAP WITHIN
MARINE AERIAL REFUELER TRANSPORT SQUADRON 452 ON 10 JULY 2017

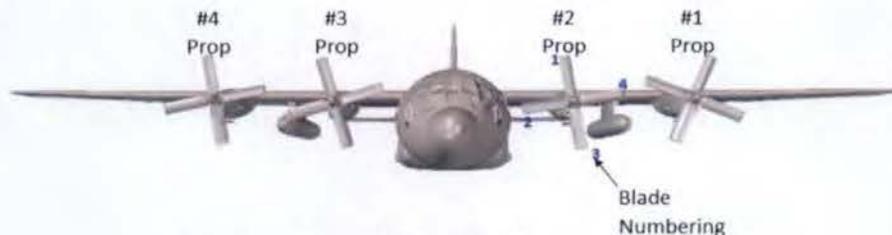
Figure 3: Frontal View of C-130

107. This impact caused the skin of the aircraft to separate along the starboard side. The energy transferred from P2B4's impact through the structure of the airframe also caused an overload condition of propeller three's drive shaft. This resulted in its associated reduction gearbox assembly (RGA) failing and the separation of propeller three from the aircraft. Propeller three then momentarily embedded into the upper right section of the fuselage. After which, it continued over the aft starboard section of the fuselage and impacted the starboard horizontal stabilizer separating a significant portion of the stabilizer from the aircraft. [Encls (13), (21), (22)]

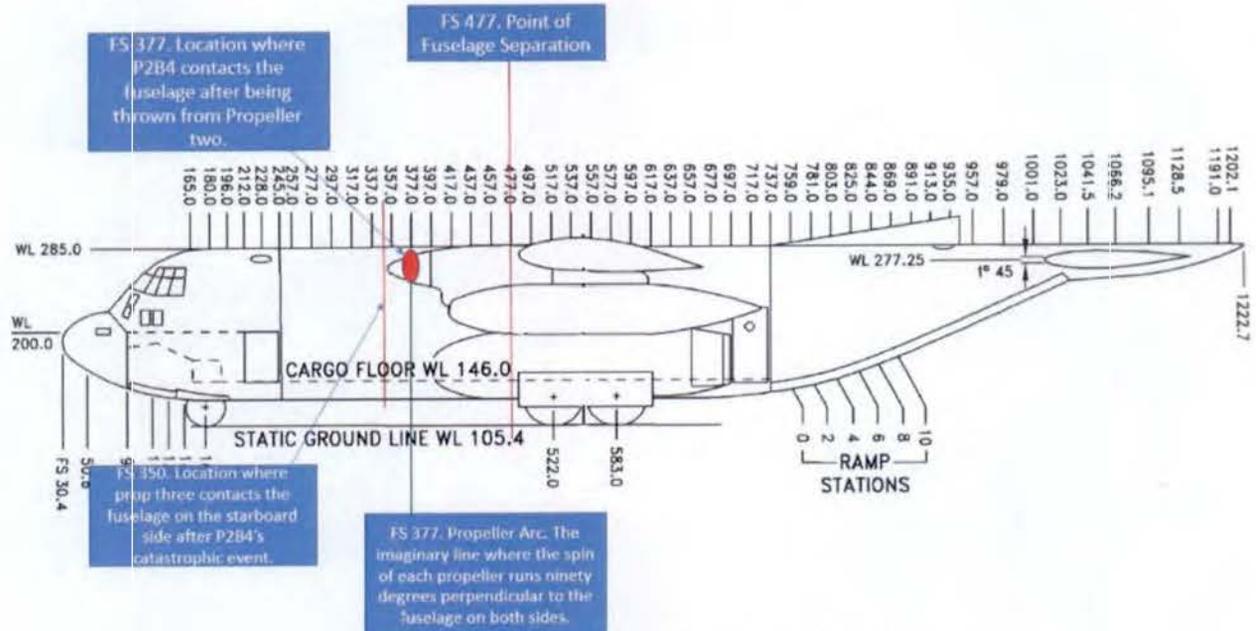
Figure 5: Side Schematic of Key Areas

121. After departure, P2B4 sliced through the port side of the fuselage at FS 377 slightly aft of the propeller arc plane upon entry in a near vertical orientation. This deteriorated the left side longeron support structures as the tip cut 36 inches below left butt line (LBL) 61 and the root end of the blade impacted 19 inches above LBL 61. P2B4 then passed unobstructed through the MAC interior, and did not exit the airframe but rather impacted the interior starboard side of the cargo compartment where it remained until cargo compartment separation. [Encls (13), (21), (22)]

122. P2B4's intrusion resulted in an overload failure of the LBL 61 longeron on both sides of the impact point at FS 377. [Encl (21)]

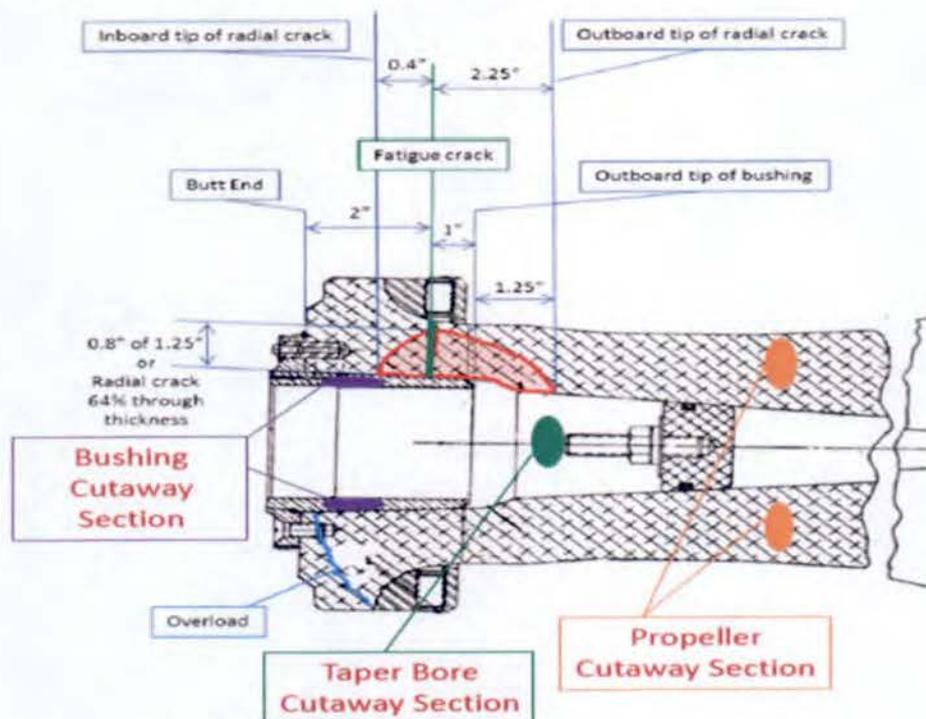
Figure 16: P2B4 Cutaway Breakdown

145. A post-mishap inspection showed that P2B4 had an intergranular crack (IGC) and radial crack in the vicinity of the bushing bore of the propeller. This developed from corrosion pitting and intergranular cracking that was present and not removed during the last overhaul performed by WR-ALC in September 2011. [Encls (22), (30), (31)]

153. This intergranular radial crack in P2B4 had grown to a total of 2.7 inches in length along the interior taper bore of the blade, extending 1.25 inches beyond the bushing. [Encls (22), (27), (30)]

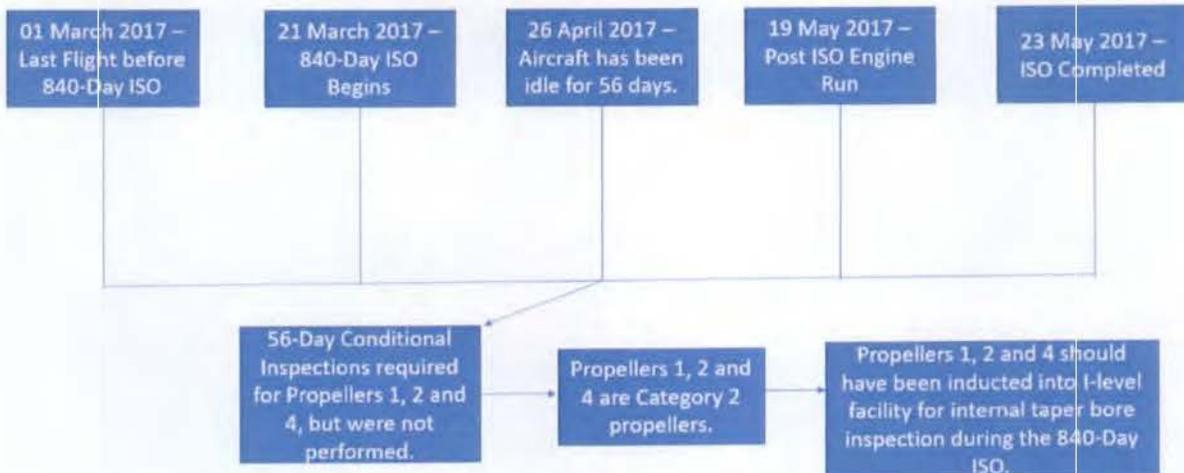
Figure 19: MAC Maintenance Inspection Timeline

312. Propellers one, two, and four remained on the MAC, and there is no evidence showing an off-wing eddy current inner taper bore inspection was performed on the MAC between the dates of 26 April 2017 and 24 May 2017. [Encls (42), (45)]
