Subj: COMMAND INVESTIGATION INTO THE CIRCUMSTANCES SURROUNDING THE  
F-35 MISHAP OF MAG-31, VMFAT-501 ON 17 SEPTEMBER 2023

**LOCKHEED MARTIN (LM) AERONAUTICS COMPANY**  
**ENGINEERING INVESTIGATION REPORT OF F-35B BUNO 169591 (BF-66)**  
**CLASS A FLIGHT MISHAP, 17 September 2023, AFSAS (b)(4)**

**Date: 13 October 2023**  
**Document Type: Engineering Investigation Report**

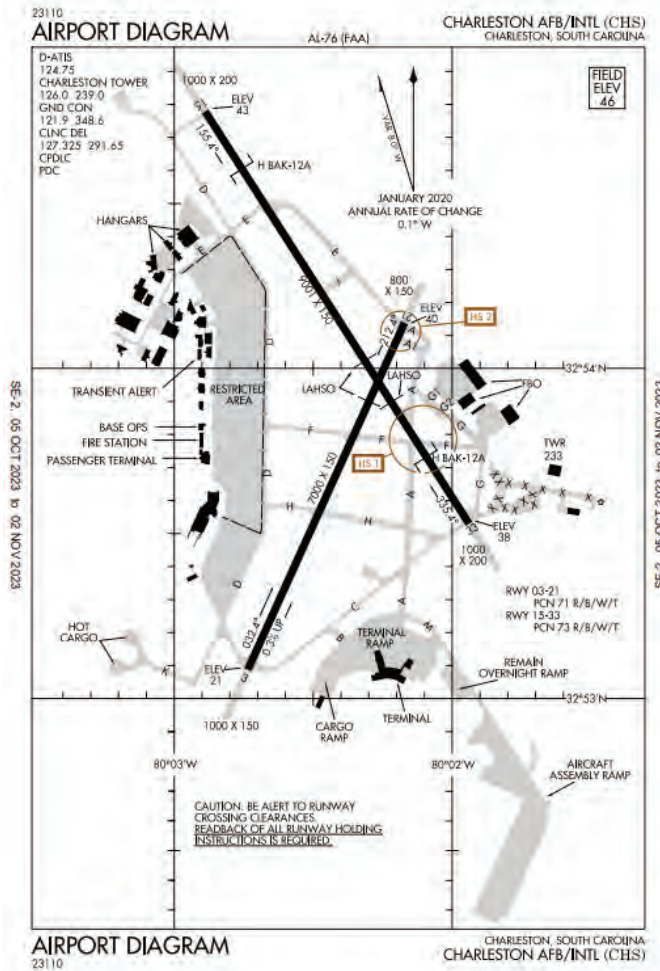
**Figure 2. Joint Base Charleston Airport Diagram**

**OBSERVATION:** Runway 15 at Joint Base Charleston is 9,001 feet long by 150 feet wide and lays on a heading of 147 degrees True with BAK-12A arresting systems at each end of the runway displaced approximately 1,260 feet from Runway 15 approach end and 1,460 feet from Runway 33 approach end. The overrun at both ends of the runway is 1,000 feet long by 200 feet wide. The airport diagram is provided in Figure 2 below.

The MA crash site involved two locations. Ejection was initiated during the approach to Runway 15 at Joint Base Charleston. CSMU data recorded ejection was initiated at AC time 4791.8s (17:32:46.3Z) at 32.919399N, 080.050836W. At the time of ejection, the MA was on a 149 true heading (T), at 1,746 feet MSL and 243 KCAS. The MA ejection seat was recovered just inside the Joint Base Charleston airfield perimeter fence.
