Figure 4: Center Fuselage Side Section Panels

Figure 8: Center Fuselage Side and Upper Section, FS 245 – FS 477

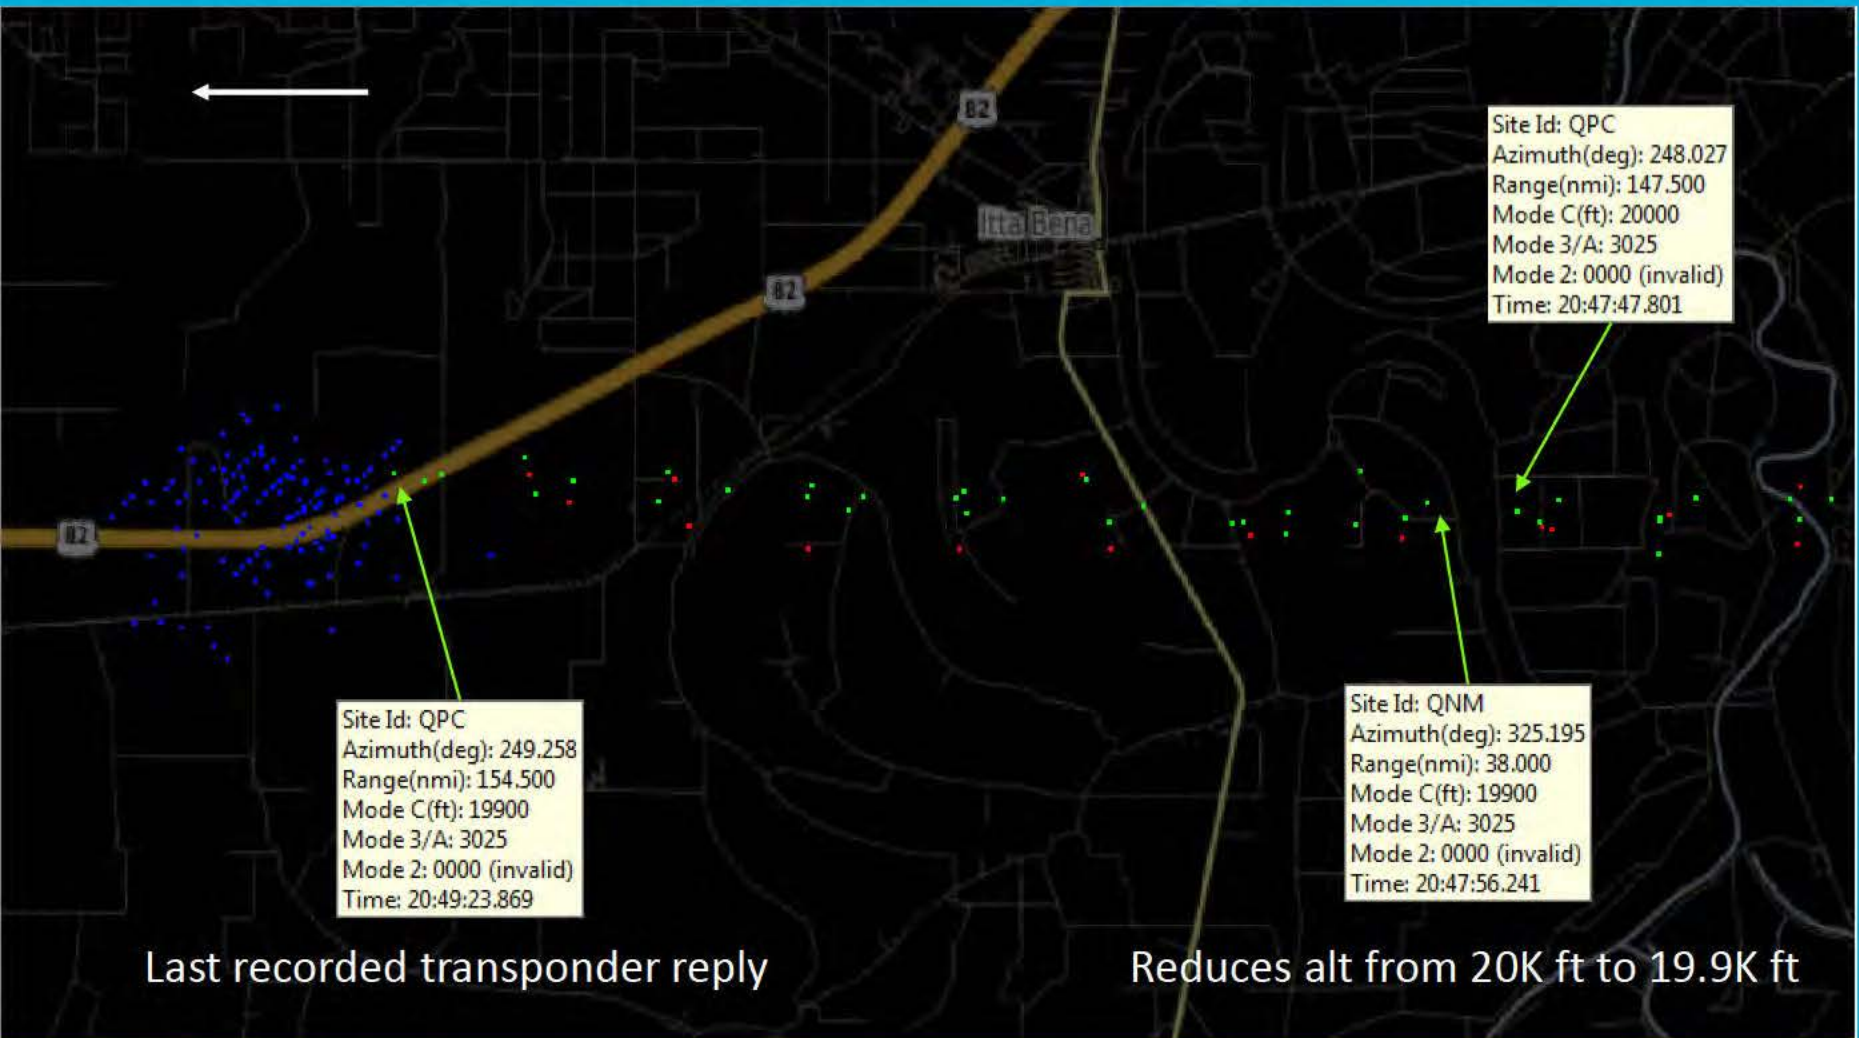
- RADAR SITE DATA FROM: 5086_AEX / 5591_QNM / 5097_QPC / 5166_QRB / 5423_QYB
- LAST 2 MIN 3 SEC (APPROXIMATE) OF KC-130 FLIGHT DATA
- SEARCH ONLY HITS DEPICTING POTENTIAL DEBRIS FIELD

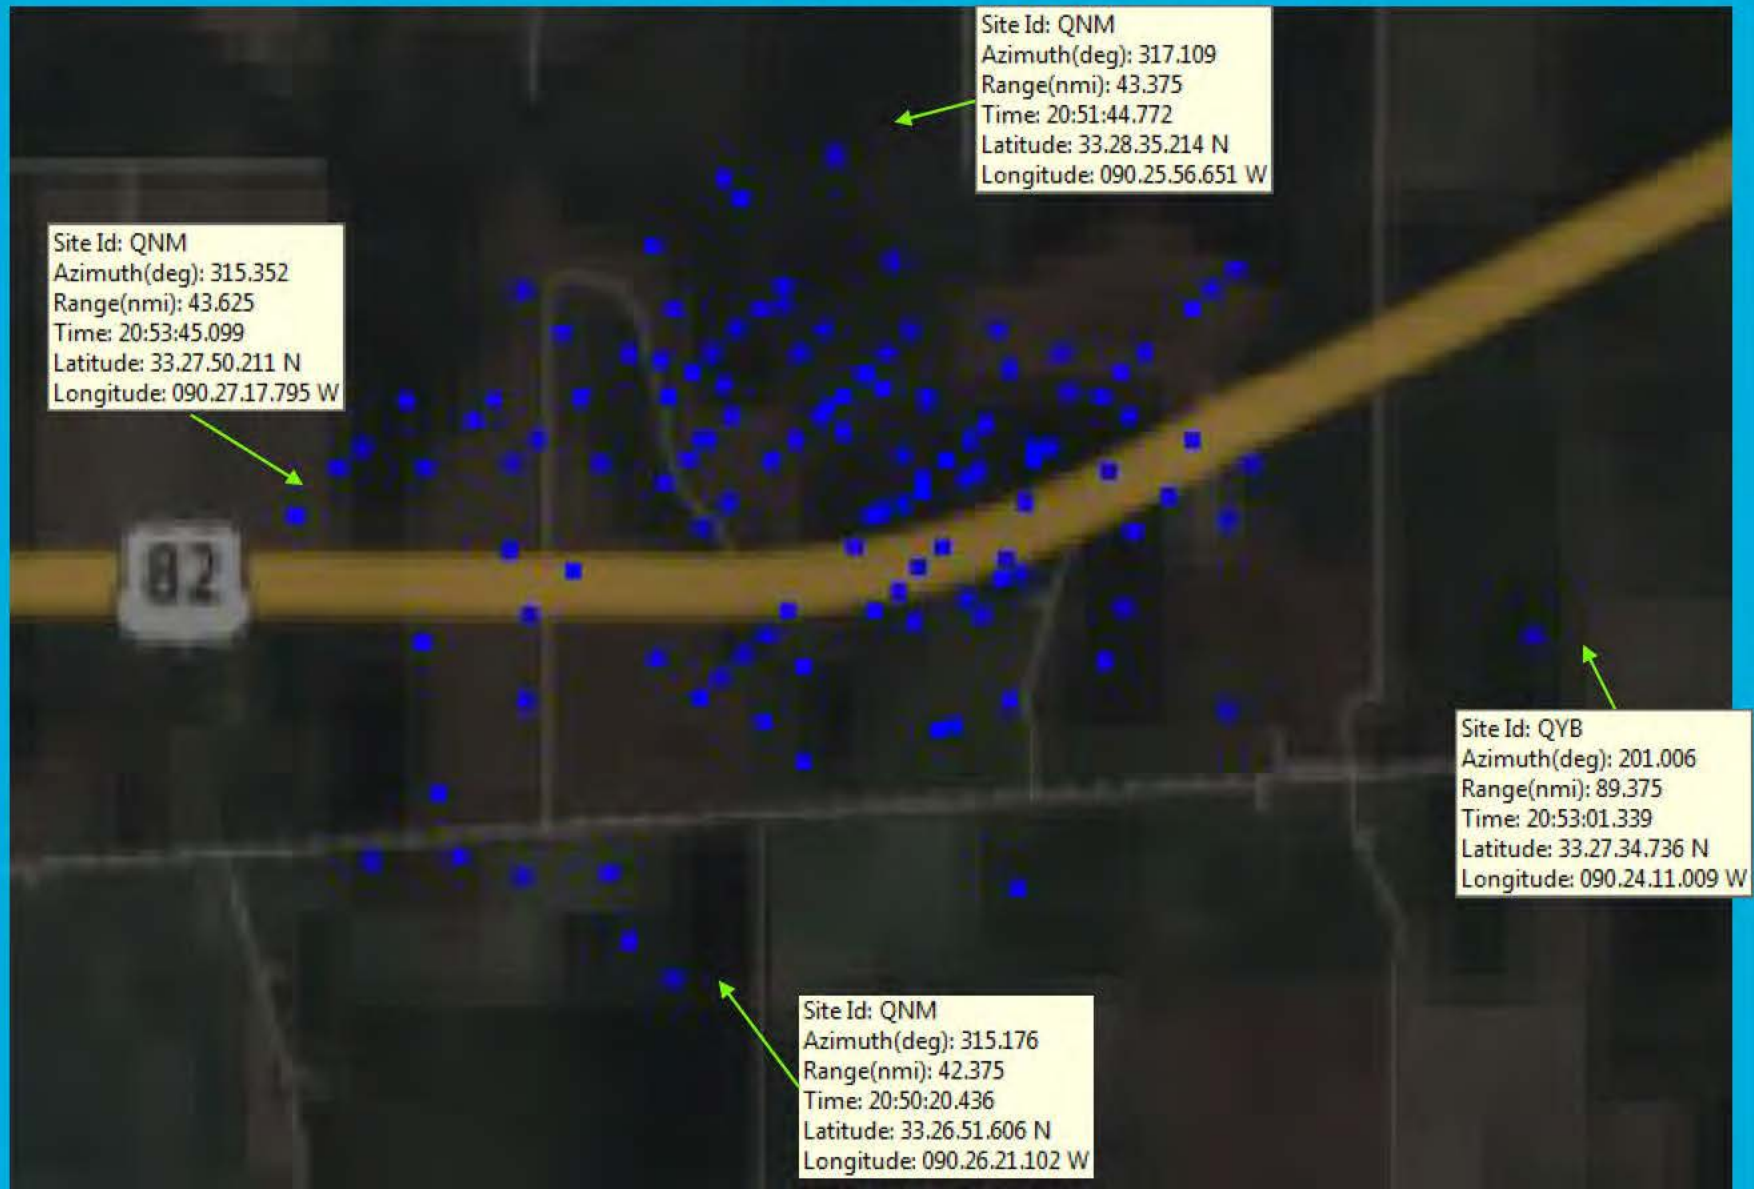
- RADAR SITE DATA FROM: 5086_AEX / 5591_QNM / 5097_QPC / 5166_QRB / 5423_QYB
- SEARCH ONLY HITS DEPICTING POTENTIAL DEBRIS FIELD

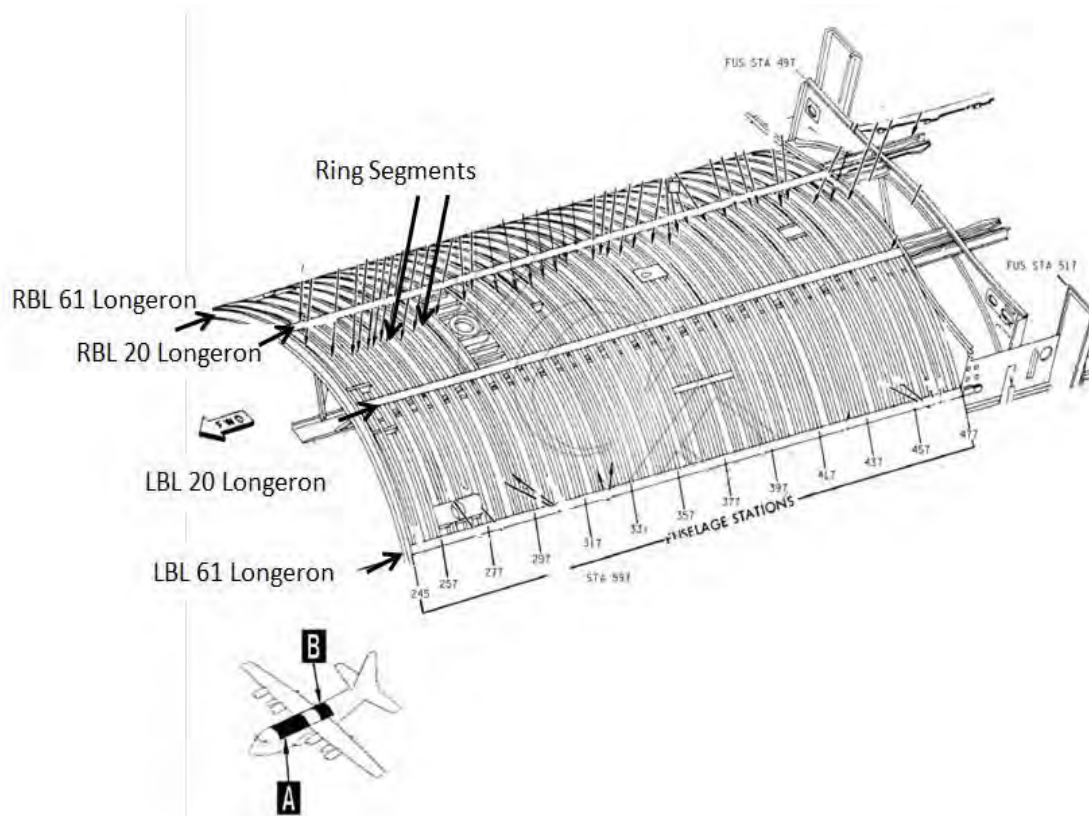
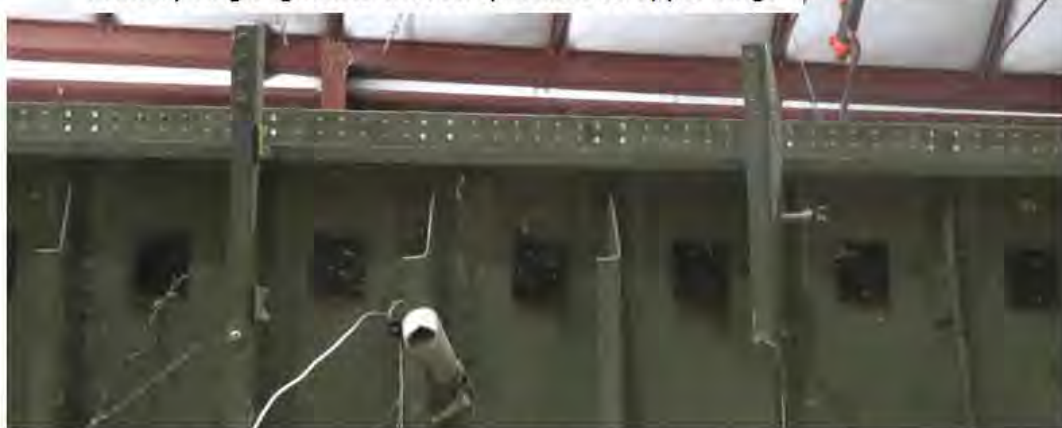
Figure 3: View of RH side panel near BL 61 showing interior configuration as it attaches to the upper panel

Primary ring segments that strap across to upper rings

Intermediate ring segments that stop short of BL 61 longeron

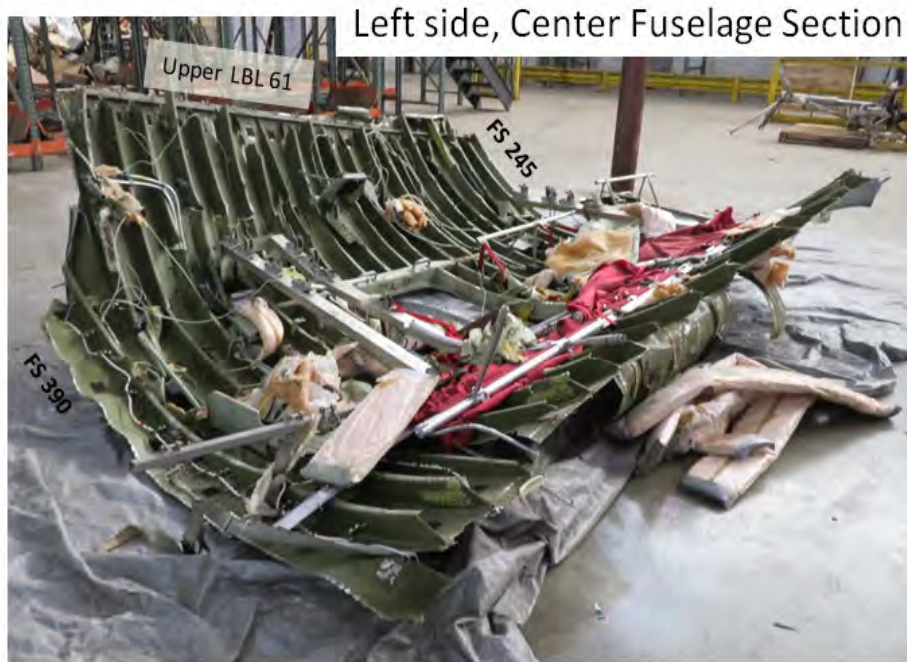
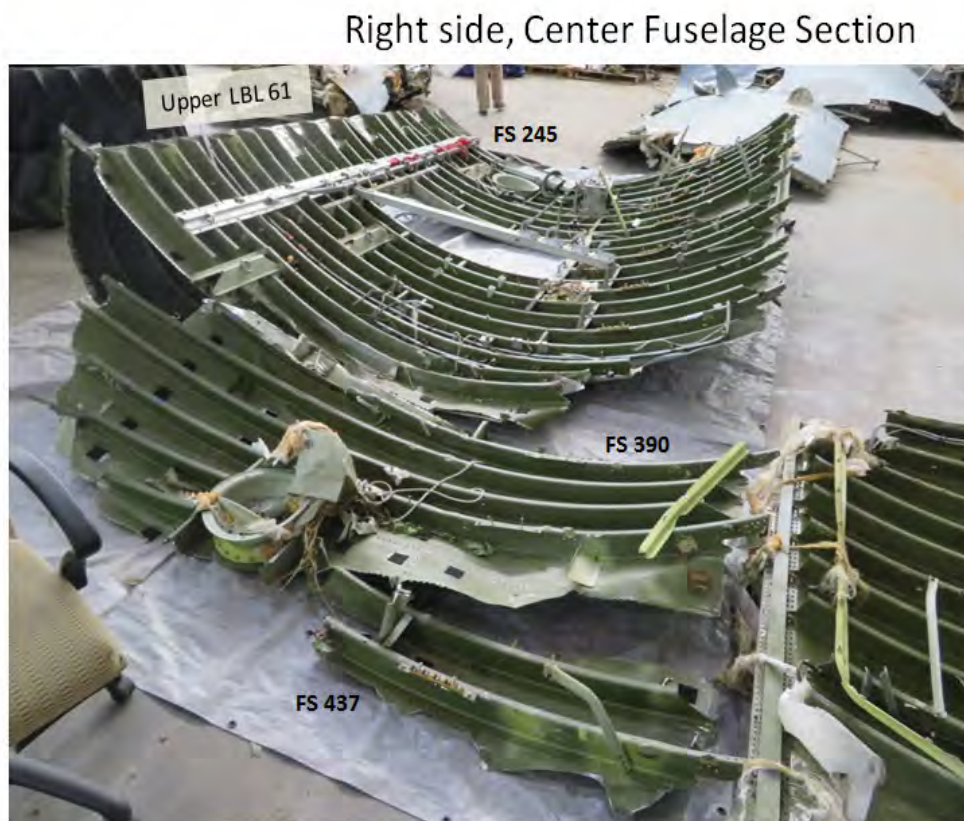
Large and small pieces of the fuselage forward of the center wing structure were recovered from the North site. The center fuselage section between FS 245 and FS 477 was recovered as one floor panel, two fairly intact side panels, four large upper section pieces and numerous smaller pieces of side and upper structure. The flight station forward of FS 165 was mostly consumed by ground fire. The forward fuselage section from FS 165 thru FS 245 was recovered in multiple pieces but was not included in the reconstruction effort of the center fuselage due to the mangled condition of the parts.

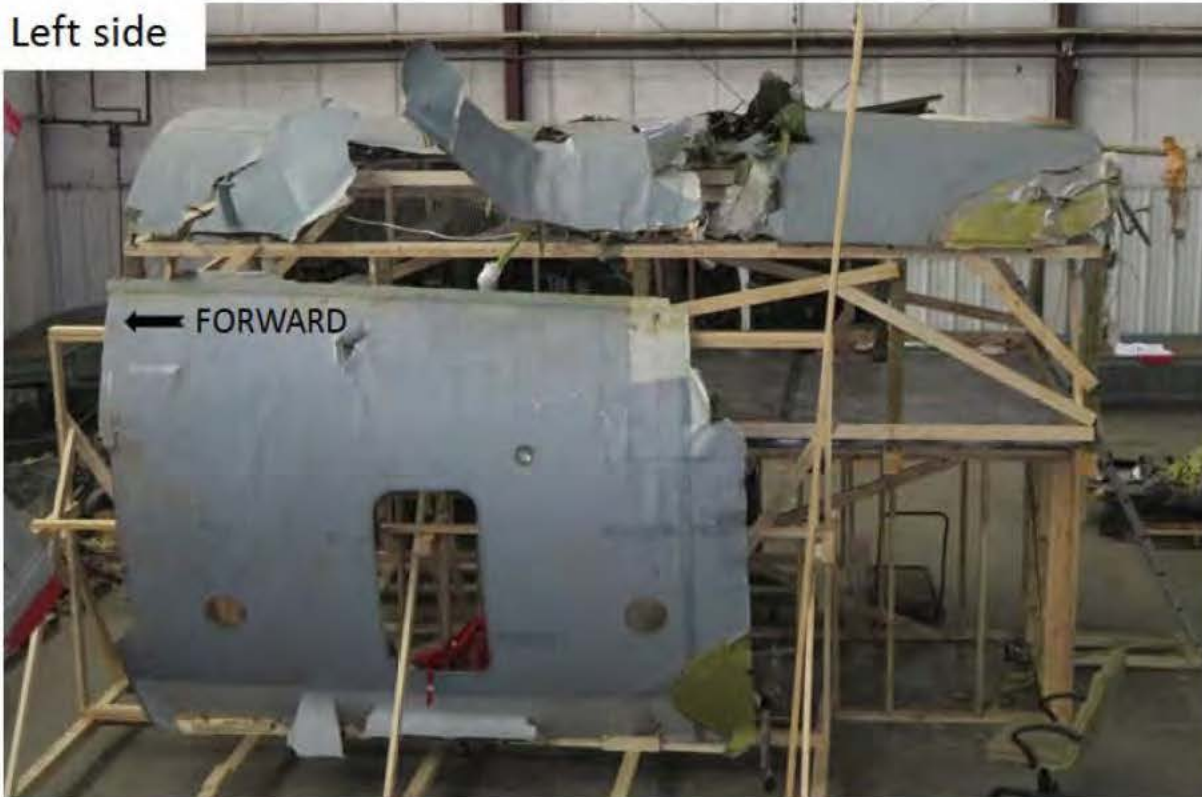
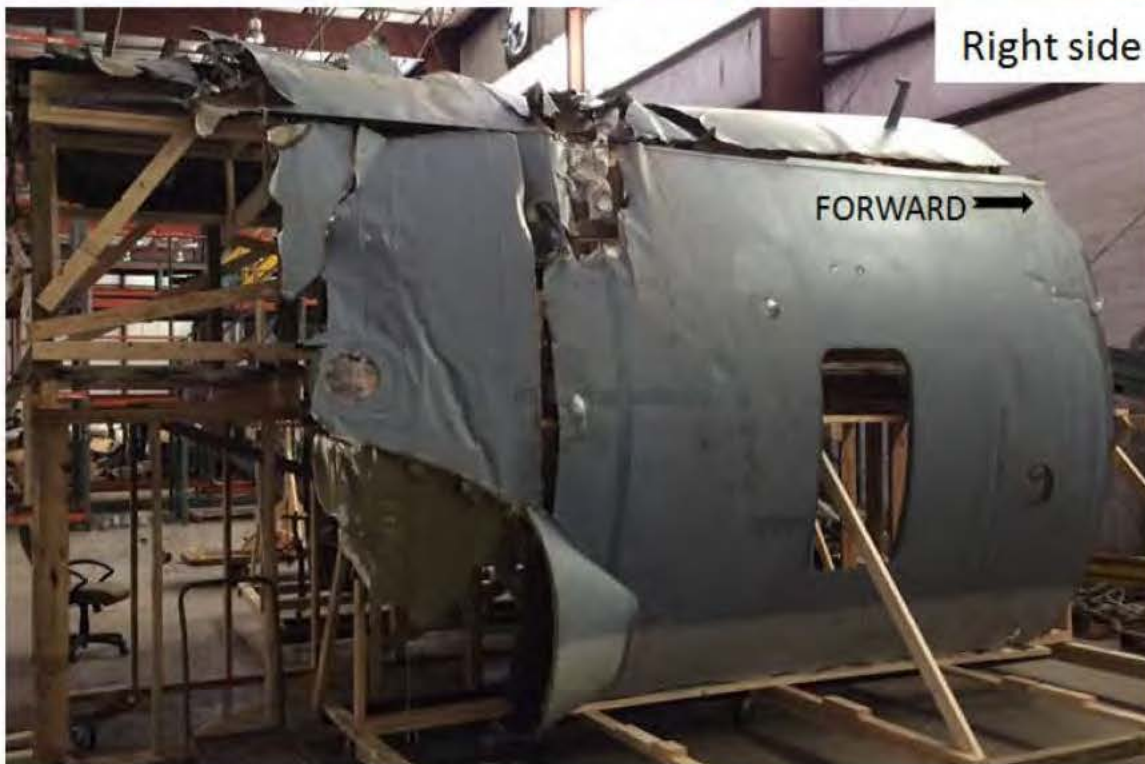
Figure 7: Center Fuselage Side Structure, FS 245 – FS 477

The left and right sides of the center fuselage showed damage from the intrusion of two separate propeller blades. Damage on the left side occurred at FS 377 coincident with the propeller arc plane. The damage was consistent with a liberated blade (identified as Blade 4 of Propeller #2) impacting in a near vertical orientation with the tip cutting through the side skin approximately 36" below the upper Left Buttock Line (LBL) 61 longeron and the root end of the blade impacting approximately 19" above LBL 61. Intrusion resulted in overload failure of the LBL 61 longeron on both sides of the point of impact at FS 377. The interior of the fuselage right side panel showed damage that was attributed to the liberated blade passing through the occupiable space of the fuselage and attempting to exit the structure. This damage occurred near Water Line (WL) 200 between ring segments at FS 383.67 and FS 397. Exit of the blade through the right side panel appeared to have been prevented by a robust stanchion bracket from a troop seatback support beam stowage assembly. The airfoil of Blade 4 from Propeller #2 exhibited damage consistent with the reconstructed attitude of blade entry into the left side of the fuselage.

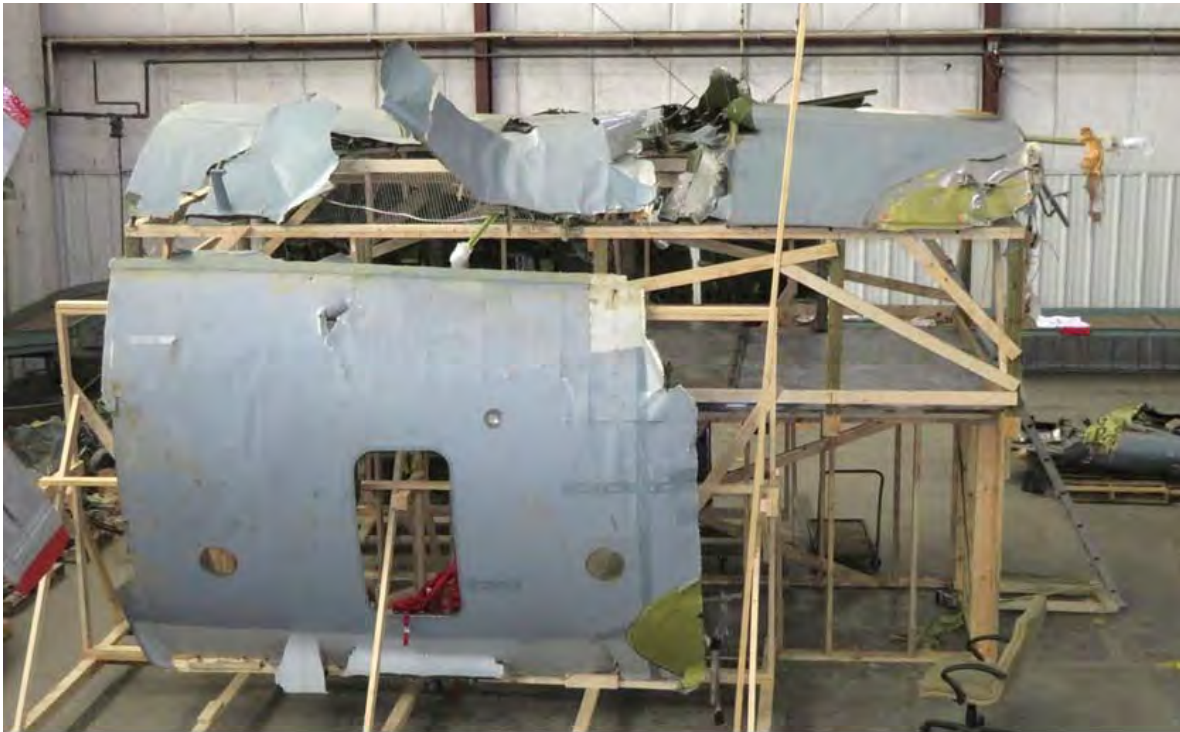
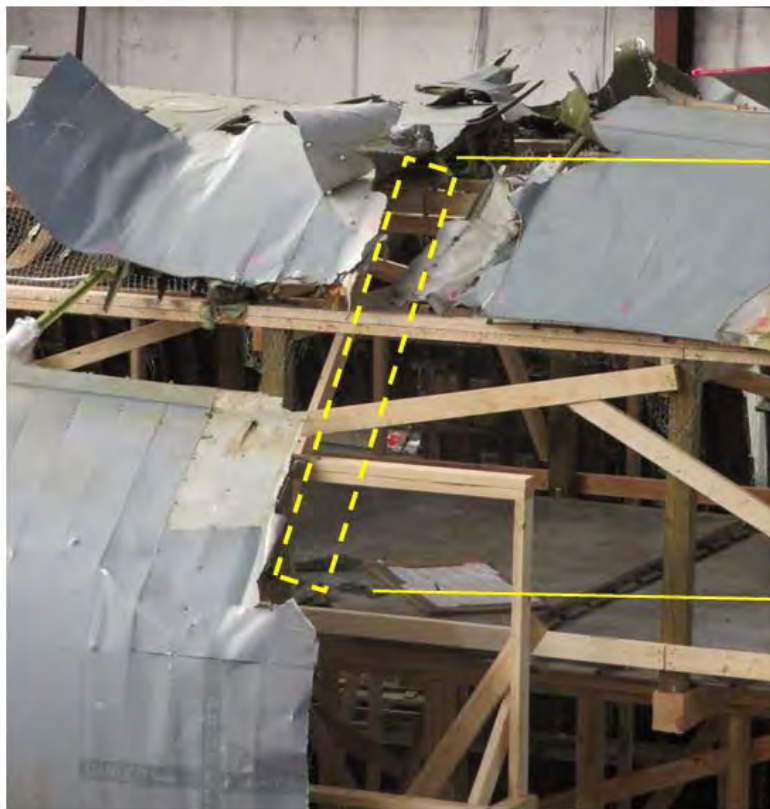
Figure 10: Center Fuselage Upper Section, FS 245 – FS 477

Structural damage attributed to intrusion by Blade 4 from Propeller #2 occurred in a near vertical plane at FS 377 coincident with the propeller arc plane. The hole in the side fuselage was bounded at the lower edge near WL 222 (approximately 36" below LBL 61 longeron) and at the upper edge approximately 19" above LBL 61 longeron. The width of the intrusion was bounded between FS 377 and FS 397 (Figures 10-11). The fuselage side panel was crushed inward above and below LBL 61 longeron. Red paint transfer on the exterior skin surface at the lower bounds of the intrusion damage was attributed to the red paint stripe at the tip of the liberated Blade 4 from Propeller #2, which showed corresponding abrasive scars at the tip of the airfoil. A 14" long section of LBL 61 longeron liberated from the side structure between FS 370 to FS 384. The middle of the longeron section was slightly bowed in the upward direction, had impact damage spanning 1.5" in the middle of the lower cap and failed by overload 7" to each side of the impact damage. Failure of the upper LBL 61 longeron was attributed to impact from the trailing edge of the blade, which had a triangular piece of similar geometry missing from the edge of the airfoil. Figure 12 shows a closer view of the left side fuselage damage at the blade impact site and views of the liberated piece of longeron shown next to trailing edge foil damage on Blade 4 from Propeller #2. The lower photo shows re-alignment of a mock full-scale blade oriented with the blade tip at the lower boundary of the intrusion damage. The triangular piece missing from the trailing edge of the blade foil aligns precisely with the impact on the LBL 61 longeron at FS 377. Distortion of the longeron indicates that the local fuselage structure was sufficiently intact to offer resistance to failure of the longeron upon impact from the blade.

The upper fuselage section damage above LBL 61 longeron, between FS 377 and FS 397, was bounded approximately 19" above LBL 61 longeron and fragmented into multiple pieces with each piece showing abrasion and inward crushing from an object intruding into the structure. Much of the outer skin surrounding the damage had black material transfer that appeared rubber-like in nature. The structure was sliced inward along the edge of FS 377 ring segment and forced inward, tearing out a small panel piece approximately 17" in length between FS 377 and FS 390. A 17" long piece of skin (ice shield) also tore away in tension from FS 377 forward to FS 363 as the structure was forced inward. Skin panels to each side and immediately above the intrusion were rolled outward pulling away from rivets along the ring segments.

FS 377 – FS 392,
19" above LBL 61 longeron

FS 377 – FS 392,
36" below LBL 61 longeron

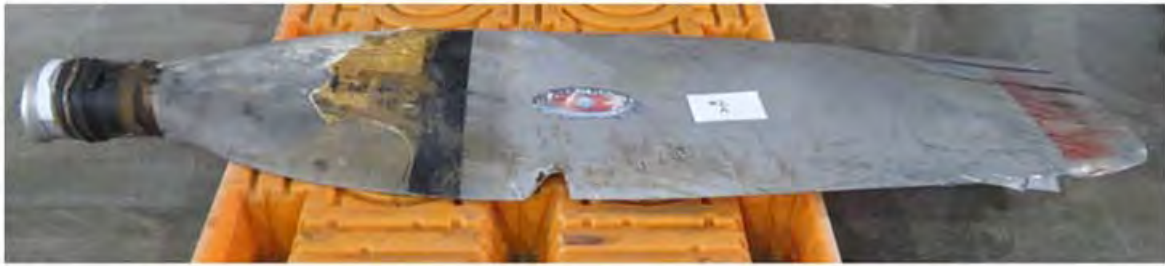
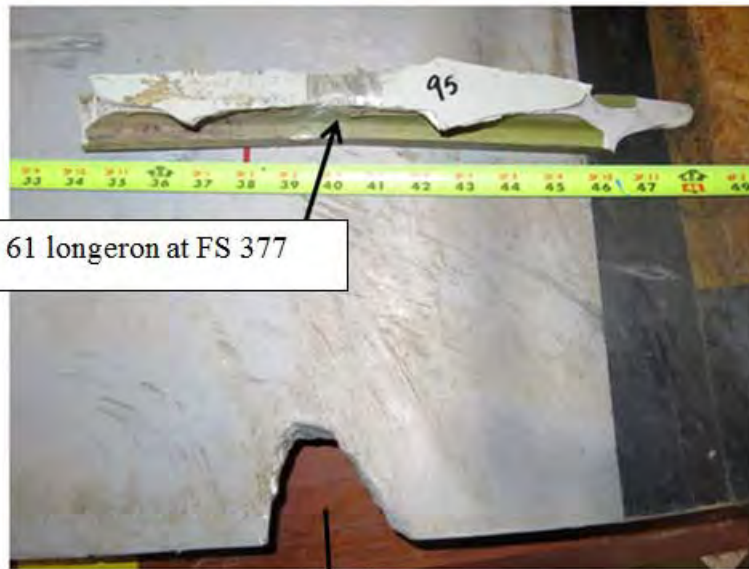
Impact to LBL 61 longeron at FS 377

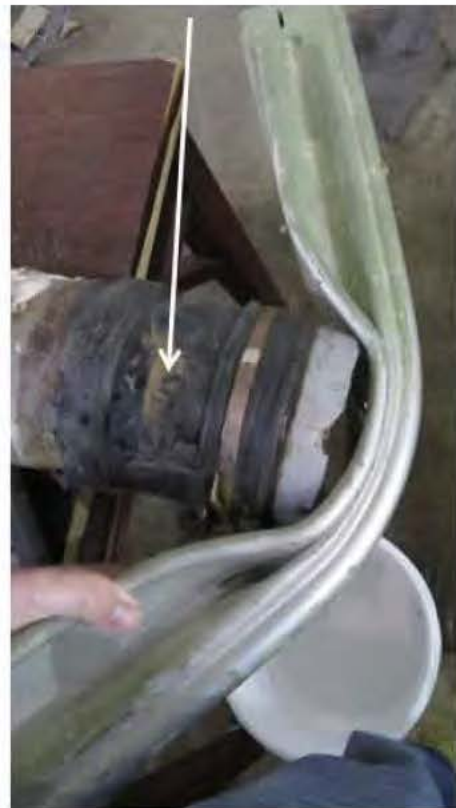
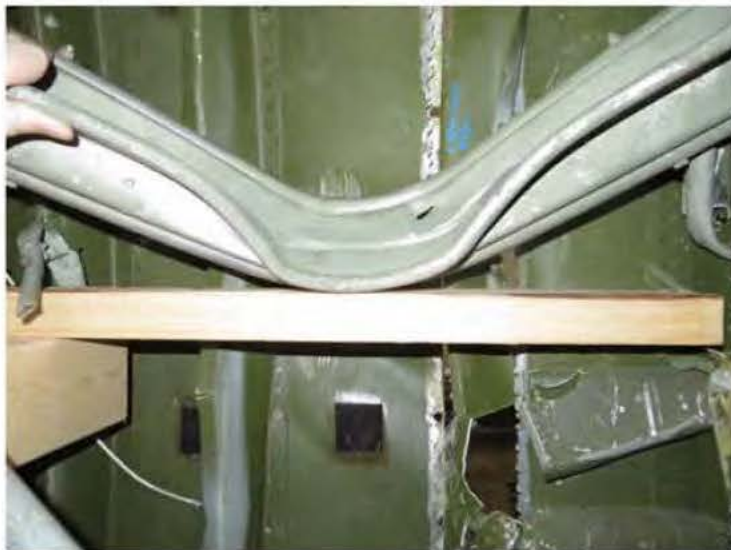
Figure 14: Troop Seatback Support Beam
Stowage Bracket, P/N 3326704

The lack of bulk structural distortion at the WL 200 impact site suggests the liberated blade was prevented from passing completely through the side structure. The stanchion bracket for a troop seatback support beam stowage assembly (P/N 3326704) mounted between FS 377 and FS 397 ring segments was bent into a cup-shape that closely conformed to the root end contours of the liberated blade and showed black material transfer near the forward upper edge. The heavy aluminum bracket in Figure 14 shows the damage attributed to impact from Blade 4, Propeller #2. A parachute stowage support structure mounted in the same area (matched to tubes attached to side panel) also showed buckling damage and one parachute cover had black material transferred across the fabric cover (Figure 15). (No laboratory chemical comparison was performed on the black material transfer due to the obvious physical conformity between the blade and bracket damage).

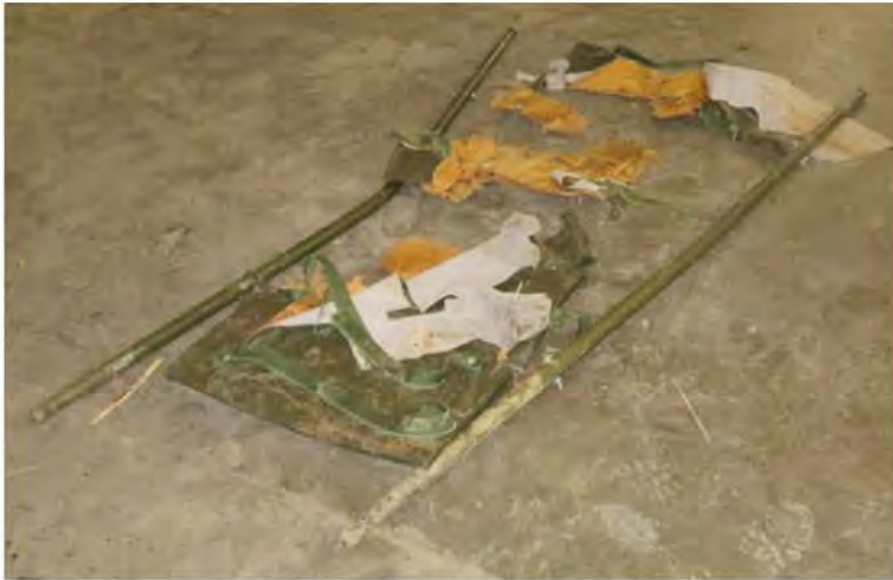
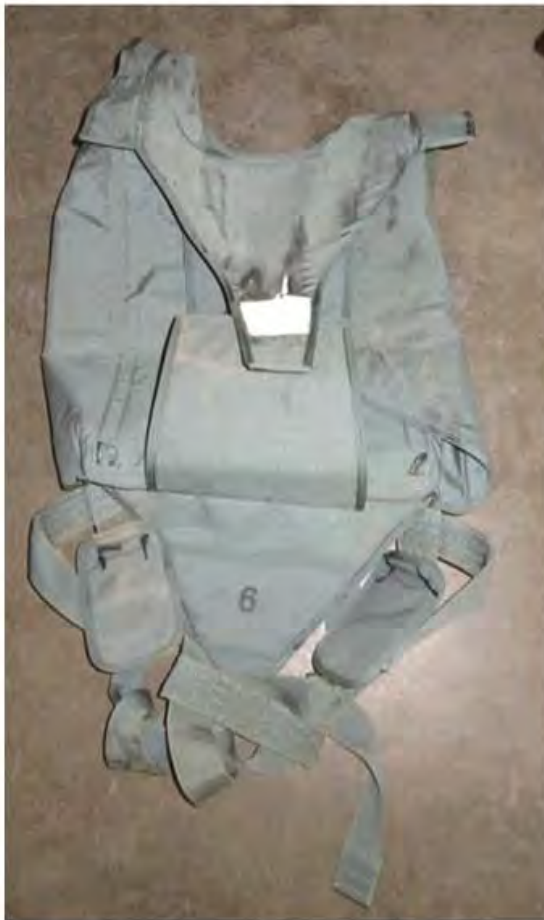
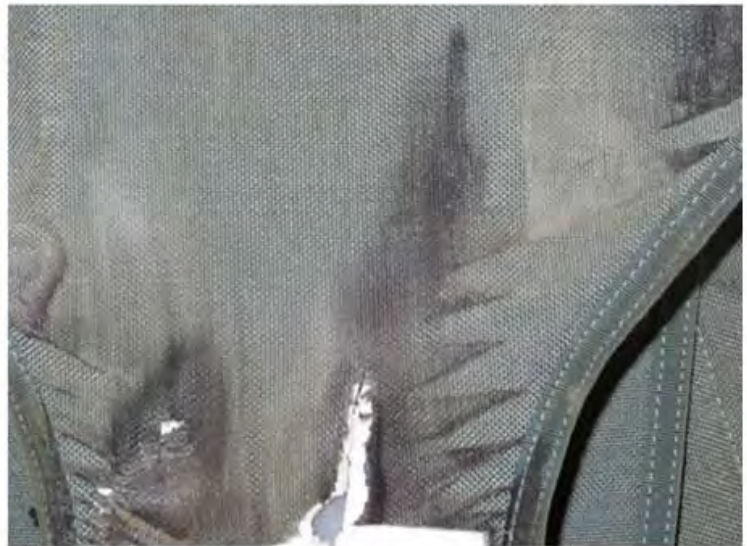
Figure 15: Parachute Stowage Support Structure and Cover

Showing crush damage and black material transfer likely from contact with the butt end of Blade 4 from Propeller 2

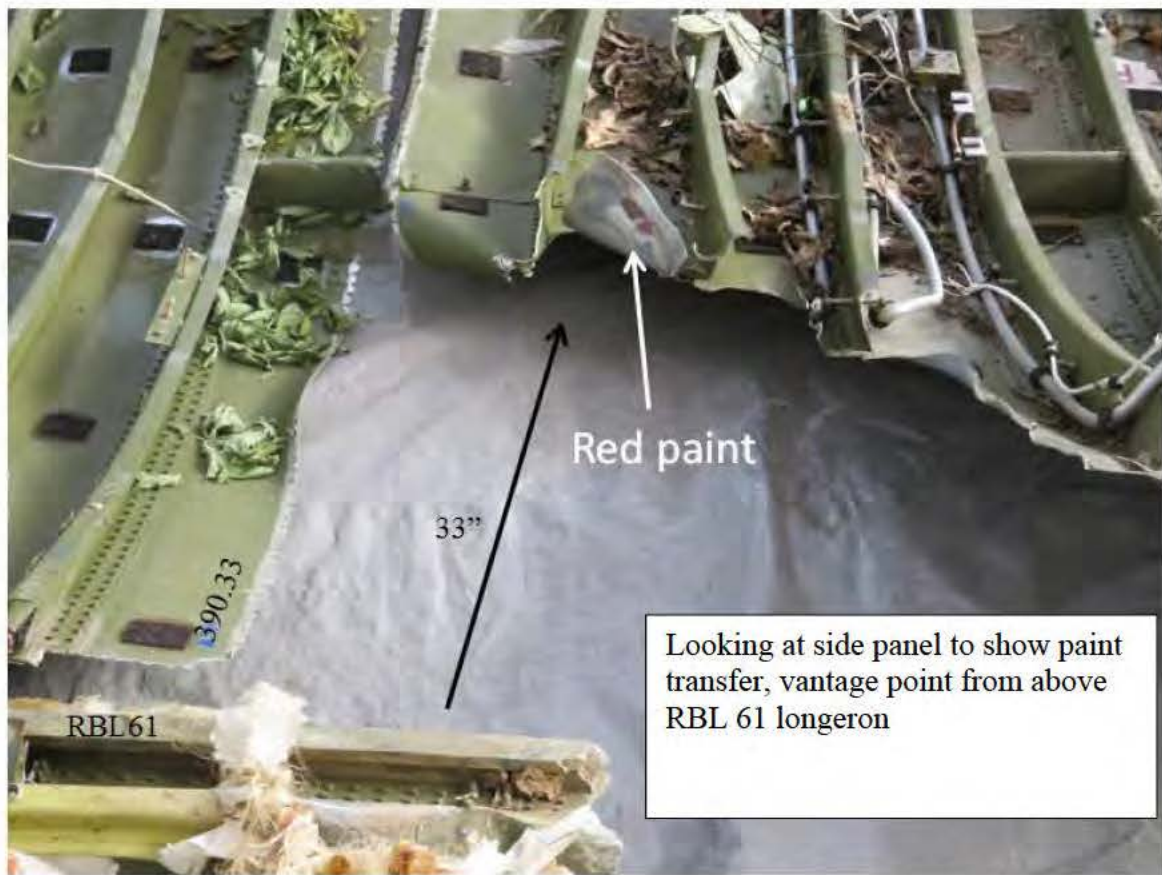
Figure 19: Lower Boundary of Propeller Intrusion

The right side and upper sections of the center fuselage showed intrusion damage oriented at a diagonal across the upper side of the aircraft (Figures 16-20). The lower boundary of the hole was near FS 383.67, approximately 33" below RBL 61 longeron; the upper boundary was approximately 20" below RBL 20 longeron near FS 350. The side panel was crushed inward and red paint (attributed to the tip strip on a blade) was transferred to the exterior skin near the lower bounds of the hole (Figure 18). The side skin was sliced upward to RBL 61 longeron producing a saw-tooth edge along the slice with the tooth direction rolled inward and pointing upward (Figure 19). The RBL 61 longeron twisted upwards and split lengthwise from FS 363.67 forward to FS 317 as the blade transited through the structure and failed in overload between FS 363.67 and FS 370.33 ring segments. The side skin below RBL 61 longeron, between FS 370 and FS 390, was forced inward and crushed aft and tore along the rivet pattern of FS 390 ring segment upward to RBL 61 longeron. The upper section tore along the rivet pattern of FS 330.33 ring segment, between RBL 61 longeron and RBL 20 longeron, and liberated two pieces of upper section in front of the impact. The upper panel behind the impact was crushed aft by Propeller #3 and caused RBL 20 longeron to fail in overload, in an accordion-like manner at alternating ring segments from FS 350.33 to FS 383.67.

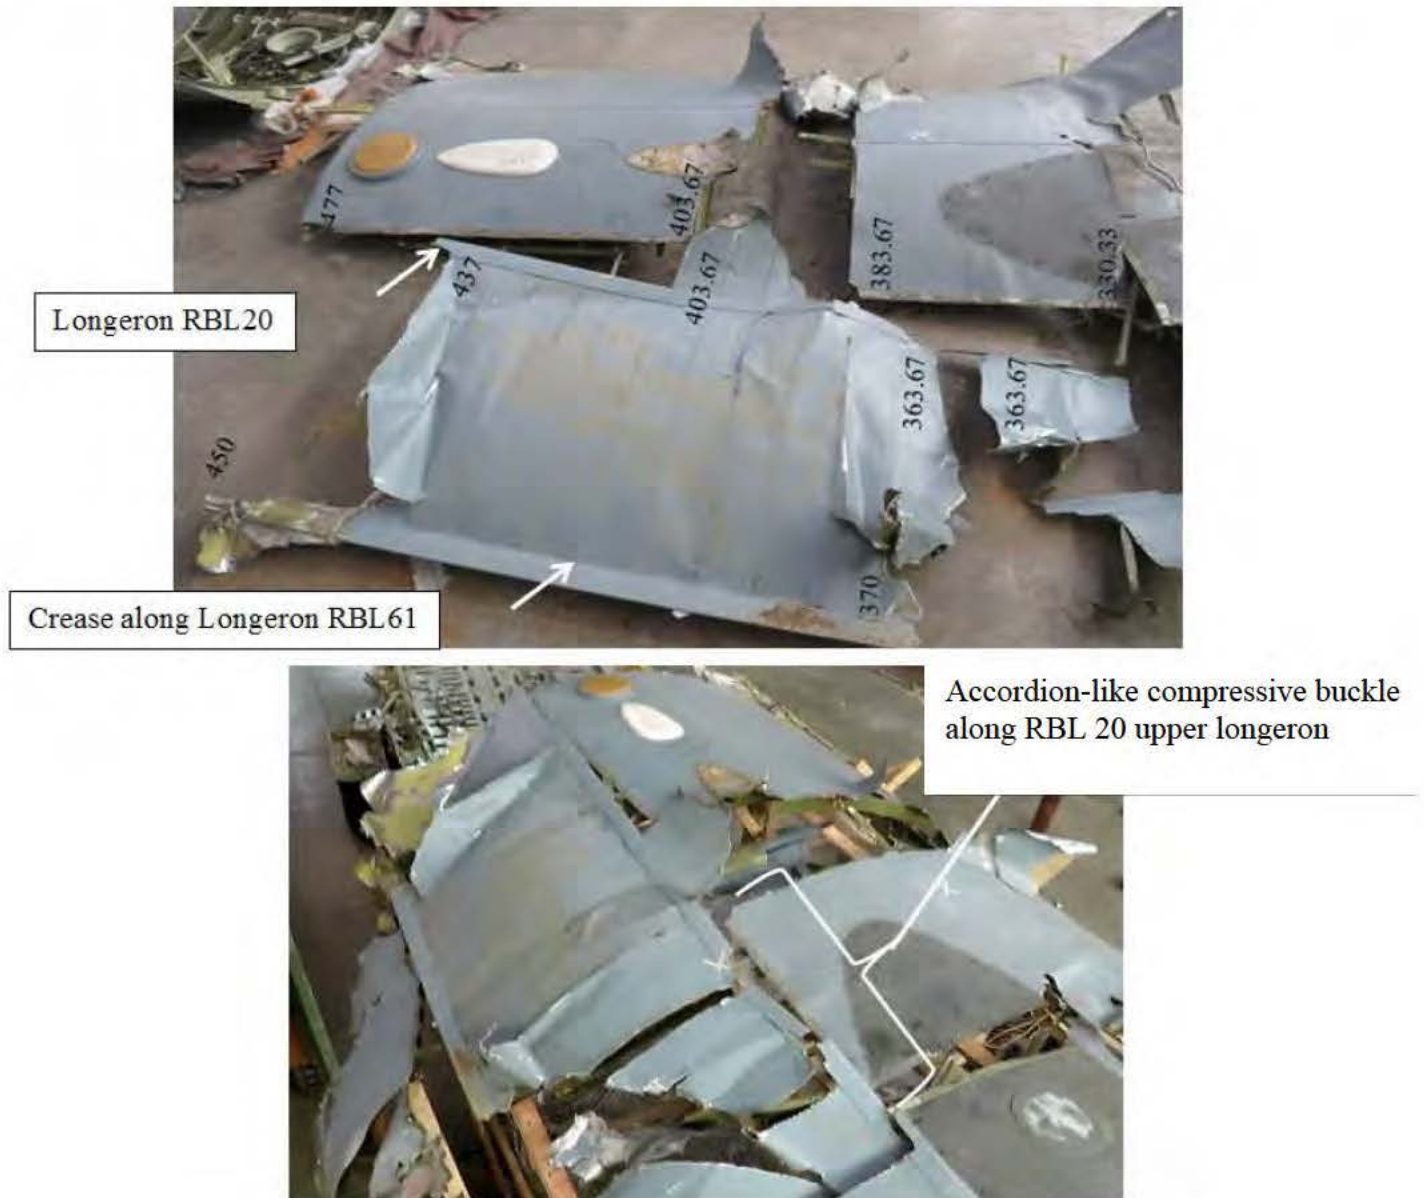
Figure 20: Closer view of Fuselage Center Section Upper Surface STA 330-477

Failure of RBL 61 and RBL 20 longerons and accordion-like buckling aft of the impact site, prompted liberation of upper section from FS 363.67 aft to FS 477 and bounded by RBL 61 and RBL 20 longerons. This section lifted upward and rolled outward, bending to the right along the upper leg of RBL 61 longeron, evidenced by creasing of the upper skin following the edge of RBL 61 longeron between FS 370 and FS 450. The upper section separated by shear overload of the dual rivet pattern along the RBL 20 longeron upper leg between FS 403.67 and FS 437.00. The RBL 20 longeron failed via torsional bending overload upward and to the right at FS 437. The side skin separated from this panel by tensile pull-out along the RBL 61 longeron lower leg. RBL 61 longeron failed in torsional overload near FS 450 allowing the panel to depart upward and to the right. As shown in Figure 20, the aft end of this upper panel section was buckled diagonally from FS 423 at RBL 61 longeron to FS 437 at RBL 20 longeron and the RBL 61 lower longeron was deflected outward and up at the aft point of fracture at FS 450. Severe distortion of the structure surrounding the impact site indicates that the right side and upper fuselage section was structurally rigid at the time of propeller intrusion and the structure offered resistance to liberation of large panel pieces aft of the strike.

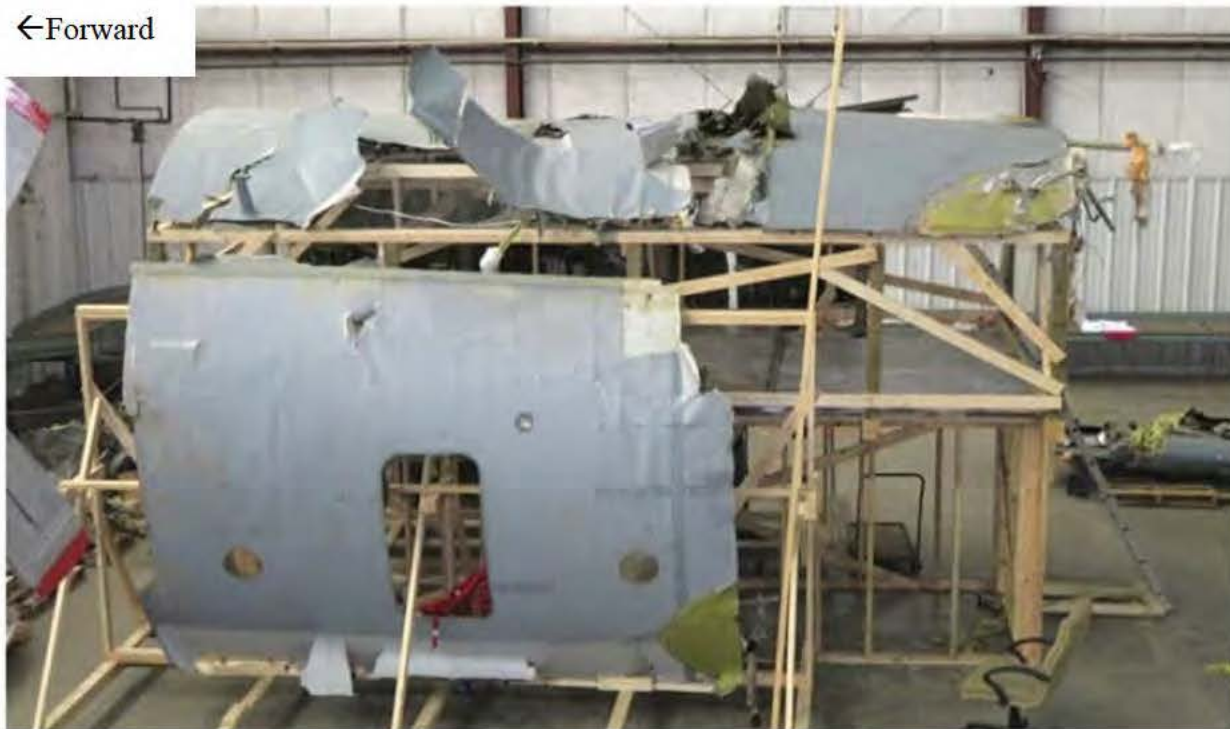
Figure 23: Left Upper Section

FS 297, 303.33, and 310.33 ring segments were broken approximately 7" to the left of LBL 20 from what appeared to be an object transiting from aft to forward, inside to outside splitting the upper section lengthwise just below LBL 20 longeron. This upper side structure between FS 290 and FS 330, which was attached to the upper panel piece extending aft to FS 377, was peeled outward bending about FS 343.67 (Figure 23). The upper skin pulled through the rivet pattern away from the FS 297-FS 310.33 ring segments below the lengthwise split and was locally bent over to the left.

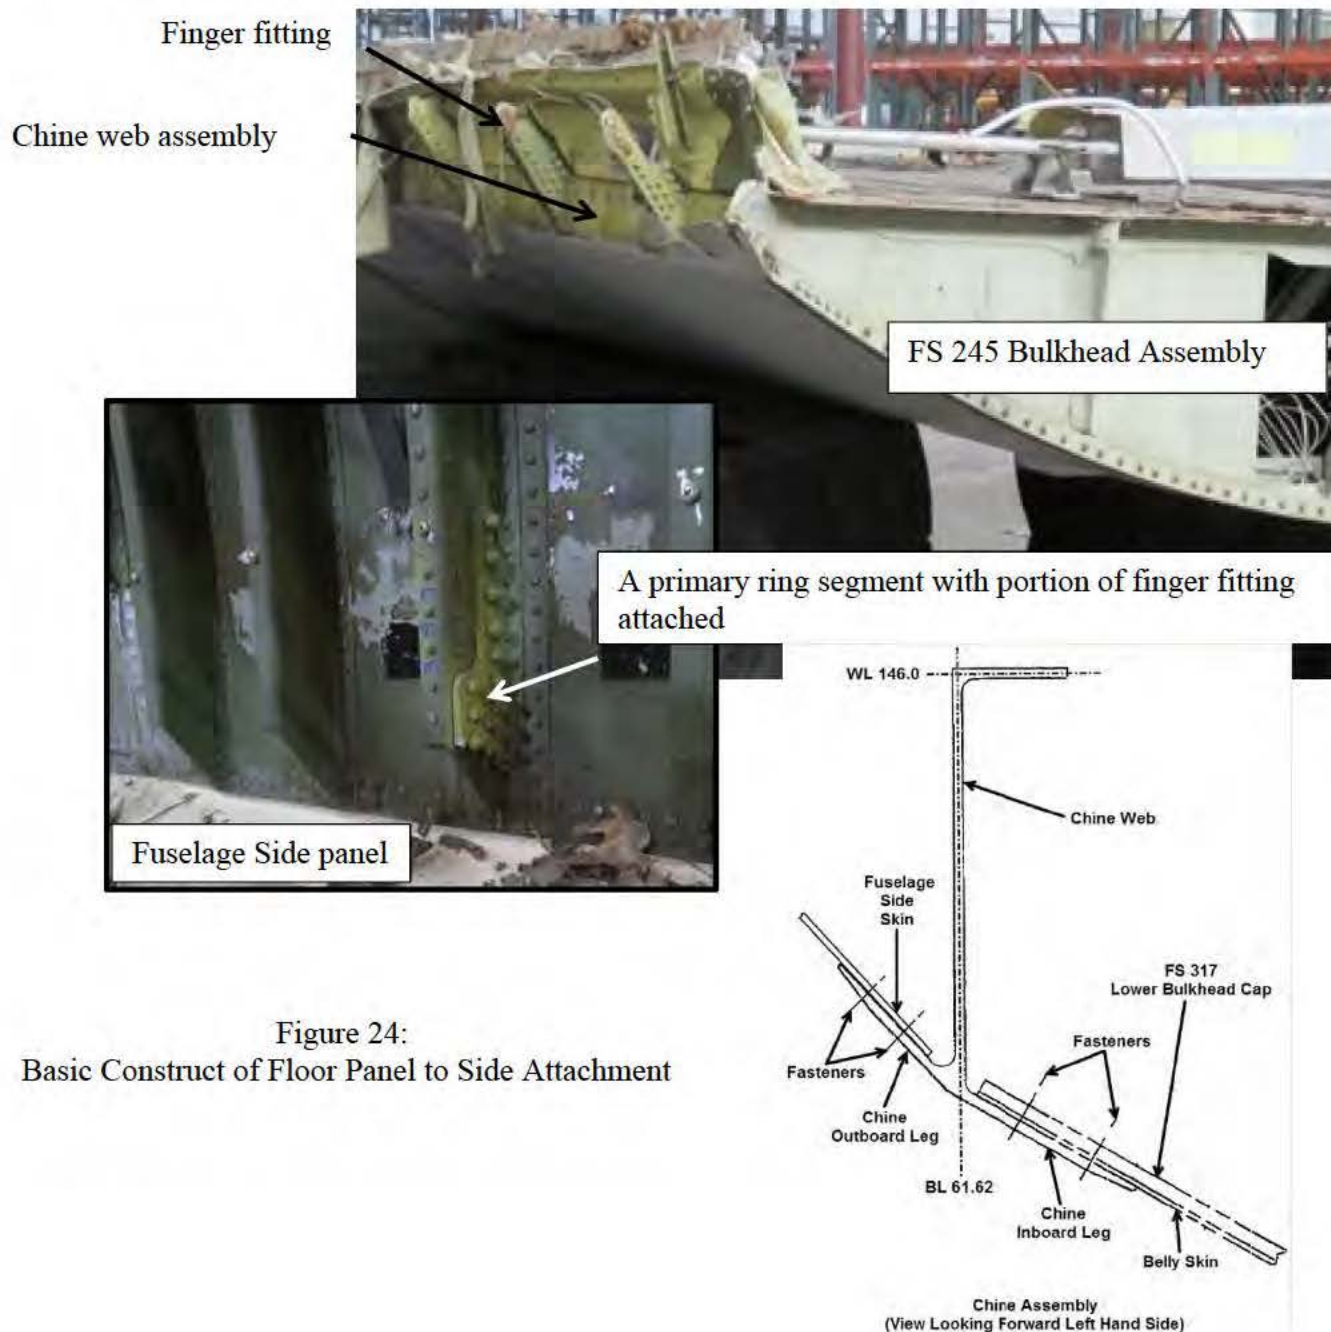
Evidence of how the side panels separated from the floor panel was gathered from examination of the floor structure. The basic construct of the floor panel to side attachment is shown in Figure 24. A chine assembly forms the side closure of the floor structure along each side and a bulkhead assembly provides rigidity to the front of the panel at FS 245. The fuselage side structure attaches to the floor by bolting to floor fittings at each of the primary ring segments (FS 257, FS 277, FS 297, etc.). The fuselage side skin attaches along the length of the floor panel by a dual rivet pattern to the chine outboard leg, with the chine overlapping the side skin. The belly skin attaches by a double rivet pattern along the chine inboard leg, again with the chine overlapping the belly skin.

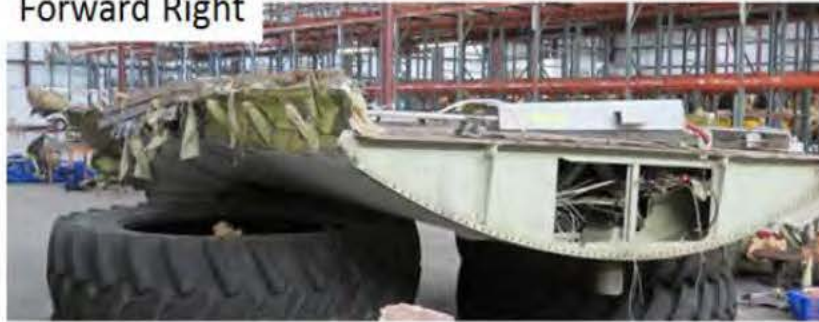
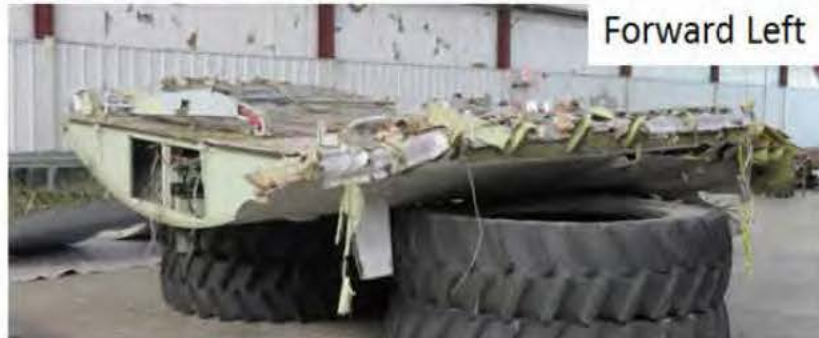
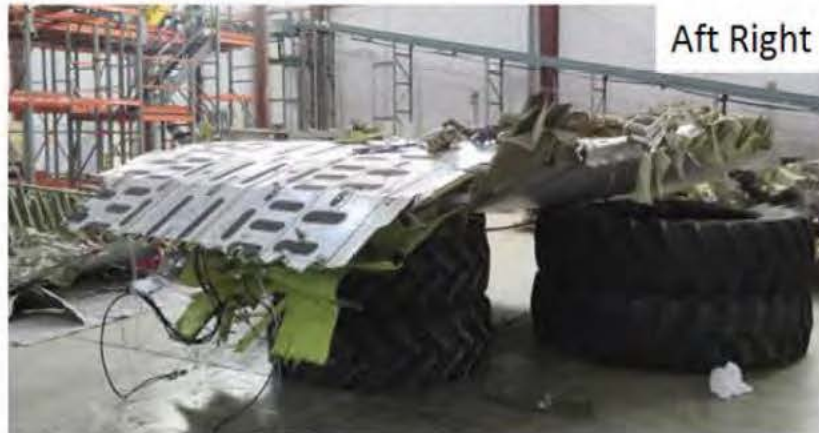
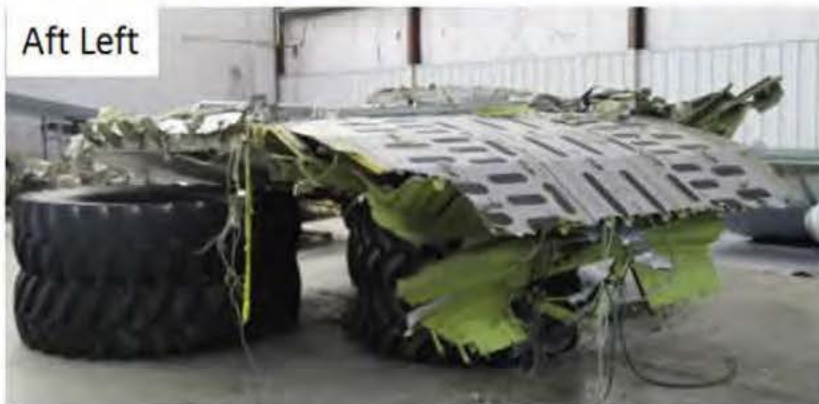
Figure 25: Floor Section, Center Fuselage FS 245 – FS 457

The center fuselage floor panel from FS 245 to FS 457 (Figure 25) was recovered from the North site. The forward end of the panel was relatively intact; the FS 245 bulkhead was secure as an assembly and showed minimal distortion (Figure 26). The center-to-forward fuselage attachment at the FS 245 bulkhead separated by stripping of the attach bolt threads at the right side and overload failure of the chine assembly across the production splice joint on the left. The chine assembly was bent approximately 20 degrees to the right. The attachment bolt at the right side was similarly bent to the right basically mirroring the deflection of the left chine fracture. The barrel nut was properly oriented within in the left chine assembly with the barrel seated to the aft side of the housing as required. There was no evidence of rubbing or rivet working at either bulkhead attachment. The similarity in distortion at the left and right sides of the floor panel attachment between the center and forward fuselage suggests that the lower fuselage structure immediately forward of FS 245 acted as a fairly rigid structure as it separated to the right away from the FS 245 bulkhead. The cockpit structure forward of FS 200 was essentially consumed in ground fire. Multiple pieces of heavily mangled fuselage structure between FS 200 and FS 245 were not reconstructed during this evaluation.
