Figure 4: Center Fuselage Side Section Panels

Figure 8: Center Fuselage Side and Upper Section, FS 245 – FS 477

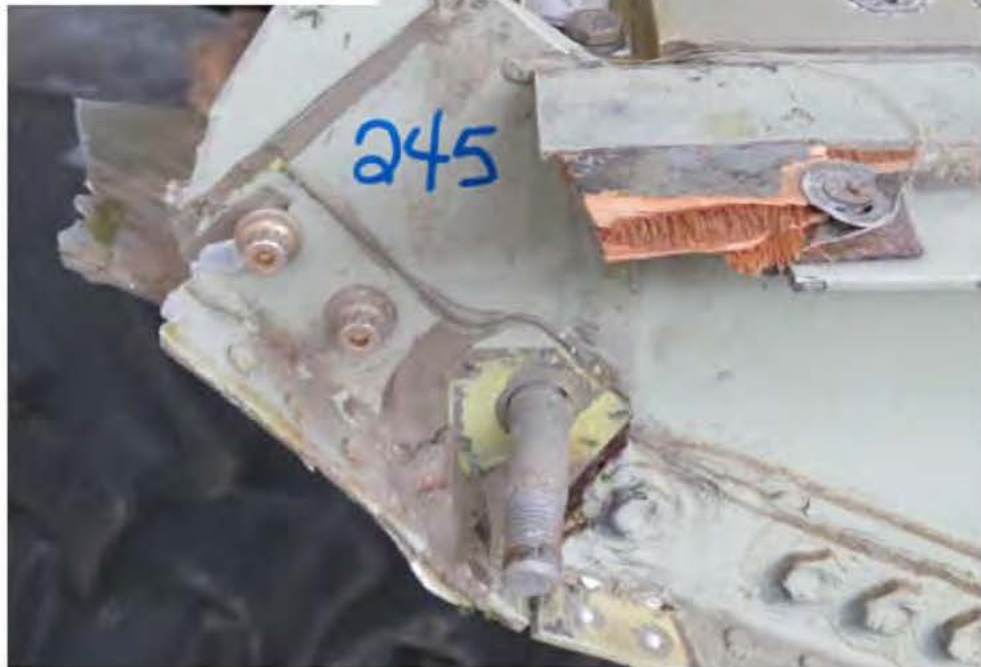
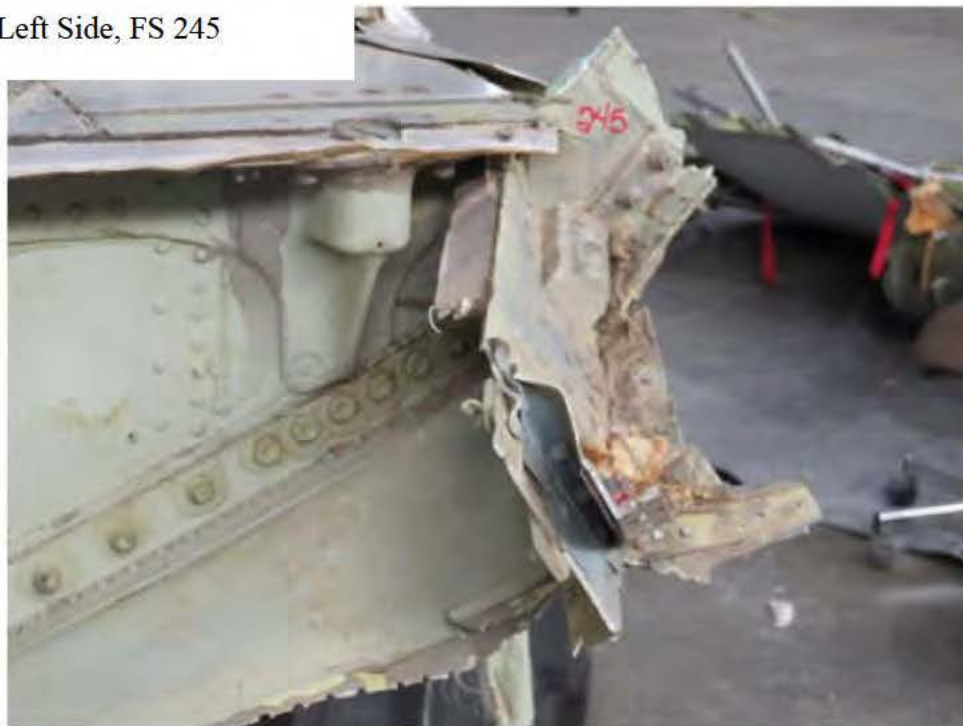
Figure 26: Floor Panel Forward End

The center fuselage floor panel from FS 245 to FS 457 (Figure 25) was recovered from the North site. The forward end of the panel was relatively intact; the FS 245 bulkhead was secure as an assembly and showed minimal distortion (Figure 26). The center-to-forward fuselage attachment at the FS 245 bulkhead separated by stripping of the attach bolt threads at the right side and overload failure of the chine assembly across the production splice joint on the left. The chine assembly was bent approximately 20 degrees to the right. The attachment bolt at the right side was similarly bent to the right basically mirroring the deflection of the left chine fracture. The barrel nut was properly oriented within in the left chine assembly with the barrel seated to the aft side of the housing as required. There was no evidence of rubbing or rivet working at either bulkhead attachment. The similarity in distortion at the left and right sides of the floor panel attachment between the center and forward fuselage suggests that the lower fuselage structure immediately forward of FS 245 acted as a fairly rigid structure as it separated to the right away from the FS 245 bulkhead. The cockpit structure forward of FS 200 was essentially consumed in ground fire. Multiple pieces of heavily mangled fuselage structure between FS 200 and FS 245 were not reconstructed during this evaluation.

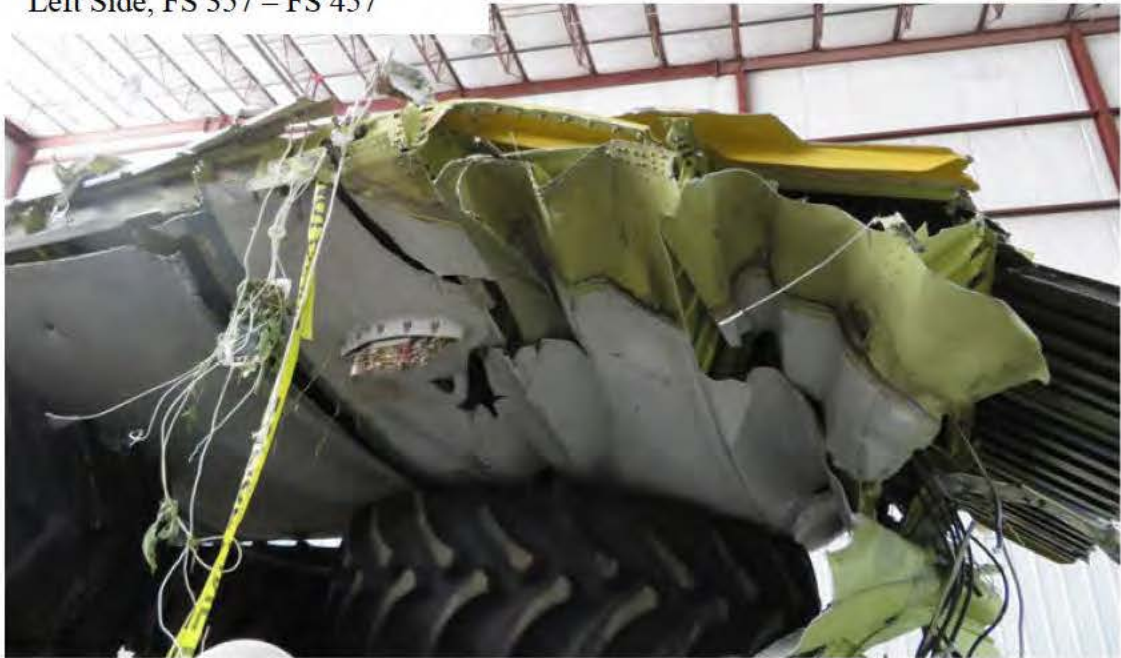
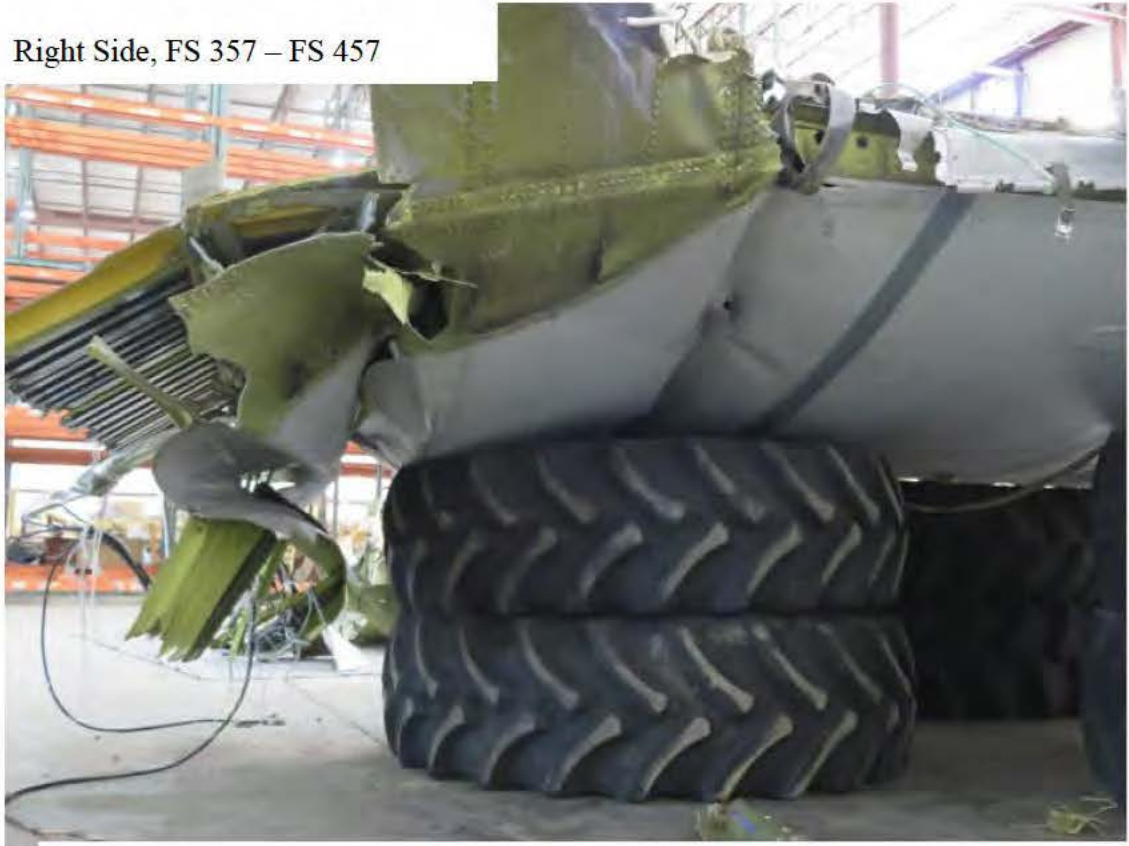
Figure 27: Floor Panel Aft End

The aft end of the floor panel structure was crushed in an accordion-like manner in the downward direction with the belly skin buckling between the ring segments from FS 357 to the end of the panel at FS 457 (Figure 27). On the left side, the chine assembly was torn completely out of the floor panel aft of FS 397 and fractured from top to bottom midway between FS 377 and FS 397 ring segments. The belly skin split away from the floor cap along FS 377 across the bottom of the floor panel. The most forward belly skin buckle occurred near FS 377 with the belly skin tearing away from the chine assembly by fracture of the chine inboard leg between FS 337 and FS 377. On the right side, the floor collapsed downward by collapse of the chine assembly and buckling of the belly skin at near FS 390.33. The fuselage side skin remained attached to the floor panel in the wheel well area from FS 397 to FS 457.

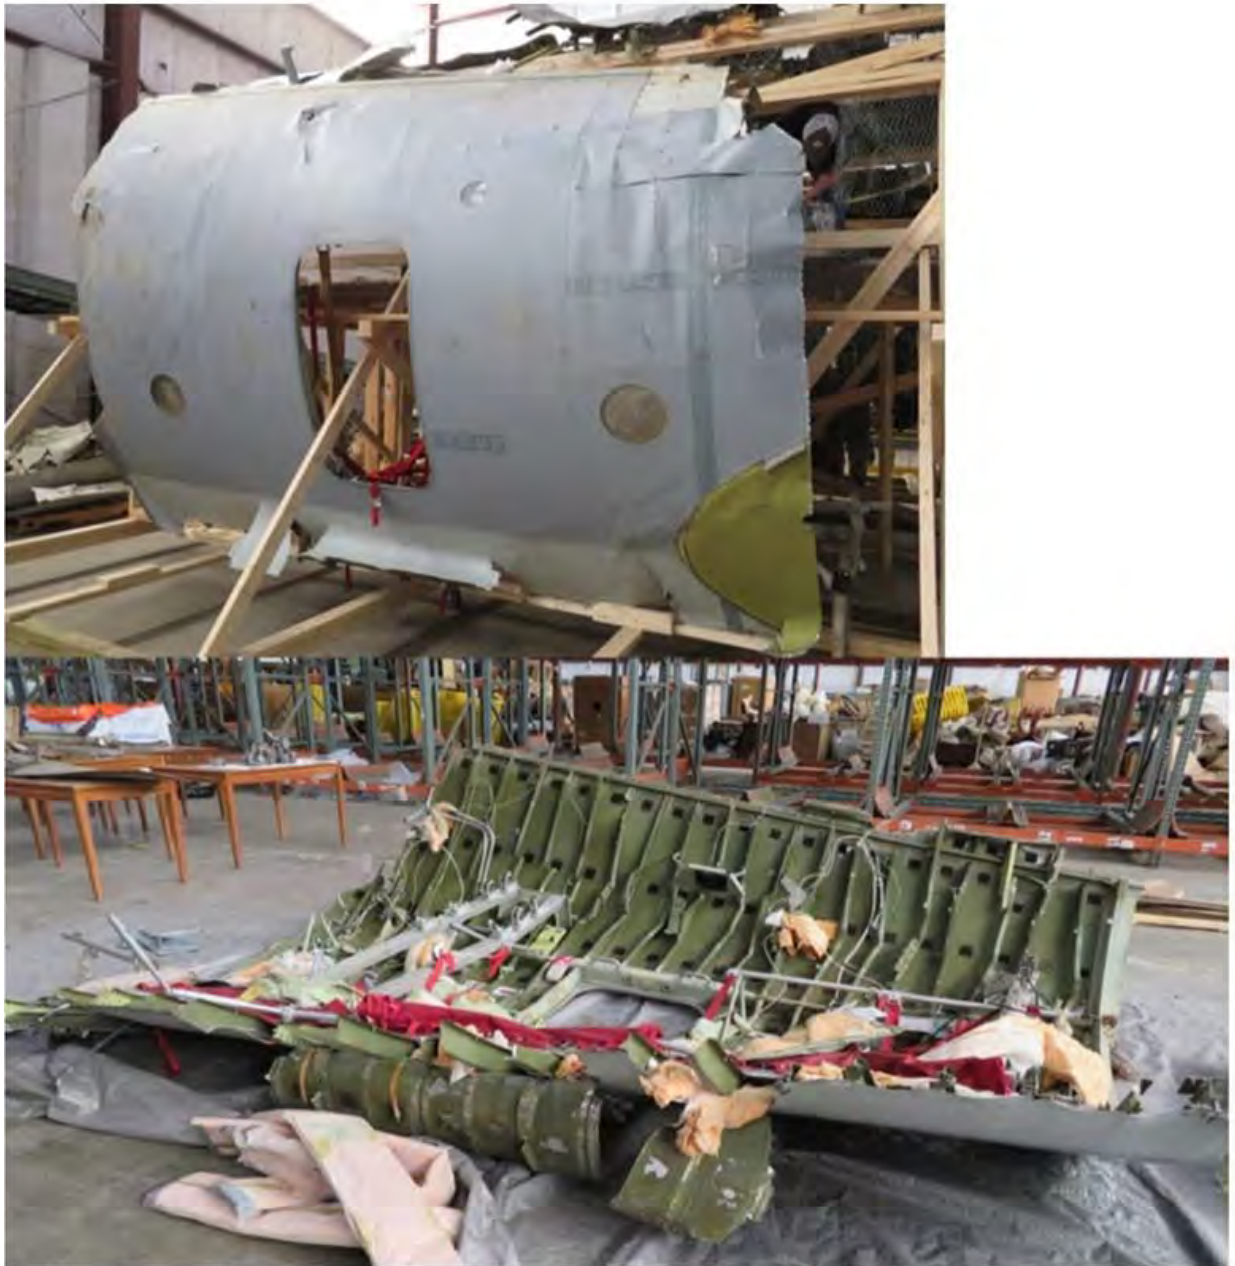
Figure 29: Left Side Panel, Center Fuselage Section

The left side panel of the center fuselage tore away from the floor panel leaning to the left. Views of each fitting are shown in Figure 28. Fractures of all floor fittings and ring segments were visually verified as overload. At the front of the panel, the FS 245 bulkhead fitting failed in tension just above the lowest bolt in the chine attachment. Minimal to no distortion was associated with fracture of this fitting. FS 257 ring segment separated by tensile failure of the chine floor fitting across the lowest bolt holes. Failure of ring segments at FS 277, FS 297, FS 317 and FS 337 occurred by tearing across the upper bolt hole in the floor fitting. Failure of the FS 357, FS 377, and FS 397 primary ring segments occurred through the lowest bolt hole of the floor fitting. The chine assembly was torn completely out of the floor panel aft of FS 397 failing the floor fittings inboard of the chine. The chine assembly collapsed and tore around the lower edge of the FS 357 and FS 377 fittings and ruptured completely through the cross section just aft of FS 397. As the panel rolled outward, the ring segments were forced inward to crush against the chine assembly aft of FS 317. The intermediate ring segments and floor fittings crushed against the chine assembly denting the chine web near FS 310, puncturing it aft of FS 317 and forcing the fitting completely through the web aft of FS 357. Between each primary ring segment where the two intermediate frames are not joined to the floor, panel separation occurred by overload failure of the chine assembly outboard leg. Most of the fuselage skin between FS 285 to FS 337, with exception of a panel to each side of FS 283.67 ring segment, rolled outward approximately 11" above the lower edge (Figure 29). The damage collectively suggests that the fuselage left side panel departed the floor rolling outward toward the left.

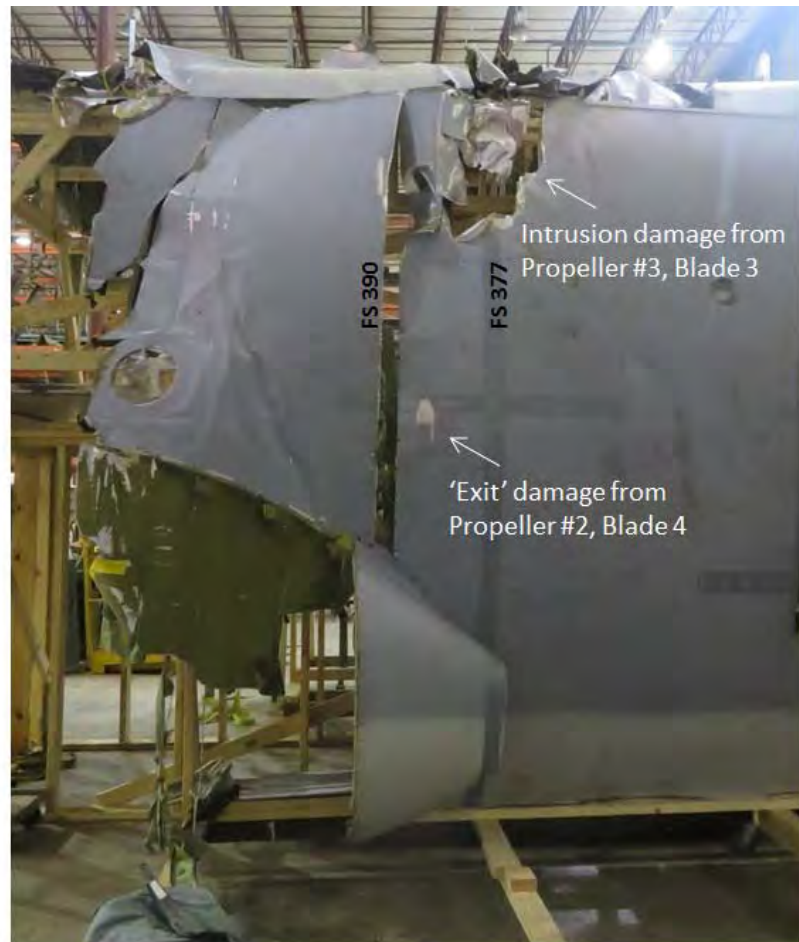
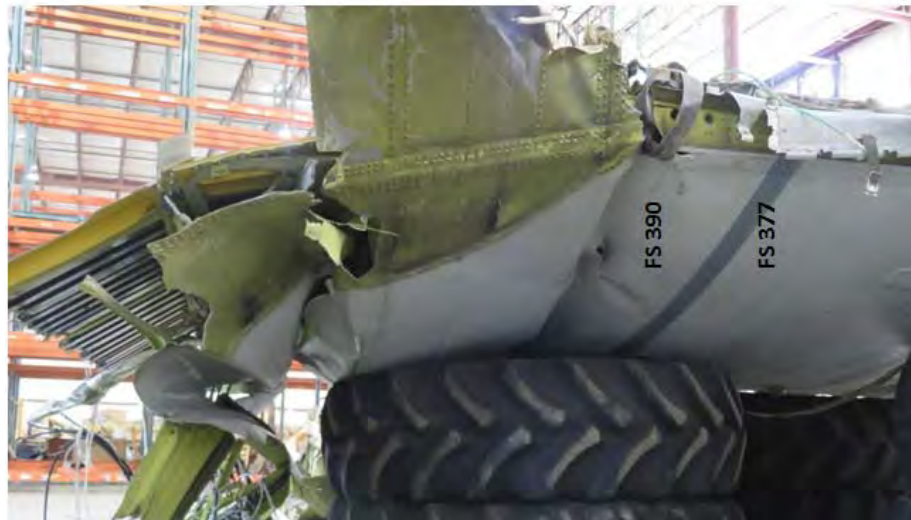
Figure 31: Right Side Floor Fitting separation aft of FS 390

The right side panel of the center fuselage separated from the floor panel by collapsing toward the left. Views of each fitting are shown in Figure 30. Fractures of all floor fittings and ring segments were visually verified as overload. The FS 245 bulkhead fitting and side panel ring segment failed in tension near the plane of the bulkhead upper cap. At the lower end of the FS 257, FS 277, FS 297, and FS 337 primary ring segments, the skin panel tore away from the floor fitting by tensile tear-out along the vertical rivet pattern on each side of the fitting. The ring segments failed via tensile bending overload through the upper bolt hole in the floor fitting. FS 357 and FS 377 ring segments failed across the floor fitting at the lowest set of bolt holes near the chine assembly (indicative of higher loading and/or higher strain rate than failure at the forward ring segments to drive failure into the stronger structure). Near FS 390, the chine assembly collapsed as a consequence of the floor panel buckling downward at the aft end. The fuselage side skin tore upward from FS 390 across to the third set of rivets attaching FS 397 ring segment to the floor fitting, upward through three rivets in the forward leg of the fitting, then diagonally across to the top of the floor fitting and continued aft past FS 417 under the wheel well fairing (Figure 31). FS 397 ring segments failed in tension immediately above the floor fitting. The floor fitting and FS 417 ring segment failed in tension immediately above the chine assembly through the lowest set of bolt holes. The chine assembly and floor fittings from FS 457 to FS 471 were torn out of the floor panel.

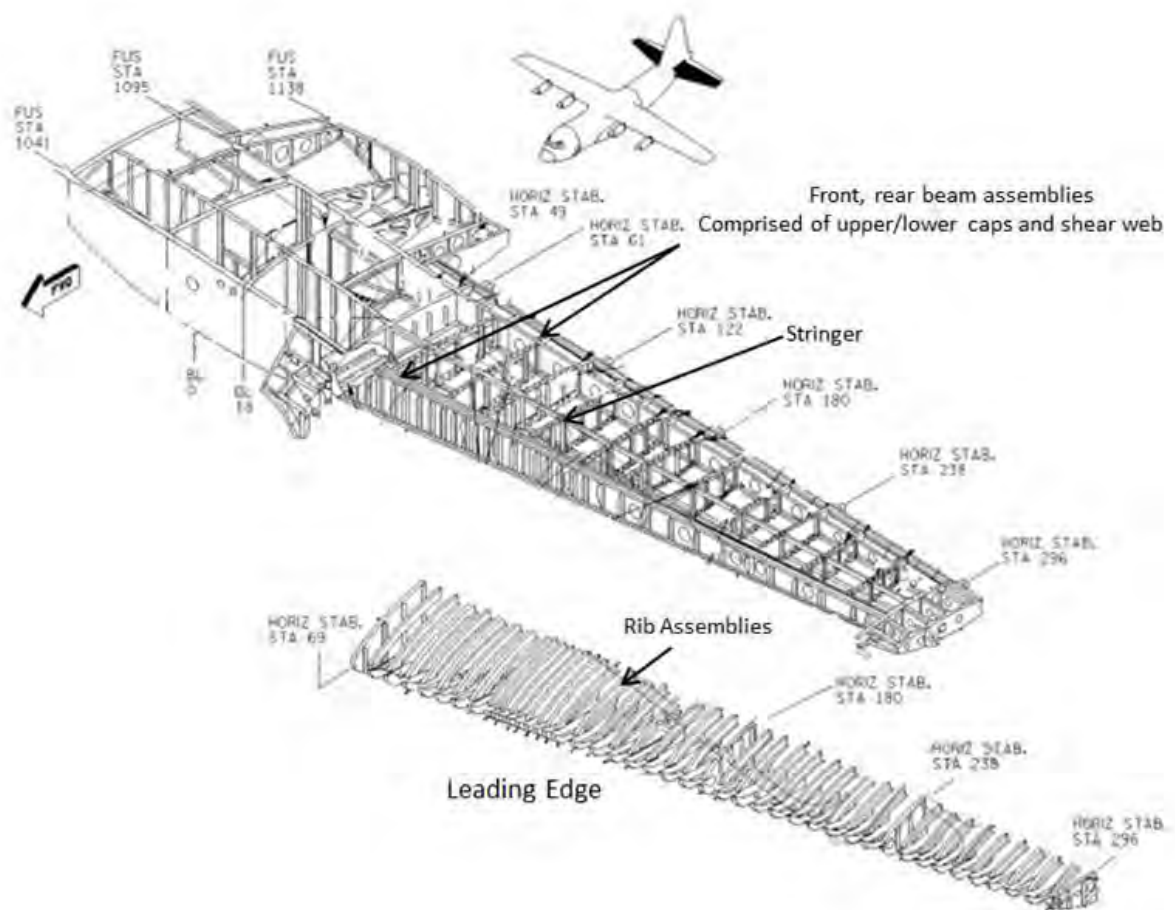
Figure 32: Schematic of Horizontal Stabilizer and Elevator

Analysis of Observations: The RH outer section of the horizontal stabilizer departed during flight as a consequence of impact from Propeller #3. The elevator appeared to have been secure to the stabilizer and separated as a consequence of liberation of the RH outer section of the stabilizer. The propeller impact sliced through approximately 75% of the stabilizer chord-wise section separating the front beam assembly and internal stringer. Overload failure of the remaining structure and rear beam assembly resulted in separation of the RH outer section of the horizontal stabilizer. Initial propeller impact occurred at HSS 130 with Blade 1 oriented such that the airfoil tip end presented to the leading edge. The span of the blade pushed aft through the stabilizer and rotated downward on contact with the front beam assembly to slice through the lower surface. During this repositioning of the propeller transiting through the stabilizer, the adjacent Blade 2 impacted near HSS 180. This blade presented trailing edge first to the stabilizer and sliced through the leading edge, halting before contact with the front beam.

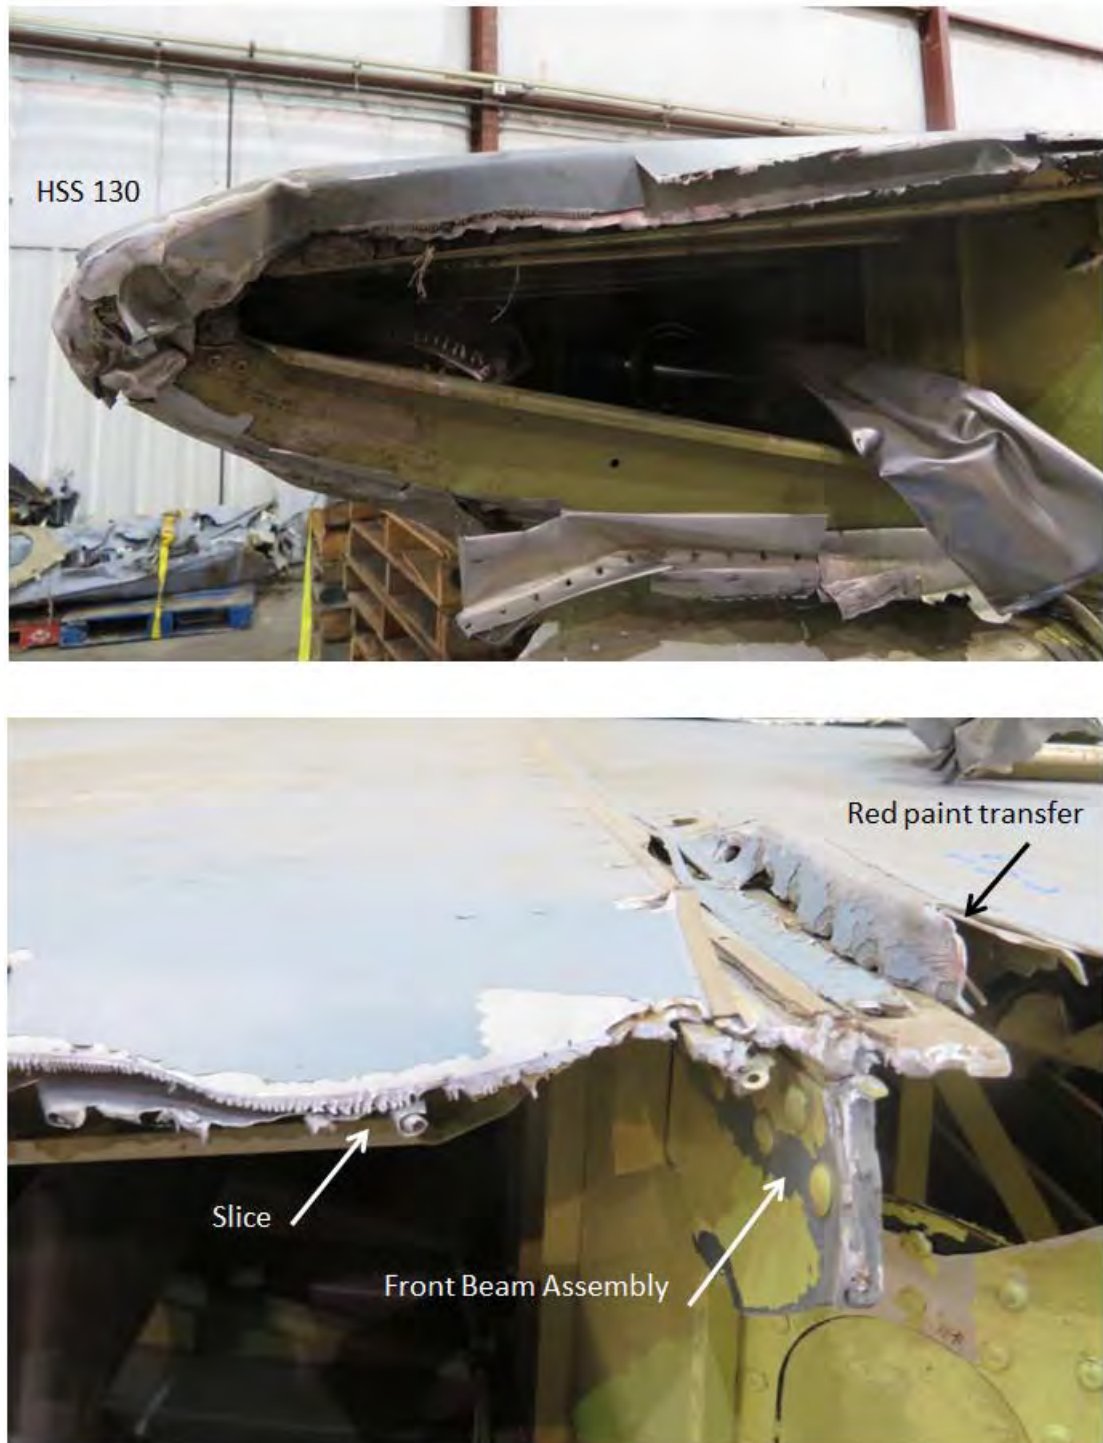
Figure 35: HSS 130 Impact Damage

Structural failure of the RH outer section of the horizontal stabilizer occurred at HSS 130 as a consequence of impact with the propeller assembly, which separated from the wing in flight due to failure of the RGB case. Blade 1 from Propeller #3 appeared to have impacted the leading edge of the stabilizer presenting the trailing edge first. The blade sliced through the upper skin, front beam assembly and internal stringer constituting approximately 75% of the chordal cross-section of the stabilizer. The leading edge skin was crushed downward and outward against the rib at HSS 130. The upper skin showed saw-tooth curls running aft to the front beam characteristic features of structure being sliced by an object passing through it. The lower skin inboard of HSS 130 was torn in the downward direction and the anti-icing heater ejector tube was severed and pushed aft against the front beam. The dissimilarity in damage between upper skin and lower skin separation suggests that the intruding blade transited spanwise through the upper skin structure and upon contact with the front beam rolled downward to force the lower structure outward. The blade continued through the stabilizer structure to completely slice through the front beam assembly and internal stringer. Red paint transferred along the upper skin structure and front beam further support blade tip entry attitude of the propeller assembly. The upper skin aft of the stringer tore diagonally inboard to the trailing edge near HSS 122 and the lower skin tore outboard to HSS 180 resulting in liberation of a section of the rear beam assembly.

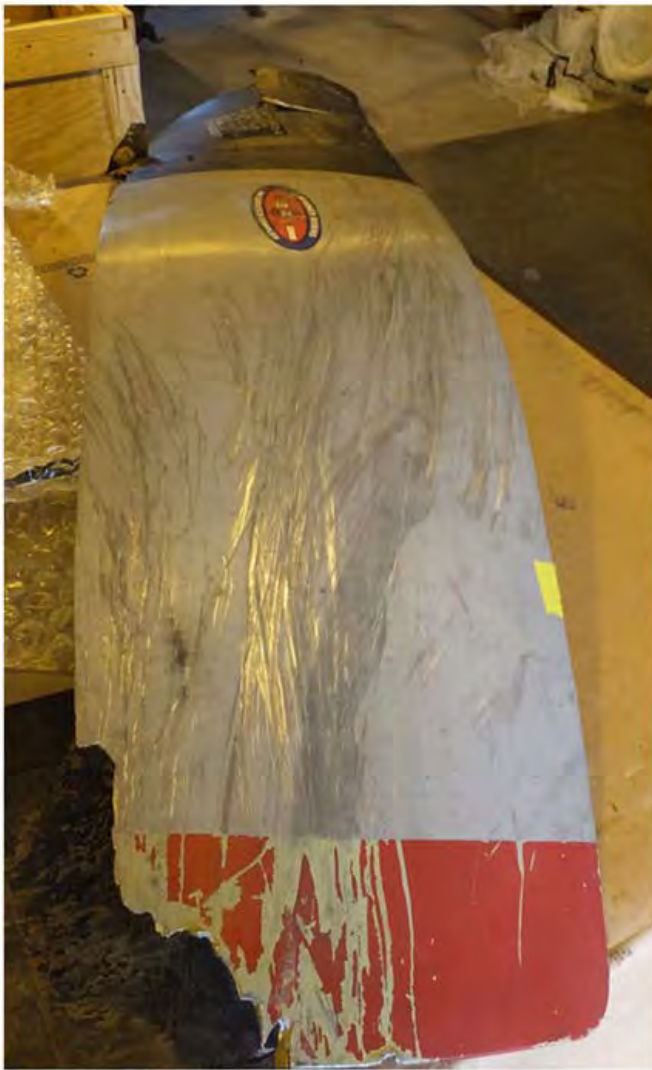
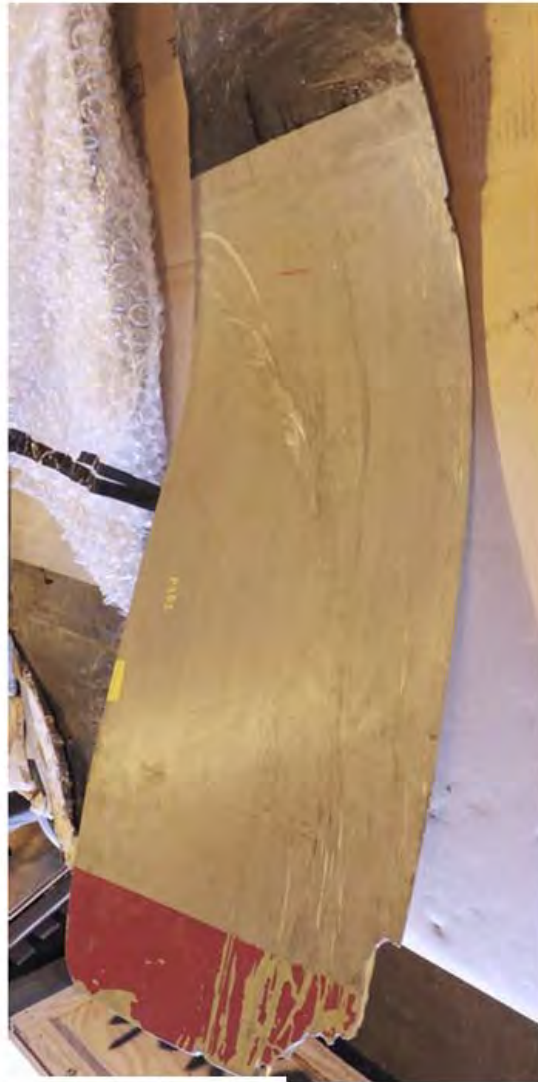
Figure 38: Propeller #3, Blade 1

Figure 37 documents the #3 Propeller that was recovered from the North site. All four blades remained attached to the propeller assembly until ground impact. Blade 1 (Figure 38) was in the feathered position on recovery and the foil was bent along the span in the direction advancing rotation. Blade 2 (Figure 39) was in a low to negative pitch position on recovery. Blade 3 fractured by overload on ground impact and multiple pieces constituting 19" of the tip end were recovered from the North site but distant from the Propeller impact site. Blade 4, was in a near feathered pitch position on recovery and the tip end fragmented on ground impact.

Based on blade scars, Blade 1 was the most likely candidate to have impacted the stabilizer at HSS 130 and by association, Blade 2 was most likely to have impacted at HSS 180 (Blade 4 showed no contact with structure; Blade 3 is in the wrong orientation to Blade 1 to create the damage at HSS 180). The damage on Blade 1 corresponds well with the stabilizer damage at HSS 130 with the blade impacting tip first and pushing through the stabilizer along the span of the blade. As shown in the left photo of Figure 38, approximately 15” of the trailing edge was missing from the tip of Blade 1 and the impact damage was oriented from tip crushing inboard. The crush damage appeared characteristic of impact with robust structure like the front beam spar cap and stringer. Both surfaces of the blade airfoil had abrasive scars oriented in the spanwise direction extending from tip toward root which rotated abruptly toward the trailing edge just inboard of the sticker. Similarly, the trailing edge of Blade 2 airfoil was crushed approximately 20-25” from the tip end and had chordwise abrasive scars running from trailing edge toward leading edge.

Using a crude mock-up of a propeller assembly, and recognizing that a flat blade does not fully replicate the true contours of an airfoil, the scar damage and tip crushing witnessed on Blade 1 was replicated by pushing a blade through the stabilizer with the airfoil oriented spanwise then rotating downward after passing through the front beam assembly. A sequence of the reconstructed evolution of propeller impact based on blade scar damage and stabilizer damage is shown in Figure 40. As the mock-up propeller rotates downward, the trailing edge of Blade 2 contacts the stabilizer leading edge at HSS 180 in the approximate location to account for the trailing edge damage witnessed on Blade 2. Reconstruction of the mock-up blades against the leading edge damage to conform to the stabilizer signatures revealed that both blades likely impacted with approximately 40-45 degree pitch attitude.

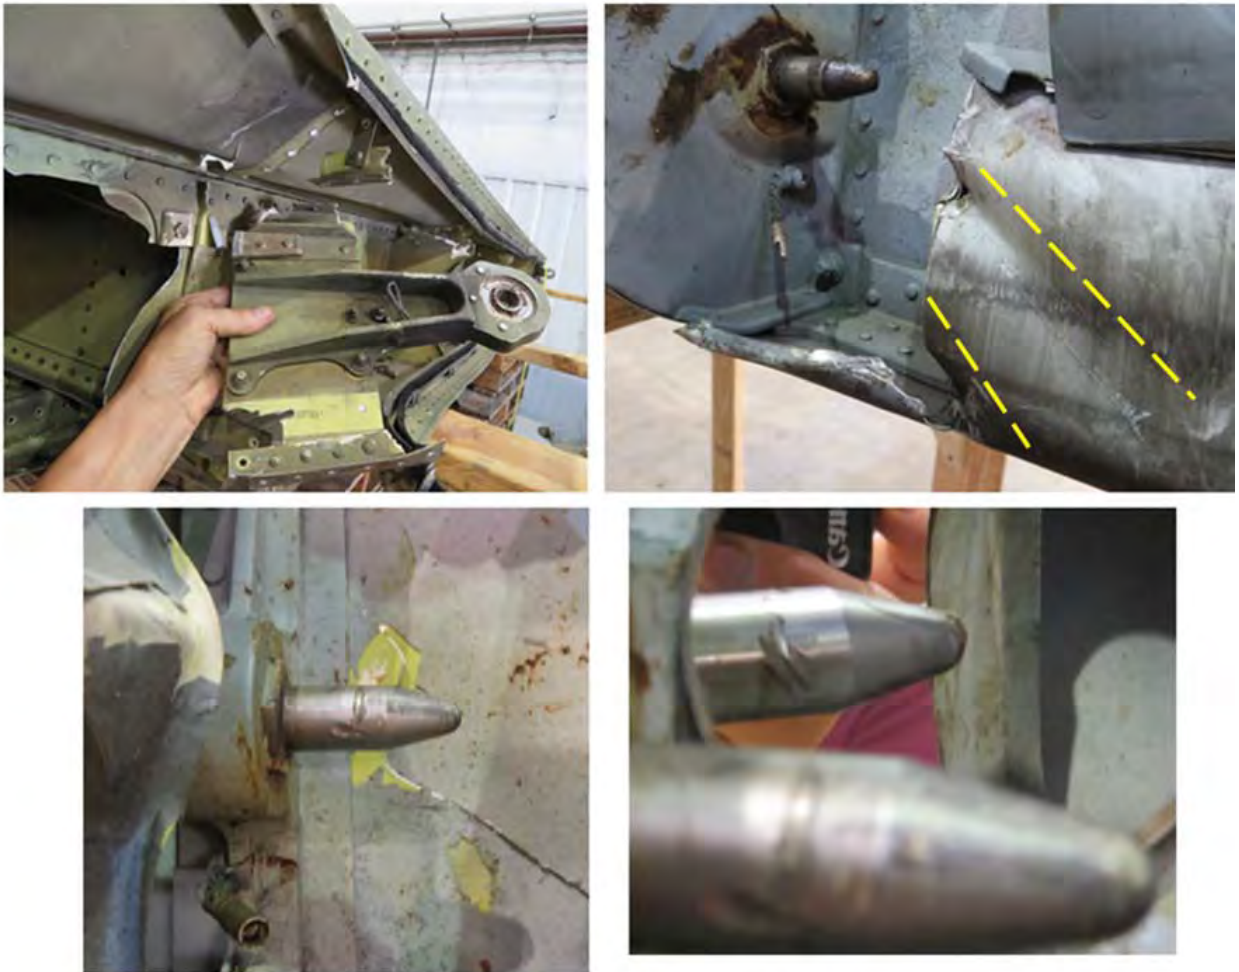
Figure 42: HSS 180 Elevator Hinge Attachment

- HSS 180 (Figure 42): The hinge fitting was torn out of the stabilizer by overload of the upper and lower support attachments to the rear beam and stabilizer trailing edge. Distortion of the attachment brackets and the direction of rivet tear-out indicate that the hinge was pulled outboard and aft to separate from the rear beam. On the elevator, the upper edge was crushed upward at the outboard corner of the pin housing support due to over-travel of the elevator in the upward direction relative to the stabilizer. The hinge bearing was intact and rotated freely. The inner race was crushed on the inboard side but orientation to the elevator pin could not be reestablished because the inner race was free to rotate within the housing. The hinge pin was intact. The elevator leading edge and lower skin corner were dented inward consistent with the hinge fitting arm crushed flat across the surface.

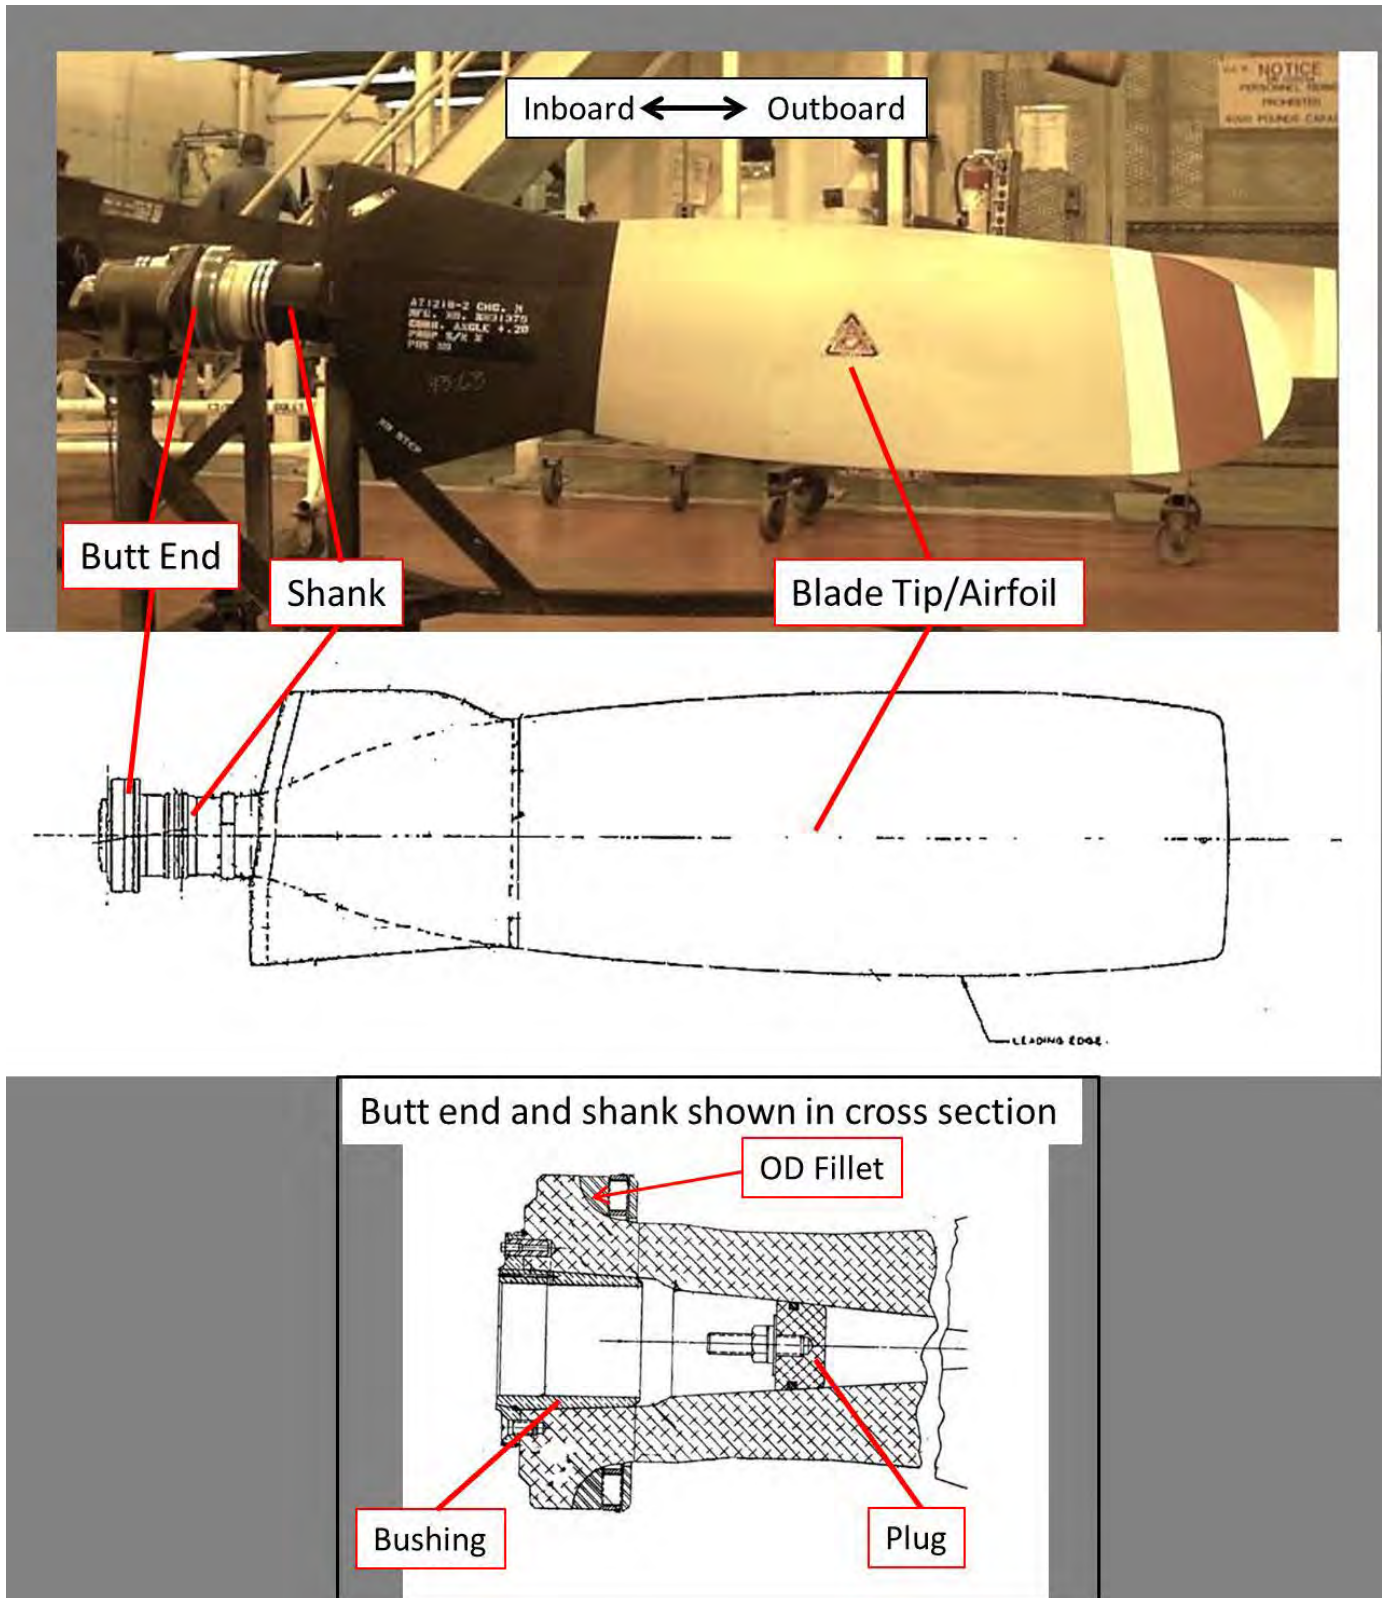
Figure 1 - A7111D-2 Propeller Blade and Cross Section

The blade is made from an aluminum forging and consists of a butt end, shank, and airfoil (Figure 1). The upset forged taper bore portion of the blade's shank serves to lighten the blade and hold the blade plug and balancing lead. An aluminum bronze bushing is press fit into the bore, located by two drive pins and secured by two screws. The bushing translates rotational loads to the blade and is used to adjust the blade pitch. The highly stressed fillet located in the outer diameter (OD) of the blade shank ("OD Fillet") is cold rolled to improve the fatigue performance of the blade.

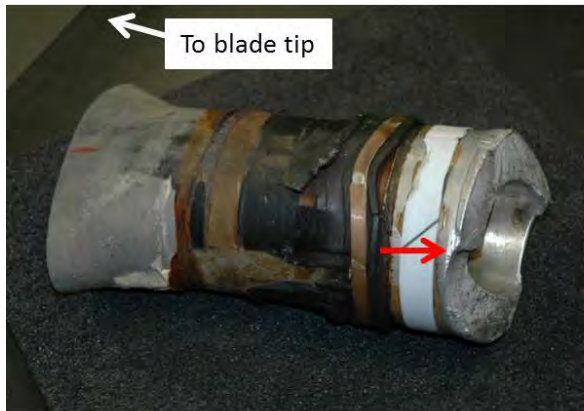
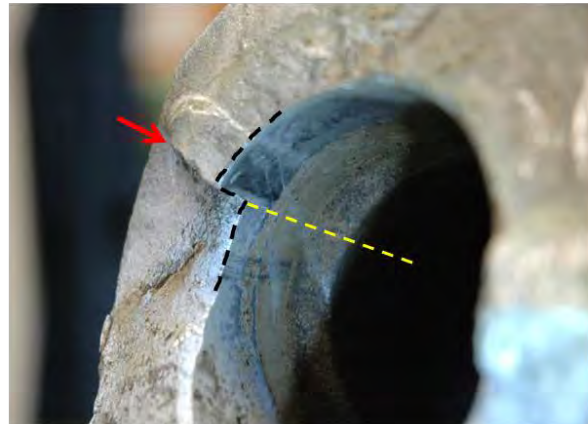
The fatigue fracture surface from the blade shank can be seen after cleaning by acetate tape replicas (used to strip dirt/loose debris from the fracture surface) followed by ultrasonic cleaning in ethanol, in Figure 5. The fatigue crack extended 5.5" around the circumference for an arc length of approximately 100° with initiation at the outer bound (outer here referencing towards shank OD) of the radial crack located at the 30° blade index marking. A discussion of the fatigue fracture surface features and propagation can be found in the subsequent *Fractography* section. The radial crack was fully opened in the lab revealing an intergranular fracture topography. Once opened (Figure 6) the fatigue could be seen initiating directly from the outer bound of the radial crack before propagating outward (towards OD) and circumferentially on two planes as previously shown in Figure 5. A discussion of the radial fracture surface features can also be found in the subsequent *Fractography* section. The entire radial crack fracture surface is shown in Figure 7. Relevant dimensions for the radial and fatigue cracks are shown in Figure 8. The radial crack initiated from the shank's inner diameter (ID) and did not break through the outer diameter before initiating the fatigue crack. The fatigue crack initiated from the outer bound of the radial crack, propagated towards the OD and circumferentially on two planes roughly 1-1.25" below the outboard tip of the bushing. At the time of failure the total length of the radial crack was approximately 2.7" with about 1.25" extending past the outboard tip of the bushing (inspectable crack length with bushing installed). Historically radial cracks tend to reach lengths around 5-6" and break through to the OD before initiating a circumferential fatigue crack. The subject crack, roughly 3" in length, progressed through only 64% of the blade shank's cross section before fatigue initiated and is the first known occurrence of fatigue initiating from a radial crack not fully through the blade shank's wall thickness.

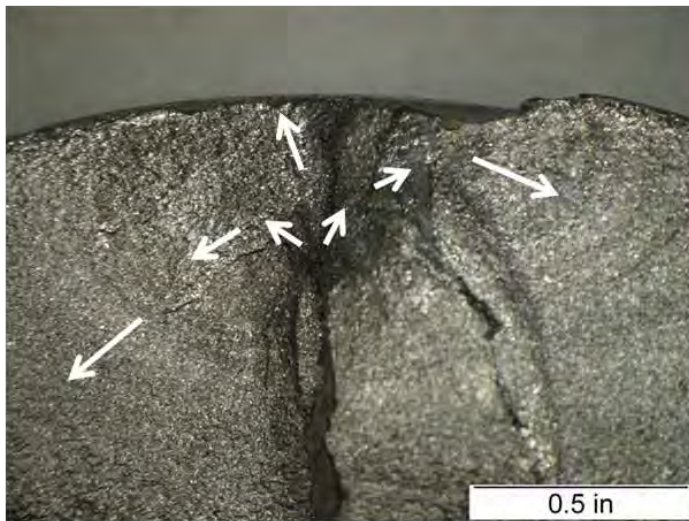
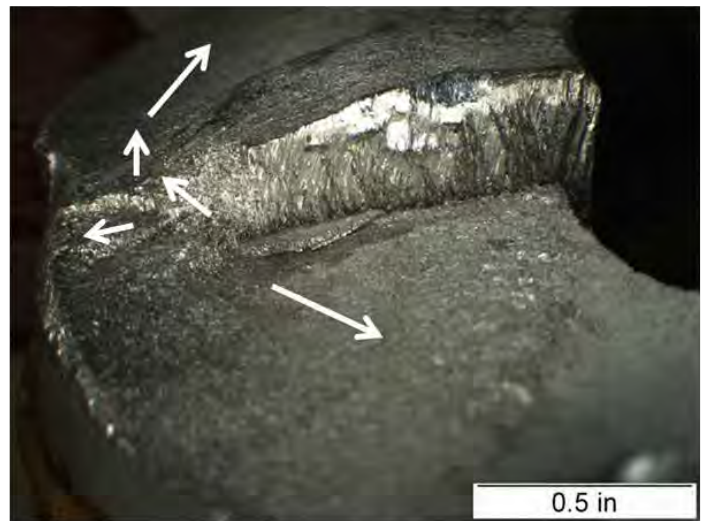
Fatigue fracture surface with arrows indicating crack propagation direction

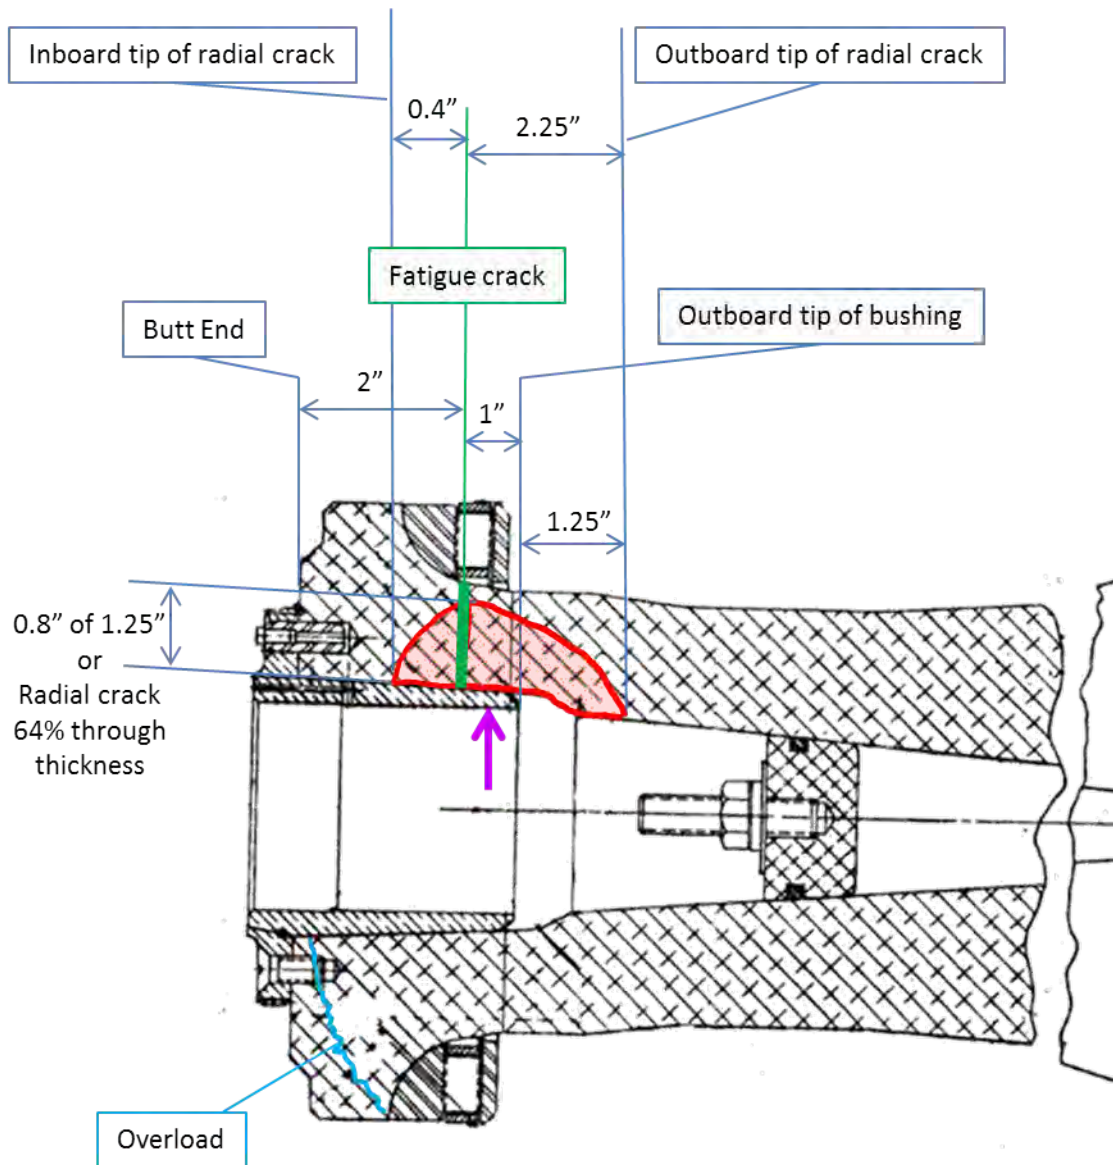
Although an exact origin could not be identified, geometry of the radial crack suggested an origin near the outboard end of the bushing seat (indicated in Figure 7, & Figure 8). This area is considered a “hot spot” as far as corrosion related failures are concerned (referred to as “distal end of bushing seat” in necrology – Appendix A). It is in this area that pitting (a precursor to intergranular cracking) is usually concentrated and numerous historical radial cracks have been found. In this area, on the subject blade, a circumferential band of flakey material was observed (Figure 9, also indicated in Figure 6). Sectioning through this band revealed intergranular cracking (IGC) emanating from tunnel-like corrosion pits beneath the surface. On top of and within the pits/IGC was a gold colored, non-conductive surface coating chemically confirmed via EDS (Figure 10) to be anodize. Also observed in the band of IGC and additionally throughout the bushing seat were gold bottomed craters. Metallurgical cross sections through some of the craters revealed them to also be corrosion pits covered in anodize. The presence of anodize within corrosion pits and the band of IGC provides clear evidence that the corrosion damage was present and subsequently processed over at the Sept 2011 overhaul.

Figure 8 – Schematic showing radial and fatigue crack location in cross section and relevant dimensions. Purple arrow indicates approximate origin of radial crack.

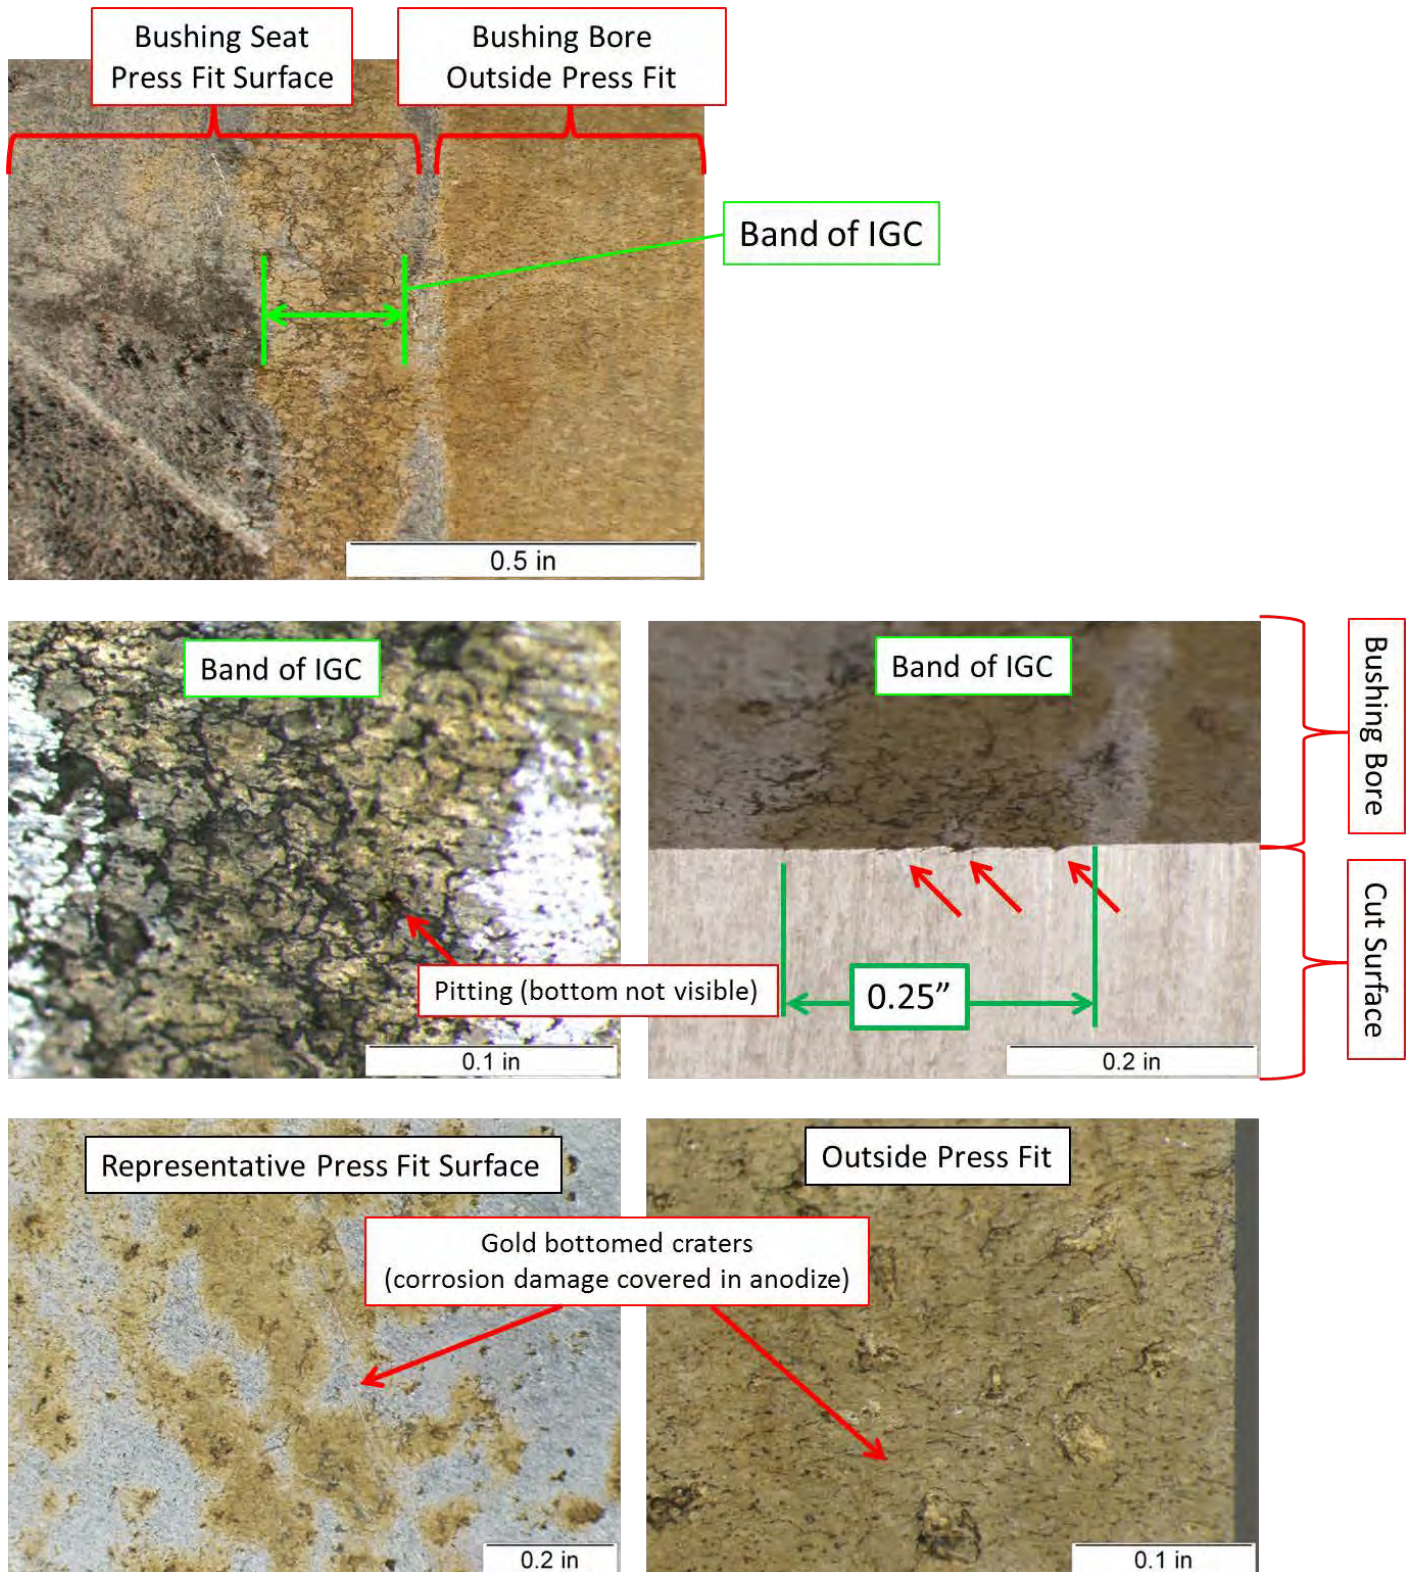
Figure 9 -Bushing bore surfaces – Note changing scale bars
