Figure 4: Center Fuselage Side Section Panels

Figure 8: Center Fuselage Side and Upper Section, FS 245 – FS 477

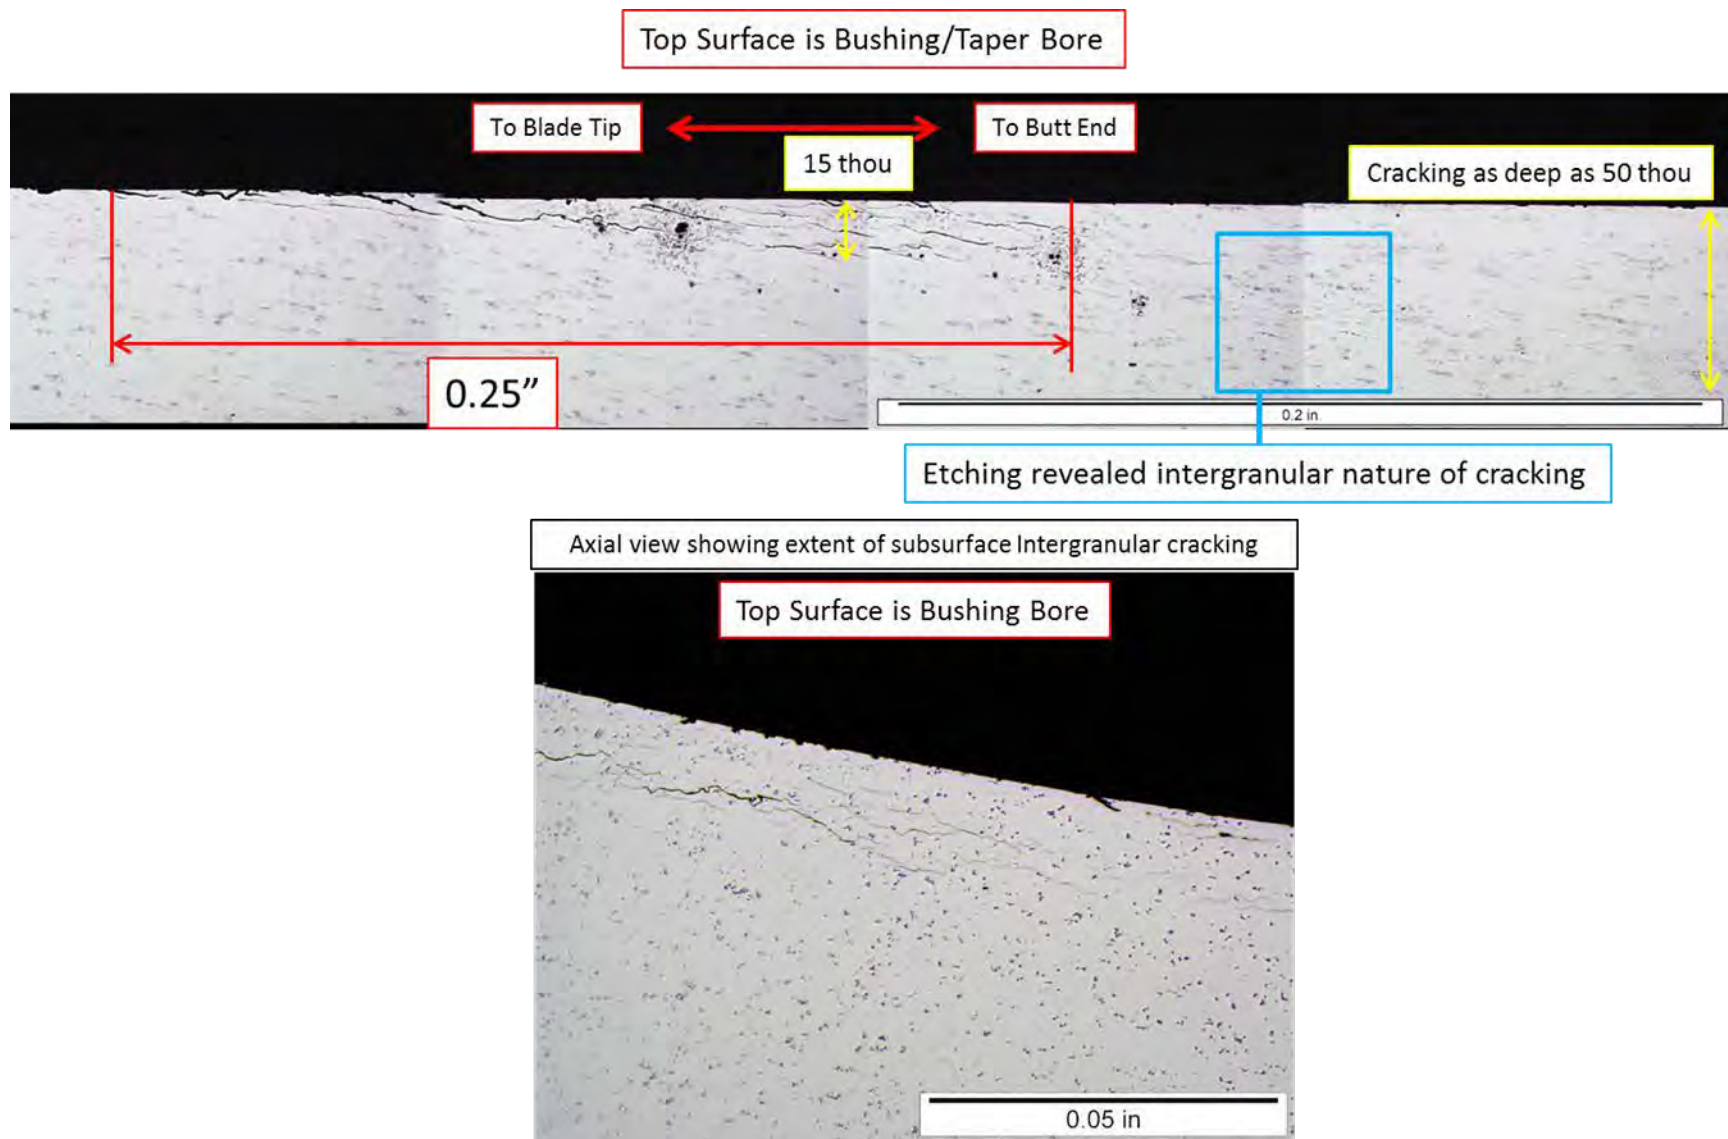
A metallographically prepared cross section was made through the band of IGC (Figure 12). Tunnel like pits can be seen following the grain flow from the forging process, running roughly 45 degrees from the surface (ID surface of the bushing bore). The tunnel-like pits extended to depths of 15 thou (0.015”) before transitioning to more hairline-like IGC. IGC was observed to depths in excess of 50 thou and also ran roughly 45 degrees to the surface.

Figure 12 – Longitudinal (top) and Axial (bottom) views of metallurgically prepared cross sections through band of IGC (As-polished)

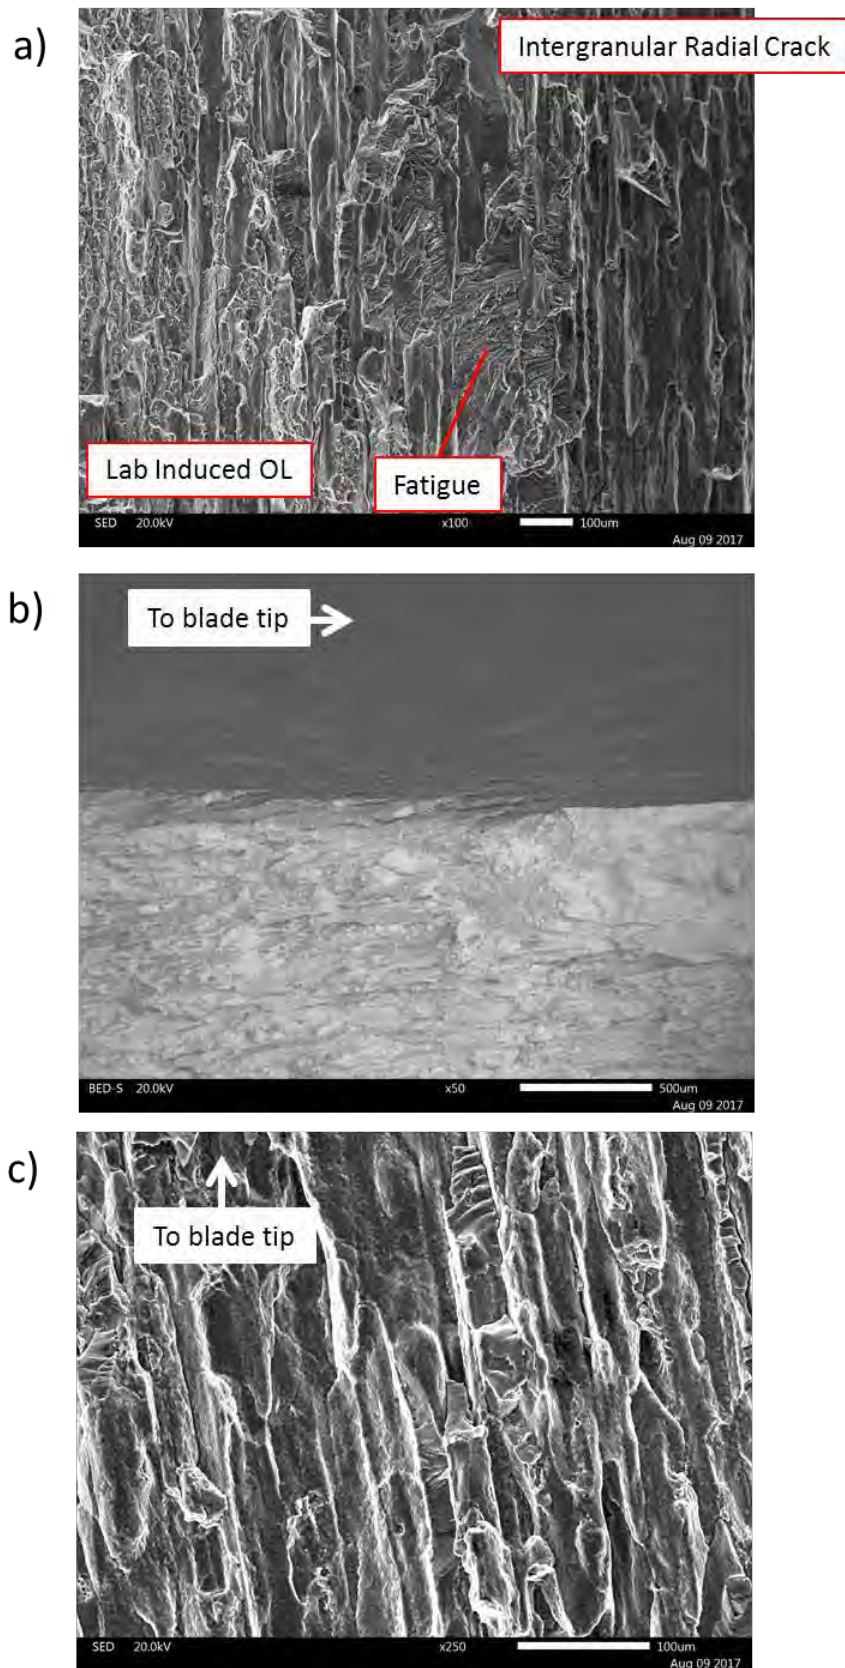
Representative Scanning Electron Microscope (SEM) images of the radial crack can be seen in Figure 13. The fracture surface had an intergranular topography covered in heavy corrosion product that required the use of acetate replicating tape to strip from the surface. As previously mentioned, fatigue could be seen initiating from intergranular fracture topography at the outer bound of the radial crack. At the approximate origin of the radial crack were layers of flakey material similar to what was observed at the band of IGC on the bushing bore surface (Figure 9) and in the cross sectional view (Figure 12). This suggests that the radial crack was formed as the network of IGC connected/coalesced and propagated through the thickness of the blade shank.

Figure 13 - Representative SEM images from intergranular radial crack; a) Fatigue initiating from outer bound of radial crack; b) Backscattered SEM image showing approximate origin of radial crack (topography similar to Figure 12a); c) Representative fracture surface

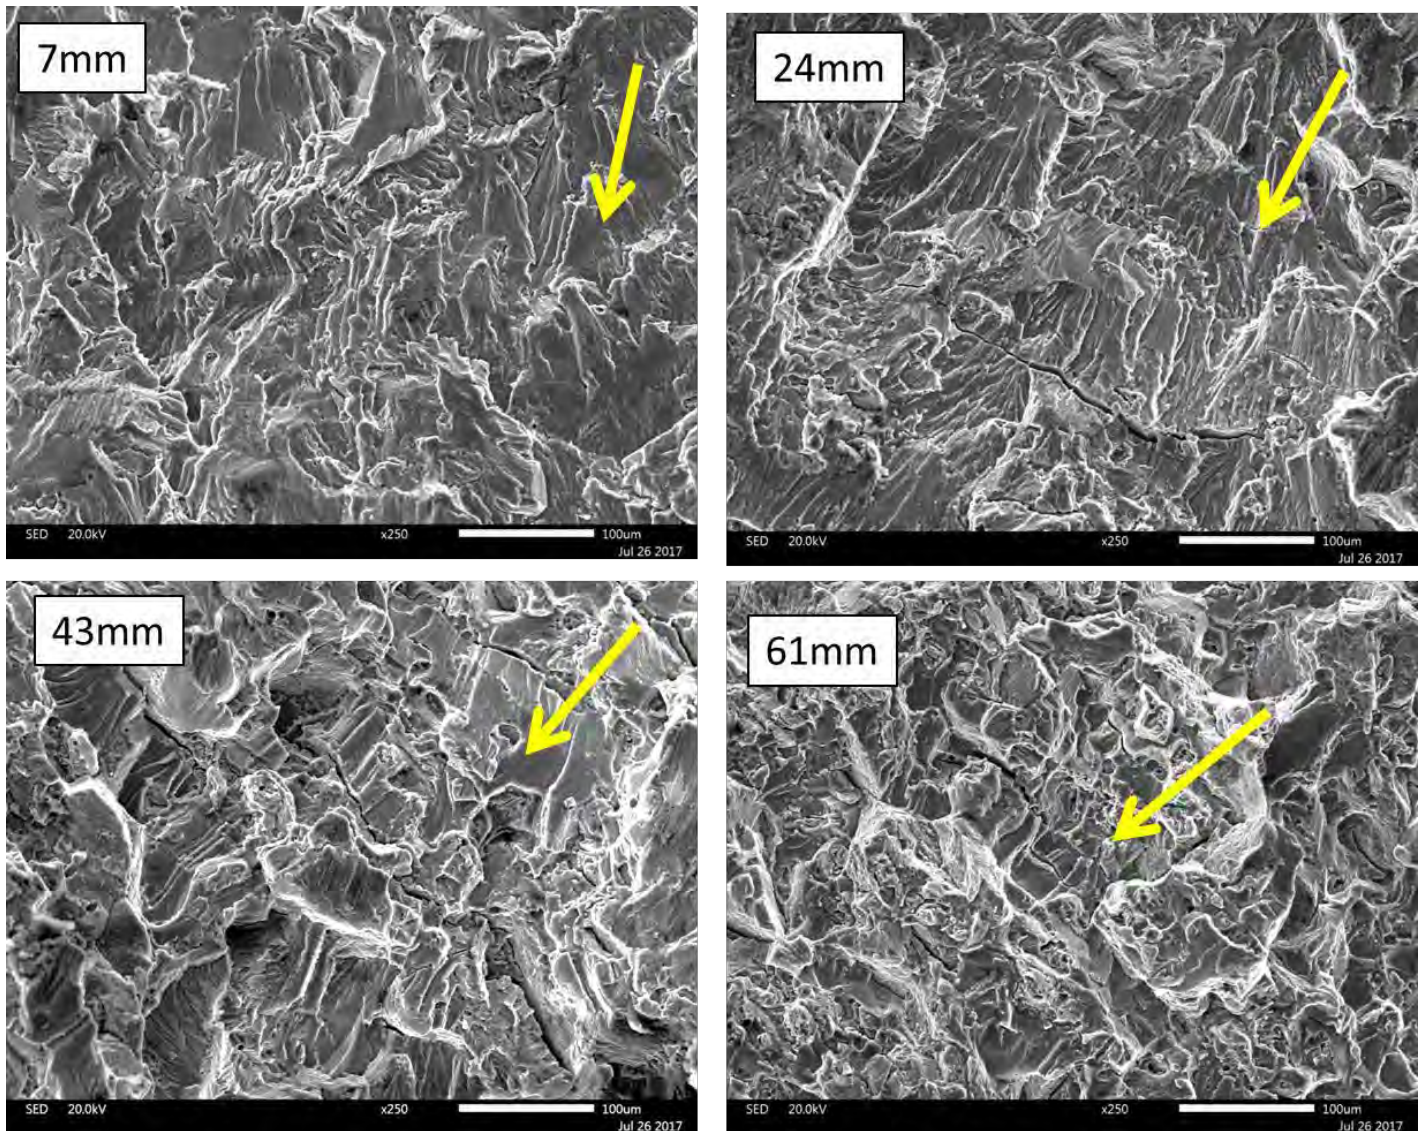
The fatigue initiated subsurface, at the outer bound of the radial crack where it propagated towards the OD, breaking through that surface first, as well as splitting onto two circumferential planes. The longer of the two fatigue planes extended approximately 65mm from the origin (tip of radial crack). The fatigue was characterized into three regions; the first extended from the origin to about 35mm, approximately when the fatigue crack broke through to the ID, and consisted entirely of fatigue fracture with no indications of ductility (overload fracture). Between 35 and 50 mm the fracture was mostly fatigue but ductility began to present and increased with distance from the origin. Finally between 50 and 65 mm the fatigue fracture was highly unstable with large amounts of ductility/overload and some fatigue scattered throughout. A macroscopic map of the fatigue fracture surface is shown in Figure 14 and representative SEM images are provided in Figure 15. Representative striations at various distances from the fatigue origin are shown in Figure 16.

Figure 15 - Representative SEM images from various locations along fatigue fracture surface. Number indicated is distance from origin. Yellow arrow indicates fatigue propagation direction. All Images 250X

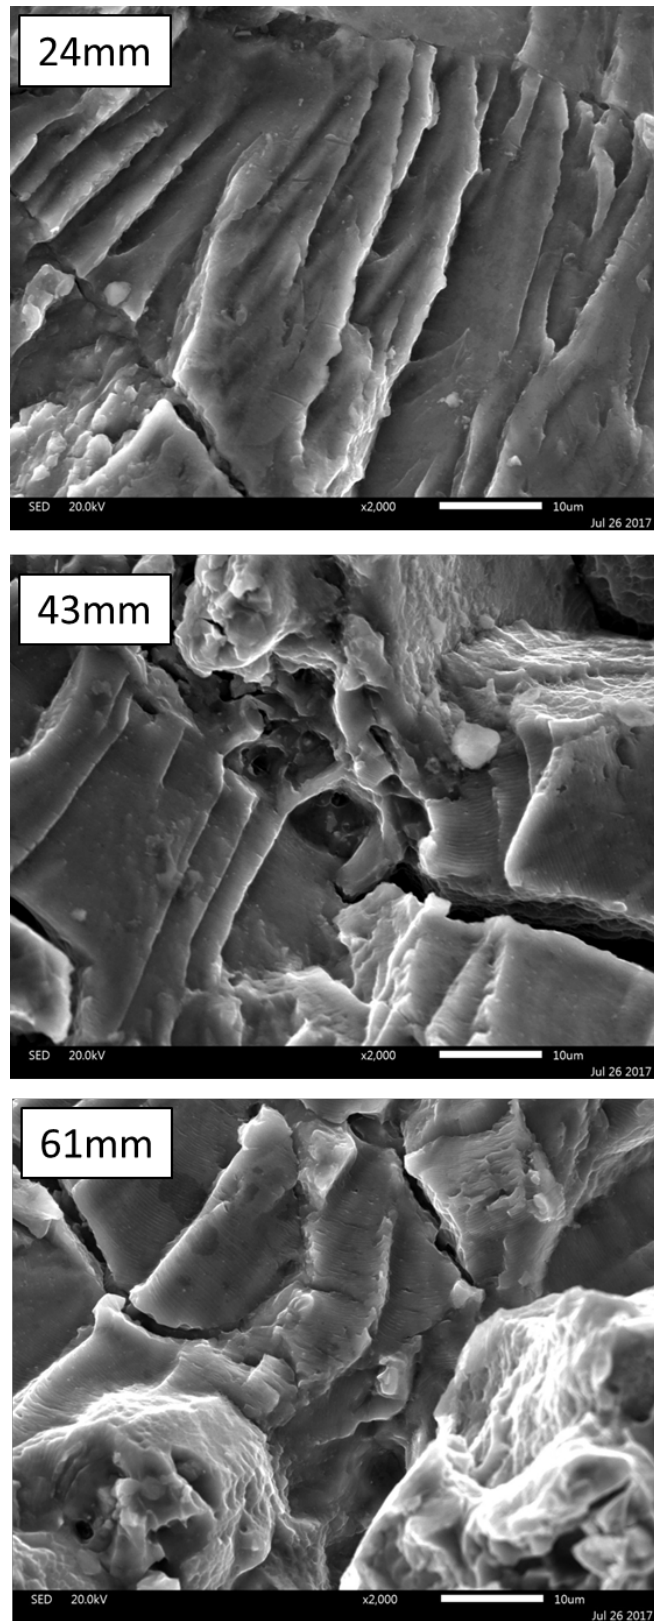
Figure 16 - Representative SEM images showing fatigue striations from various locations along fatigue fracture surface. Number indicated is distance from origin.

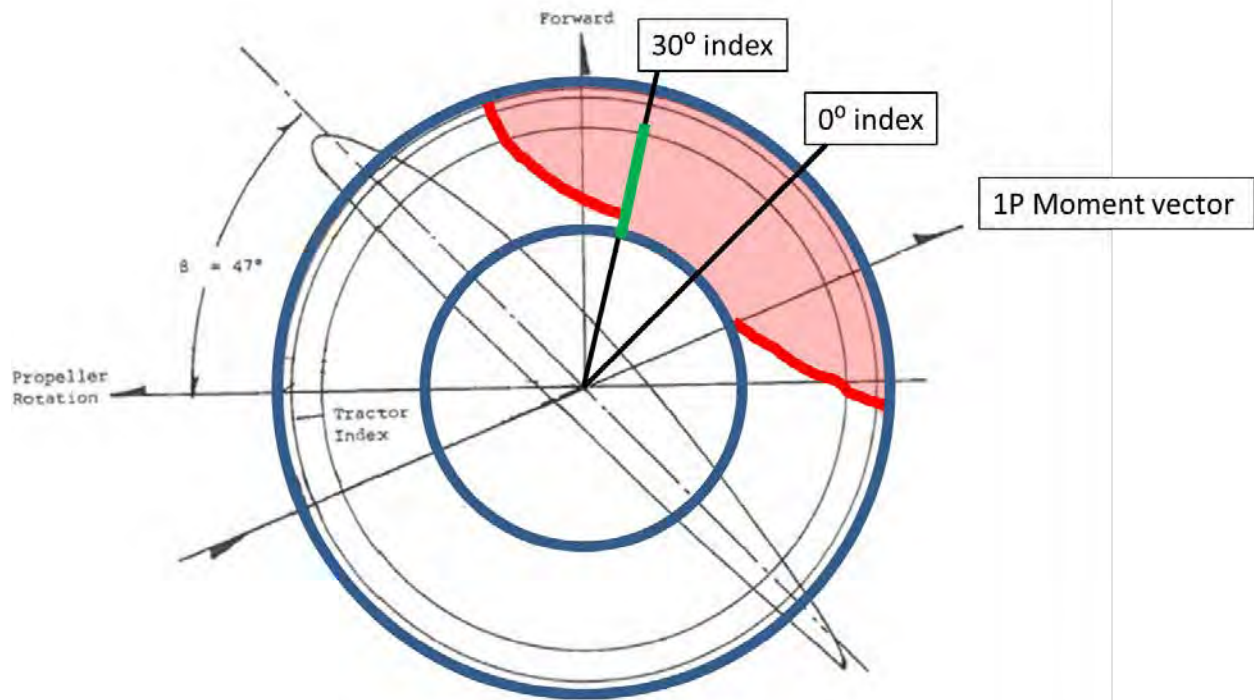
Following discussions with UTAS stress analysis expertise it was determined that propagation of the fatigue crack is motivated by the blade flexing/bending/twisting stresses which are largest in magnitude in the direction of the 1P Moment vector. The exact location and magnitude of the 1P Moment vector is dependent on flight conditions such as takeoff/cruise, altitude, etc. Since the initiation of the fatigue crack is dictated by the location of the radial crack, and the propagation of the fatigue is motivated by a dynamic 1P Moment vector, the critical (circumferential) crack length prior to catastrophic overload has been shown to vary throughout historical instances ranging anywhere from 90° to 300°. For reference, a sketch of the subject fatigue crack with respect to the 1P Moment vector at climb conditions is shown in Figure 17.

Figure 17 - Sketch of subject fatigue crack (red) and radial crack (green) with respect to 1P Moment vector and blade angle at climb conditions. View is from hub looking towards blade tip, airfoil shown at 42" reference station.

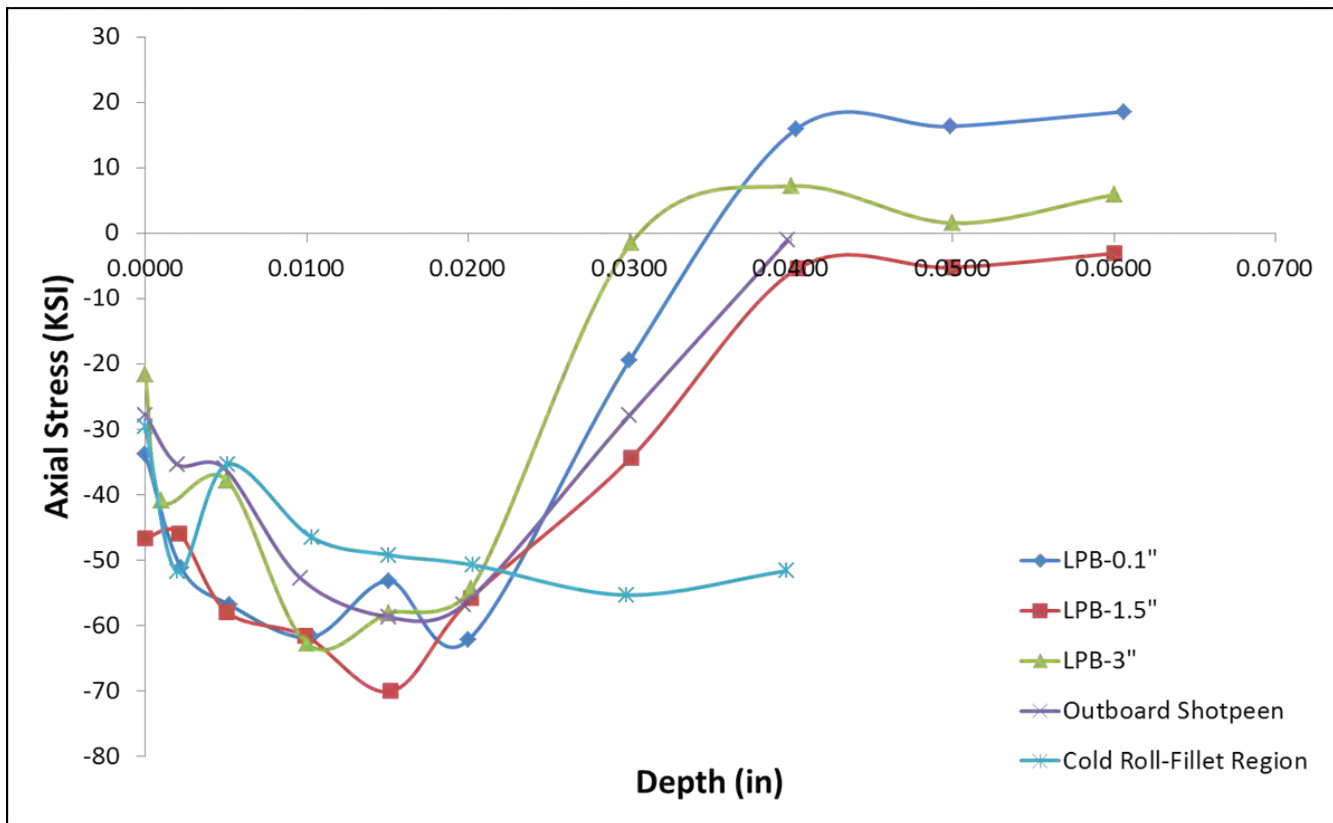
Figure 18 - Residual Stress Analysis XRD Results. Approximate locations shown in cross section.

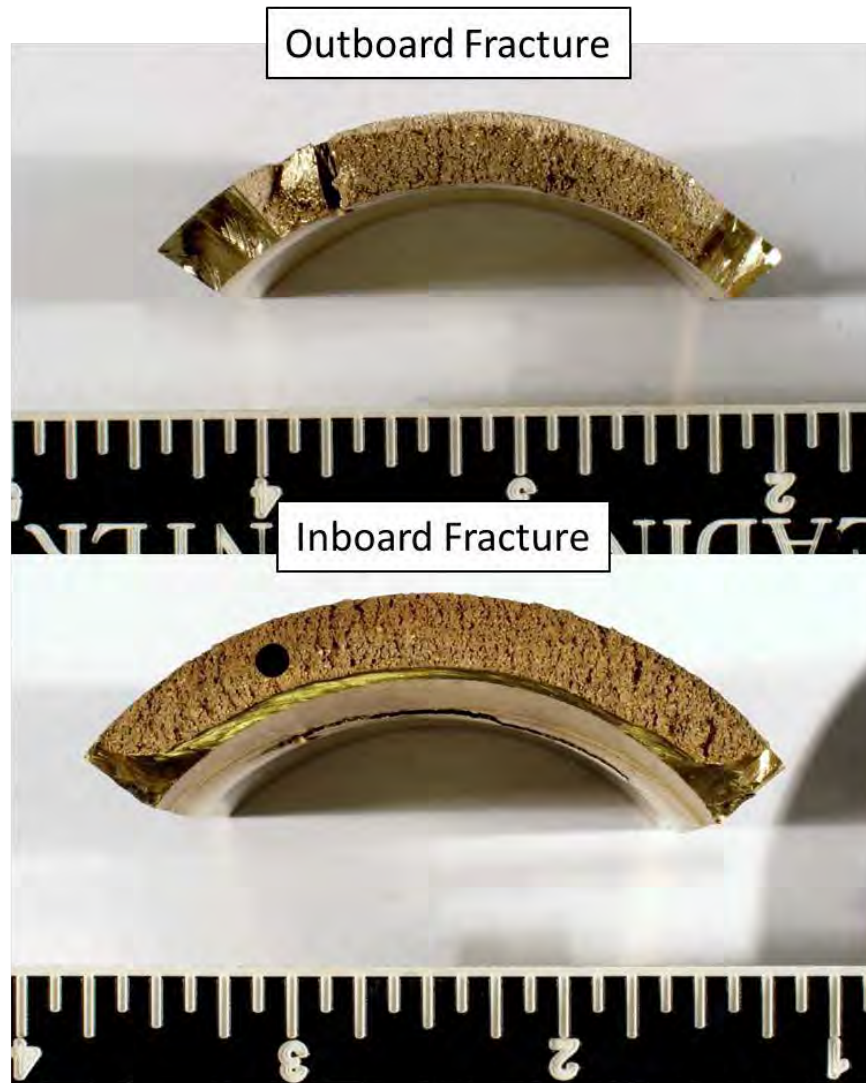
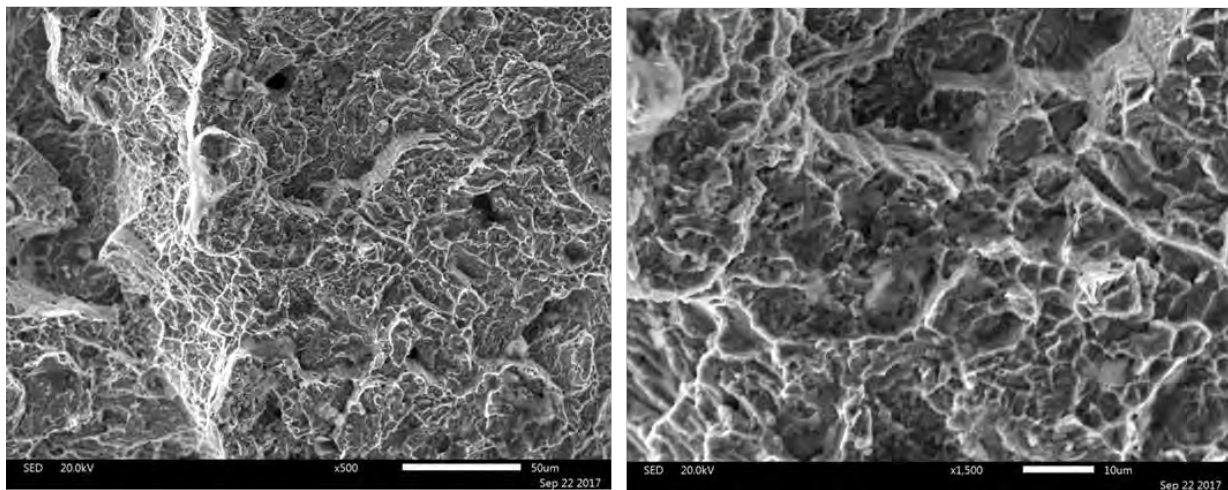
Figure 20 - Bushing fracture surfaces (view looking outboard) and representative SEM Images at 500X (left) and 1500X (right)

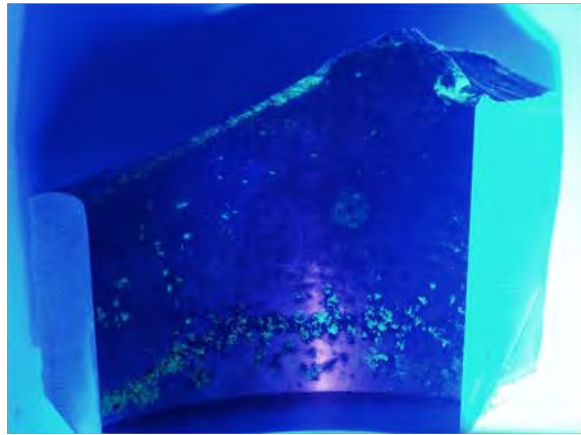
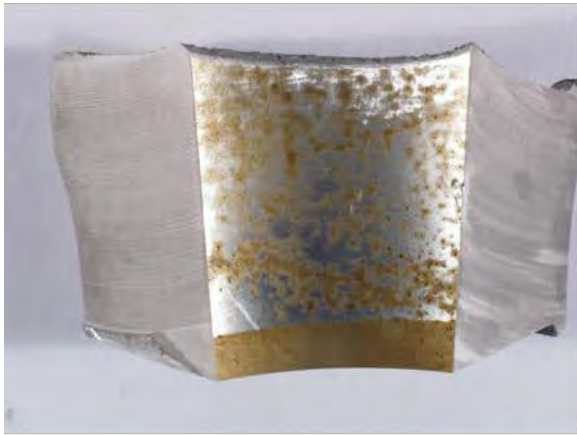
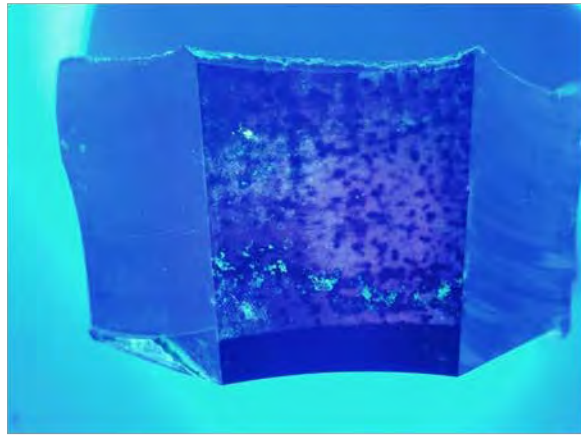
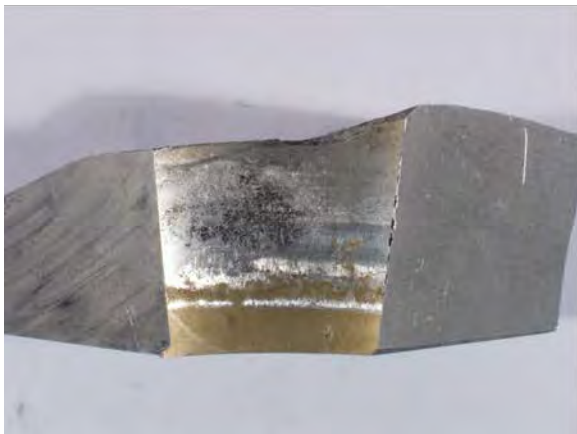
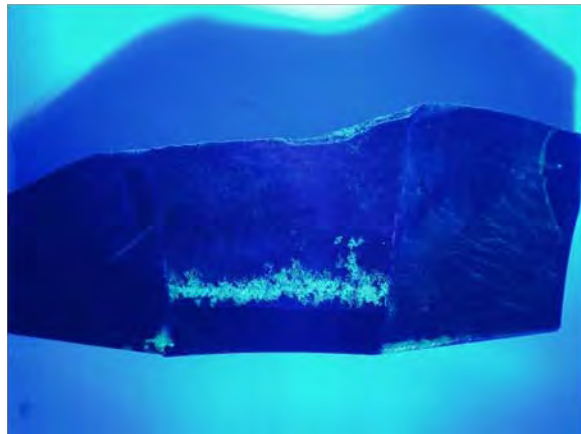
UV Lighting
(FPI Indications will fluoresce)

Figure 21 - FPI Indications from band of IGC on subject blade. In all images bushing bore surface is shown and circumferential fracture is upper surface. Blade tip direction is down.
